# CONSERVATION MANAGEMENT PLAN FOR BRUSSELTON RESERVOIR

**Archaeo-Environment  
for the Friends of the  
Stockton & Darlington  
Railway**

**AE-0205 April 2020**

**CONDITION SURVEY REPORT**

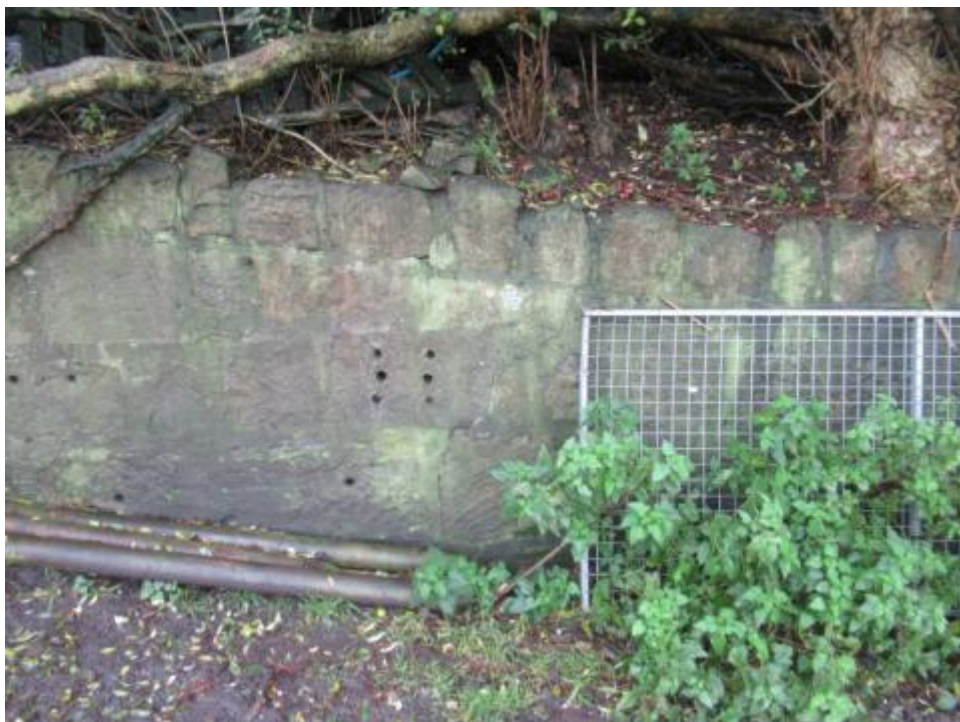
P2 - West Elevation retaining wall with reused railway sleeper blocks (holed)  
(**Note:** structural cracking)

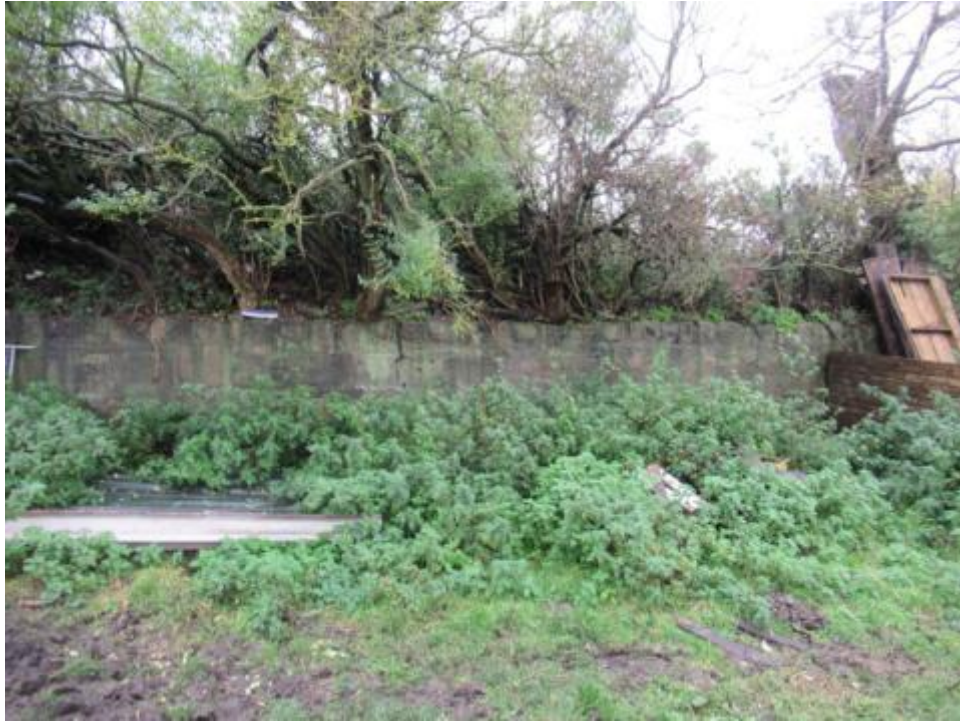
P3 - West Elevation retaining wall with reused railway sleeper blocks (holed)  
**(Note:** structural cracking over the height of the wall)

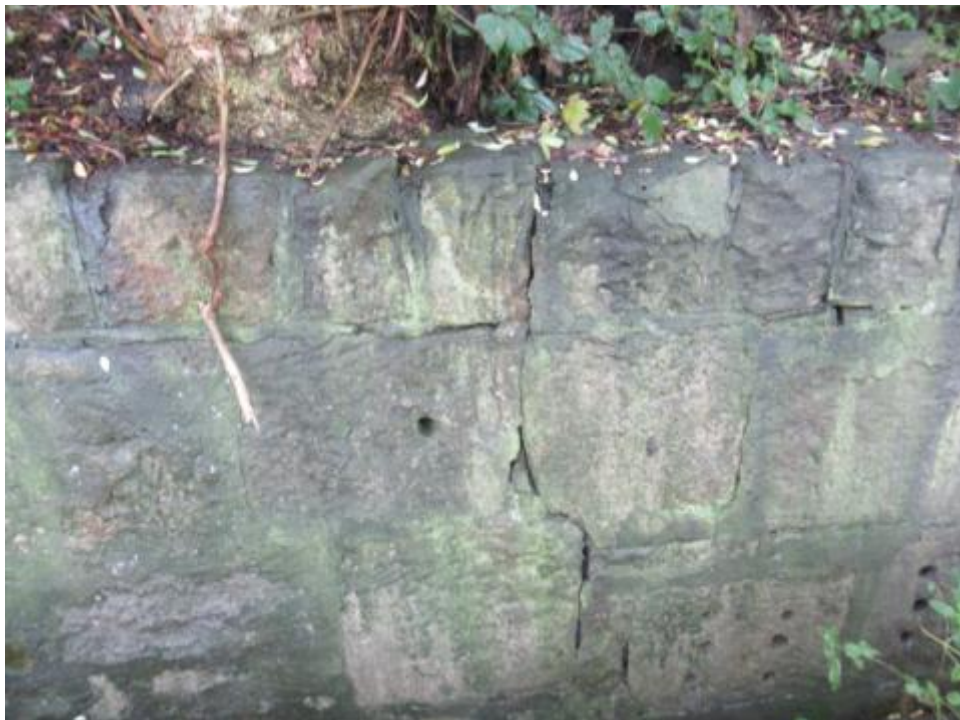
P4 - West Elevation retaining wall with reused railway sleeper blocks (holed)  
**(Note:** structural cracking)

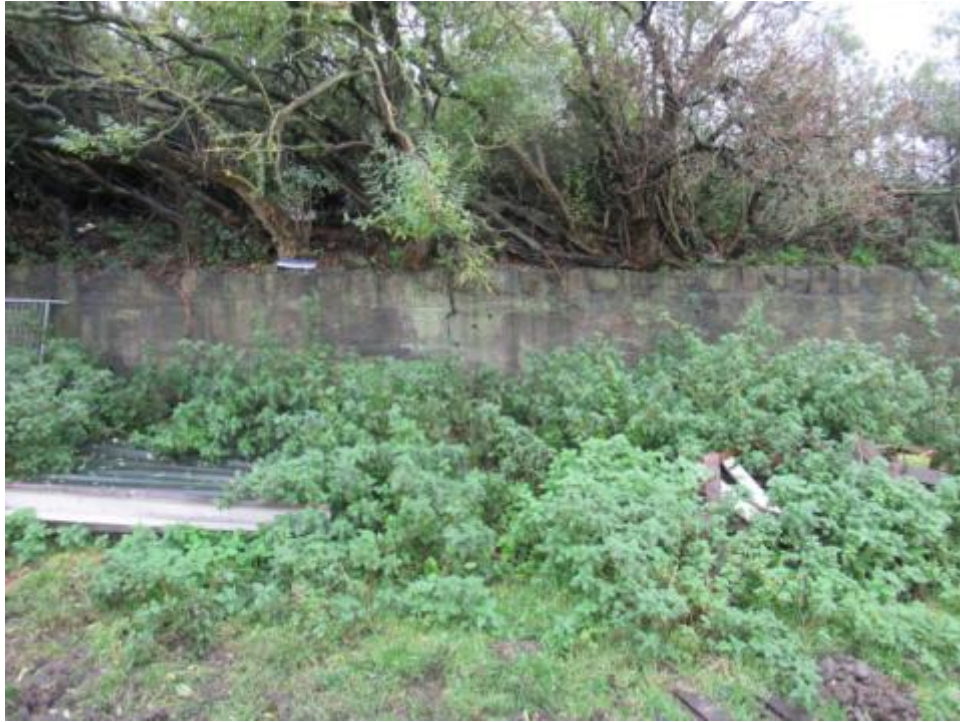
P5 - West Elevation retaining wall with reused railway sleeper stones (holed)  
(**Note:** structural cracking)

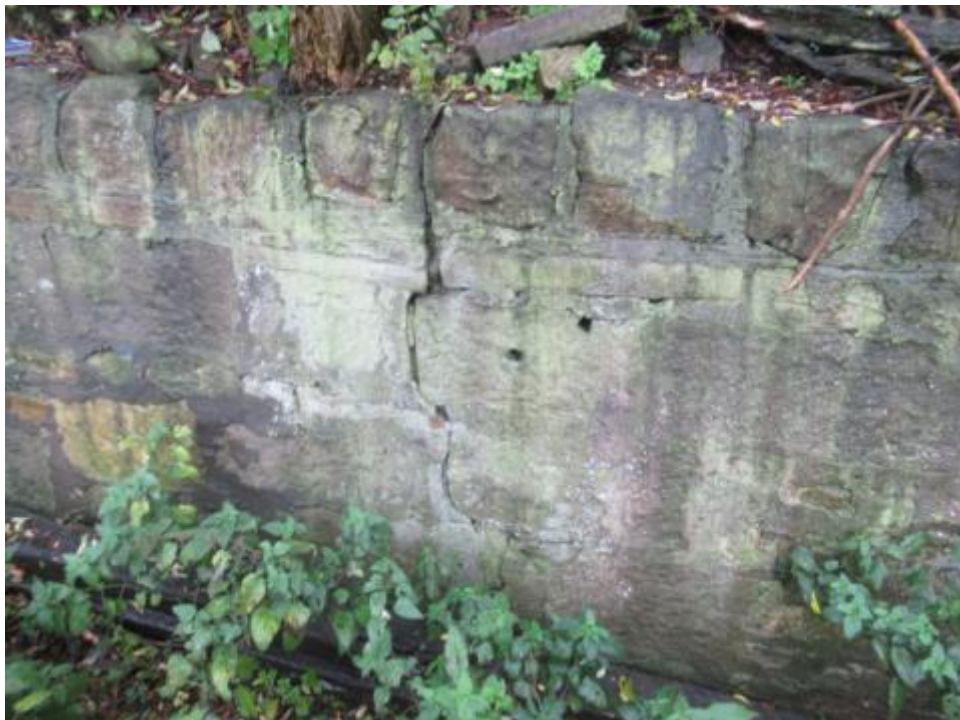
P6 – West Elevation structural cracking

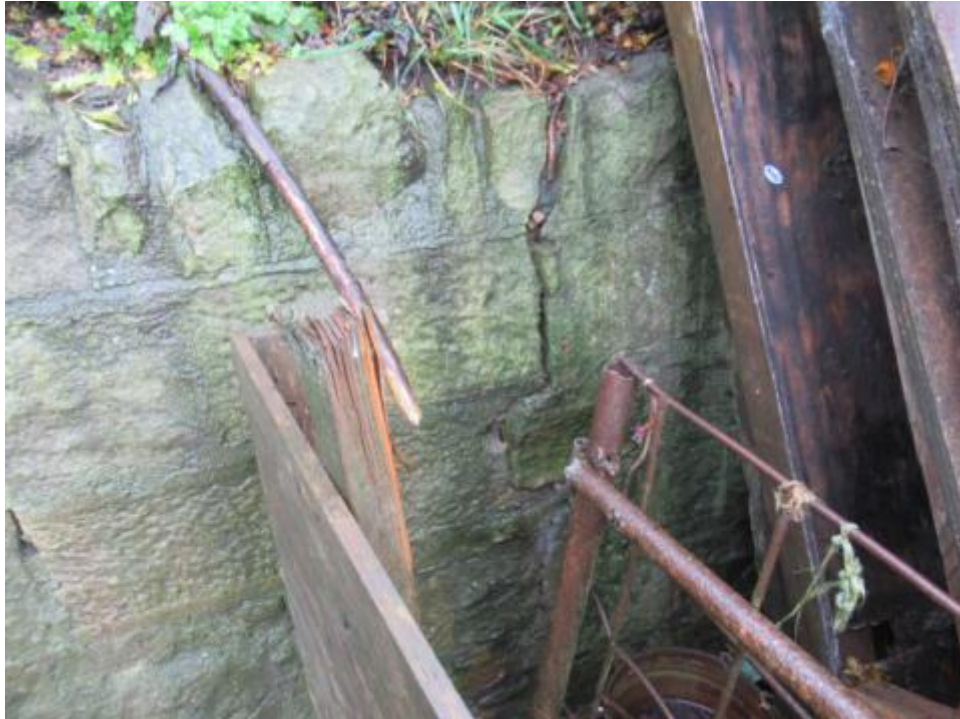
P7 – West Elevation structural cracking and outwards displacement of the stone

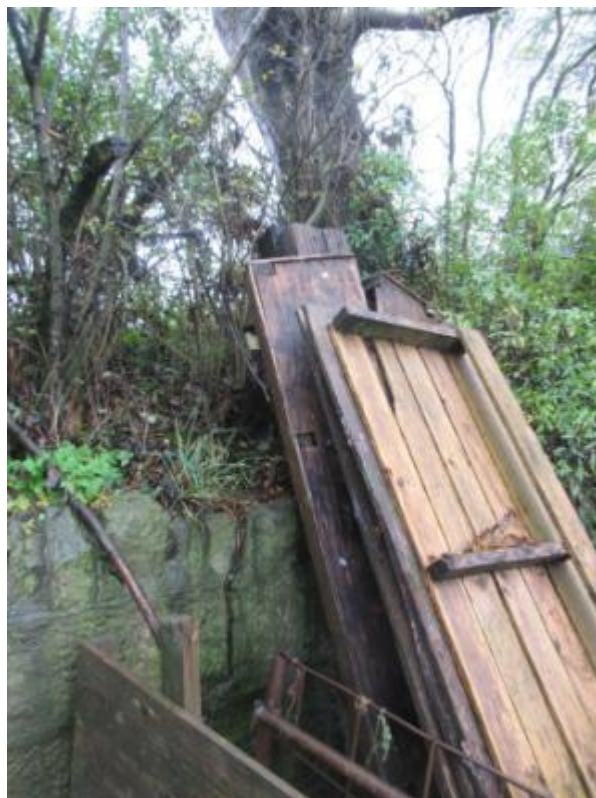
P8 - West Elevation retaining wall structural cracking and displacement indicative of outer movement

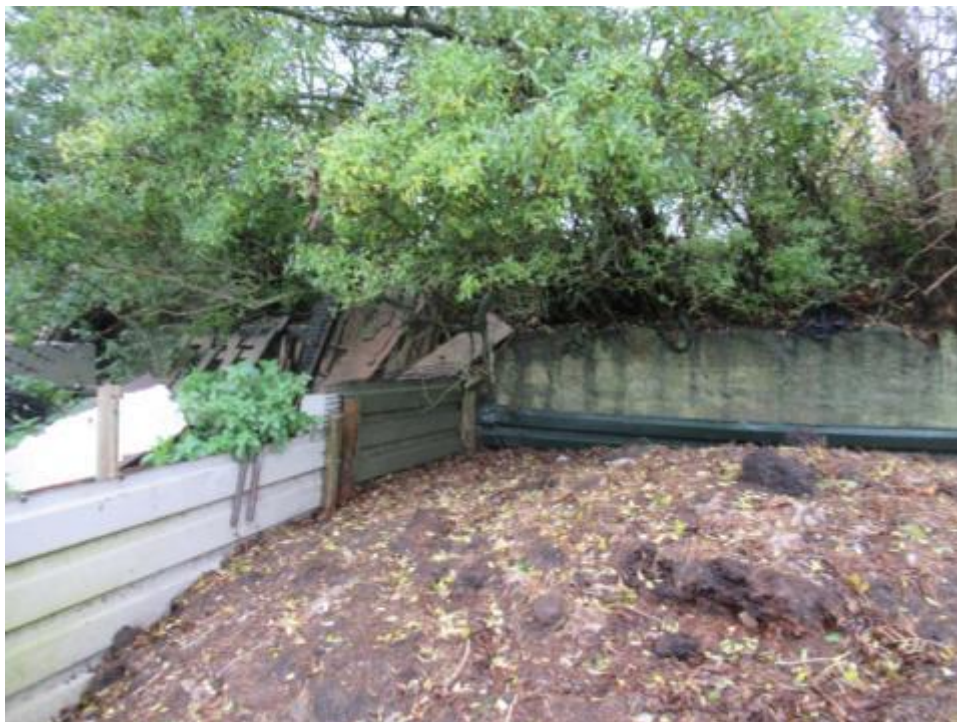
P9 - West Elevation manure heap stacked up against the stone retaining wall

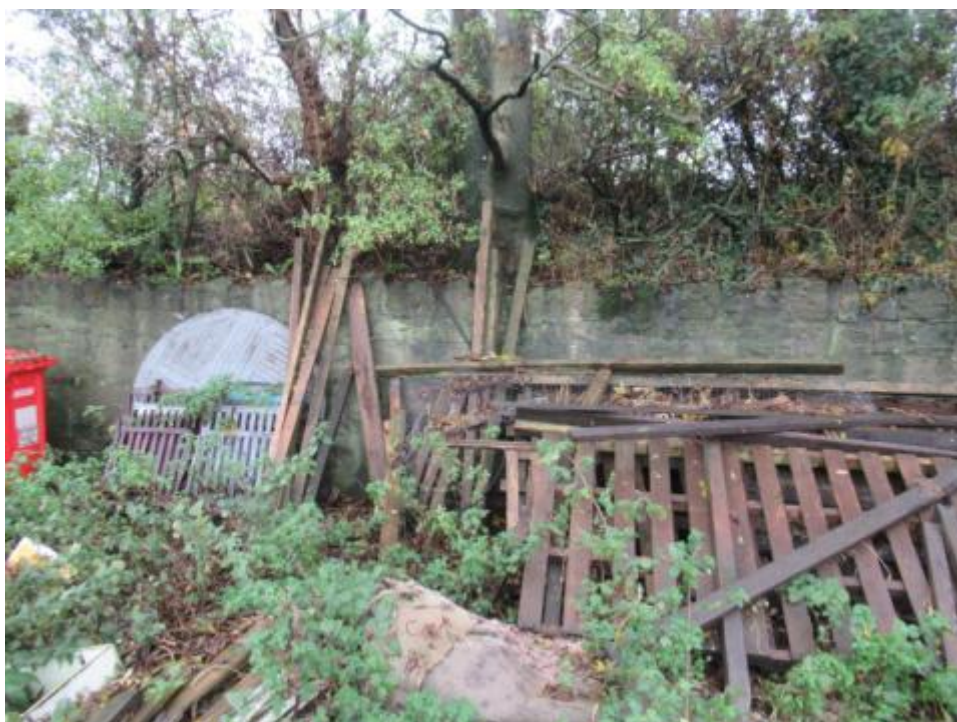
P10 - West Elevation debris stacked up against the stone retaining wall

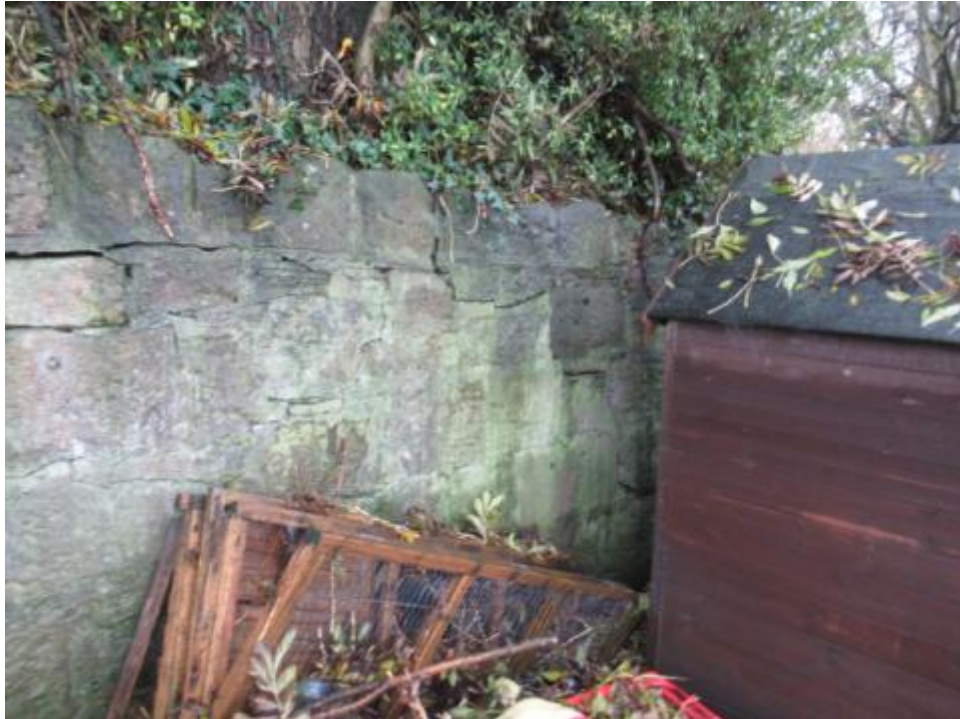
P11 – West Elevation section of structural cracking and displaced stonework to the retaining wall

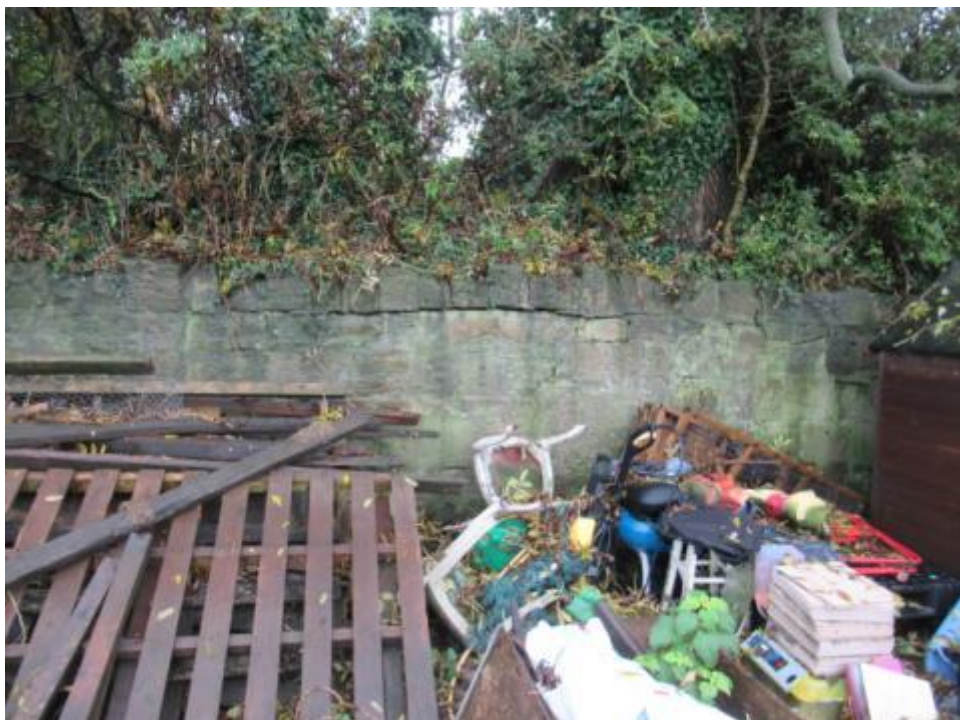
- 2.1.5.2 ➤ Vertical structural cracking and isolated displacement of the retaining wall resulting from the mechanical root action of the trees on top of the wall (Refer to Appendix C Tree Report indicating the extent of the tree growth on the West boundary). It is noted that to the majority of the areas the structural cracking has not resulted in outward displacement and could be remediated by the installation of stainless steel bars inserted and resin bonded across the cracking to provide restraint

P12 – West Elevation structural cracking and displacement of the wall caused by tree root growth

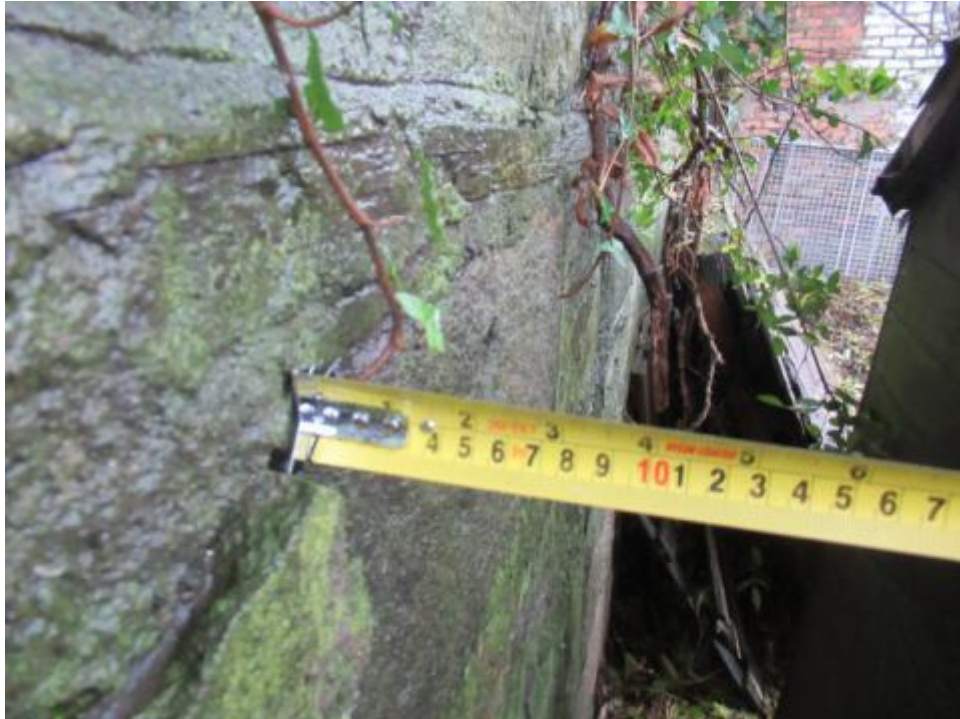
P13 – West Elevation stonework outward displacement

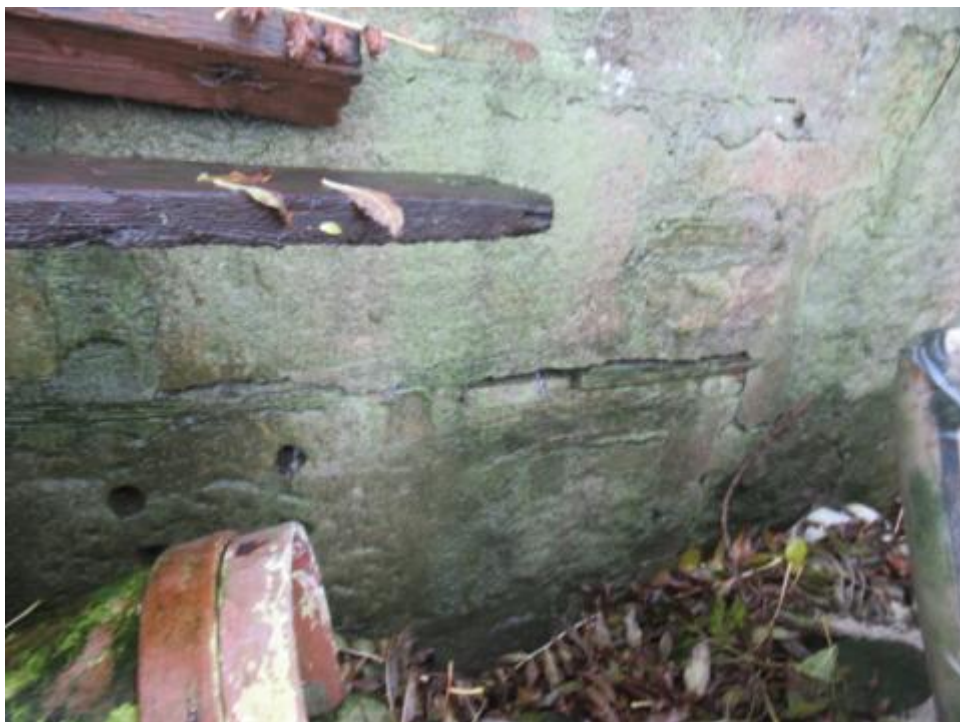
P14 – West Elevation

**(Note:** in 'built in' bonding timber decayed and within the bulged section of the stone retaining wall

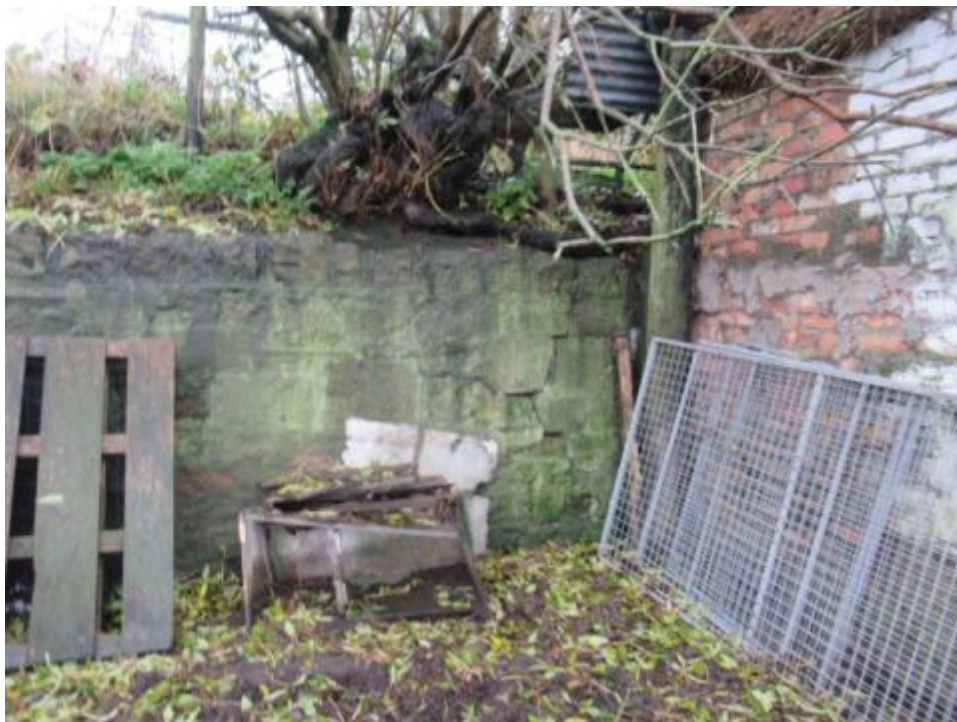
2.1.5.4 ➤ Diagonal, horizontal and vertical cracking and outward displacement of the retaining wall by up to 15 mm is evident (Refer to Photograph P15). This section of the wall has been subject to considerable lateral forces caused by root action of the tree (marked as 'Goat Willow' in the Tree Report at the top of the retaining wall). Given the extent of the bulging of the walling it is unlikely this section of the wall could not be stitched and restrained effectively whilst insitu. It should be taken down and carefully rebuilt which may necessitate the removal of the tree.

P15 – West Elevation structural cracking and displacement of the stonework adjacent to the lean-to offshot

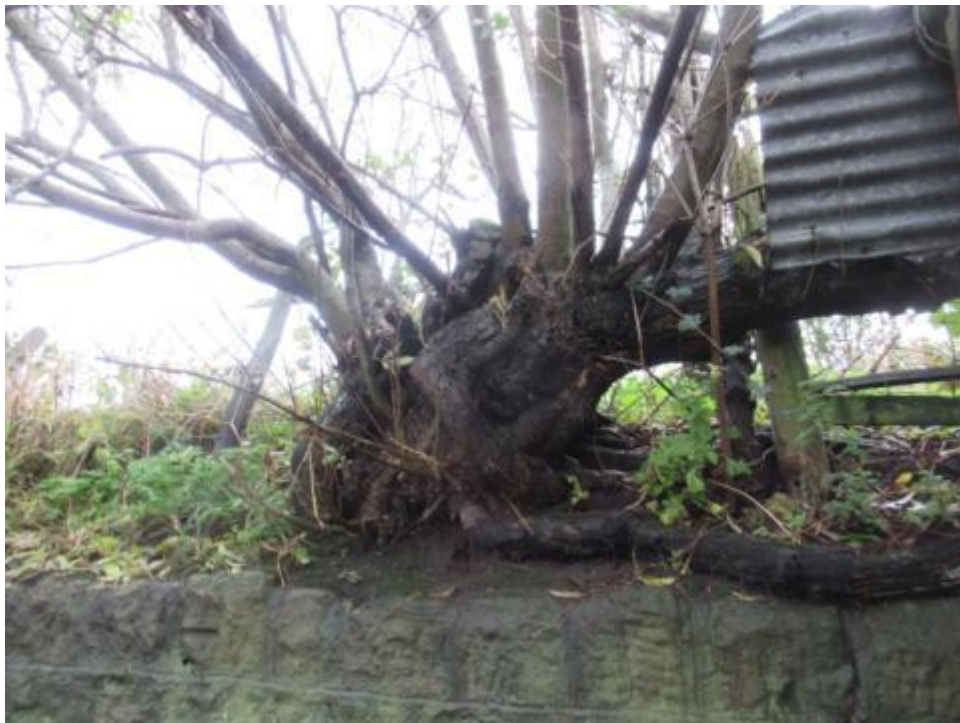
P18 – Tree root growth at the top of the retaining wall

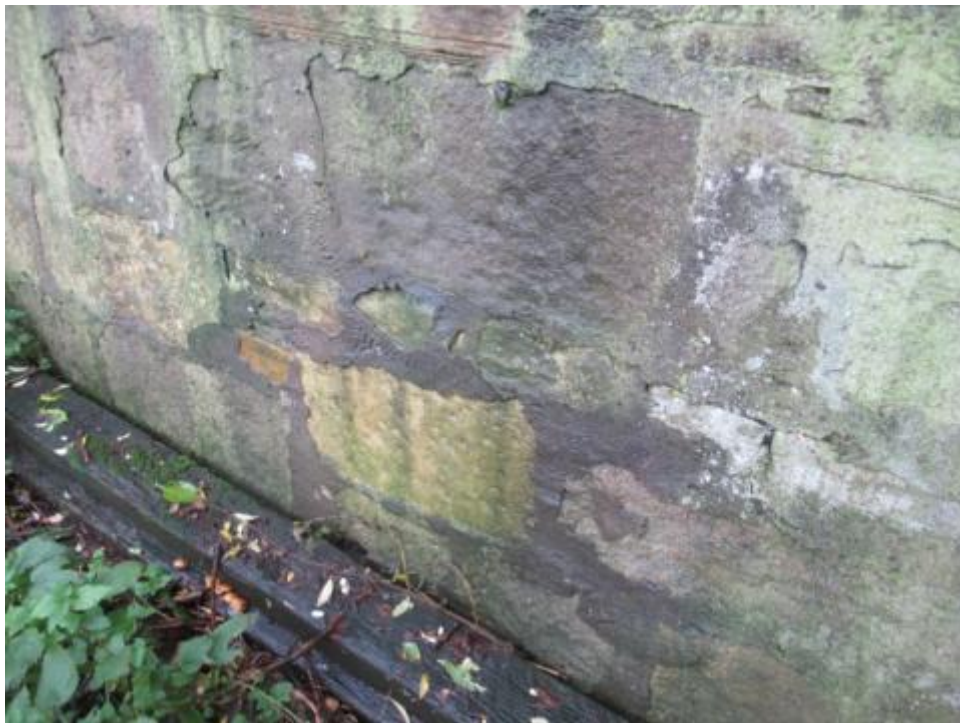
- 2.1.3 It is evident the wall has been repointed in a cement based mortar which has been applied over the original lime mortar and extends onto the face of the stonework having been liberally applied. It is noted that there are holed stone blocks within the wall which were reclaimed sleeper stones re-used from the original railway in the 1820's.

P26 – Hard cement mortar applied to the face of the stone units resulting in increased erosion

2.1.5.5 ➤ To arrest any further delamination and spalling of the stonework in the medium term it is recommended the wall is raked out and repointed in a NHL (Natural Hydraulic Lime) mortar based upon the original mortar mix which should be chemically analysed. The copings should also be removed and rebbed to the top of the wall and its full length.

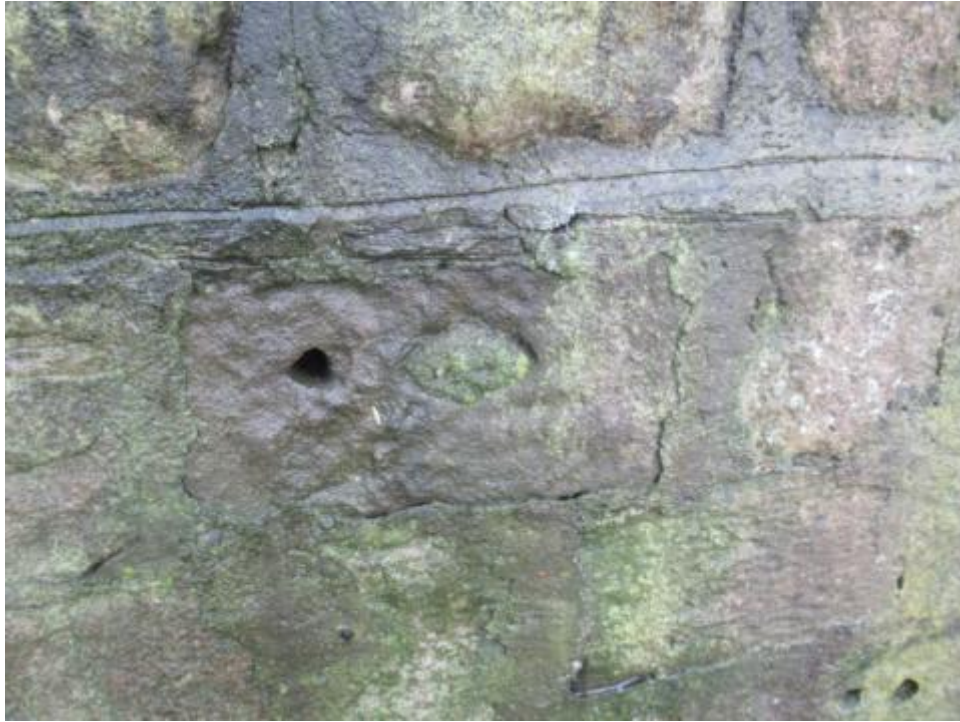
- 2.1.5 The inspection revealed the following defects within the wall and these are identified in the photographs appended to this report:-
- 2.1.5.1 ➤ Isolated areas of eroded stonework resulting from increased frost action and erosion due to the use of cementitious mortar repointing exacerbated by its application upon the surface of the stone thereby creating ledges to trap surface water

P27 – Hard cement mortar applied to the face of the stone creating ledges, water entrapment and increased erosion of the stone

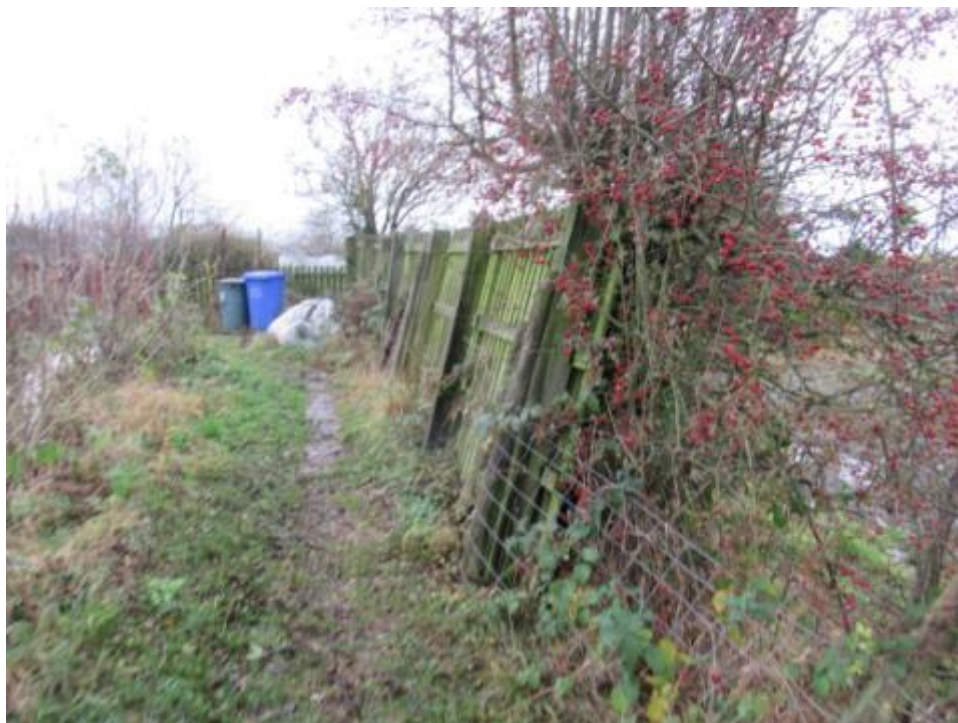
P34 – East Elevation – timber pales 4 Nr rail fence with timber posts and railway sleepers used as posts; posts collapsed and outward lean of the fence

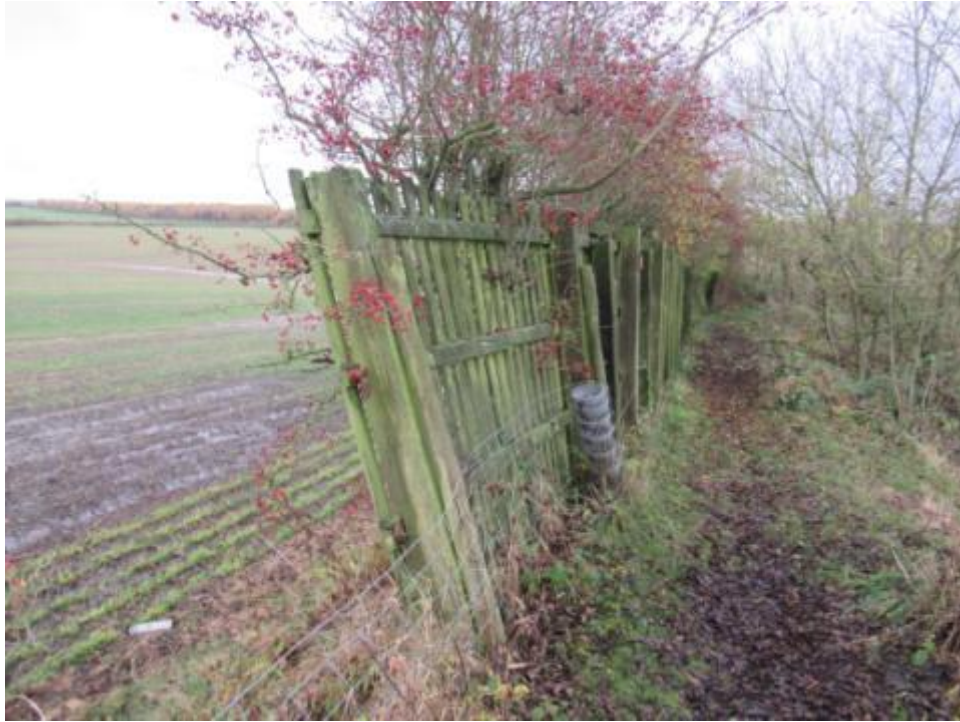
P35 – East Elevation – section missing and collapsed fence
