## The 1825 Stockton & Darlington Railway: Historic Environment Audit

### Appendix 4. County Boundary to North Road Station, Darlington.

October 2016

**A**rchaeo-Environment for Durham County Council, Darlington Borough Council and Stockton Council.

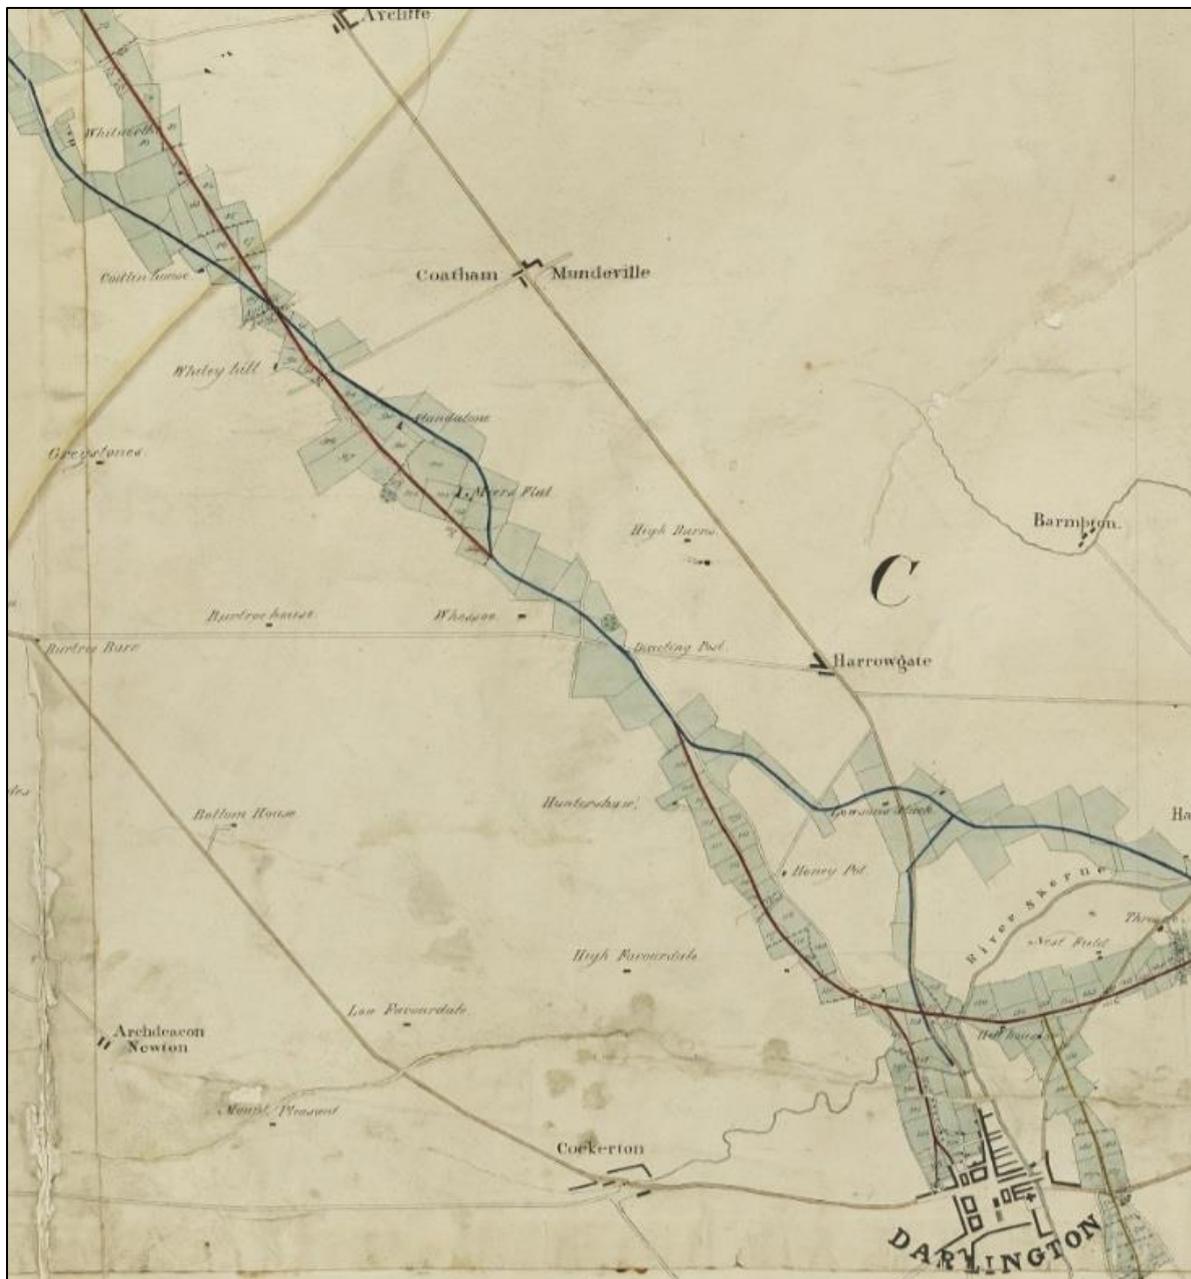
Figure 2. George Stephenson's map of the proposed S&DR railway, showing the route, in red, from Heighington to Darlington and incorporating some of Overton's earlier proposed route (in blue) surveyed in 1822 (DRO Q/D/P/8/1).

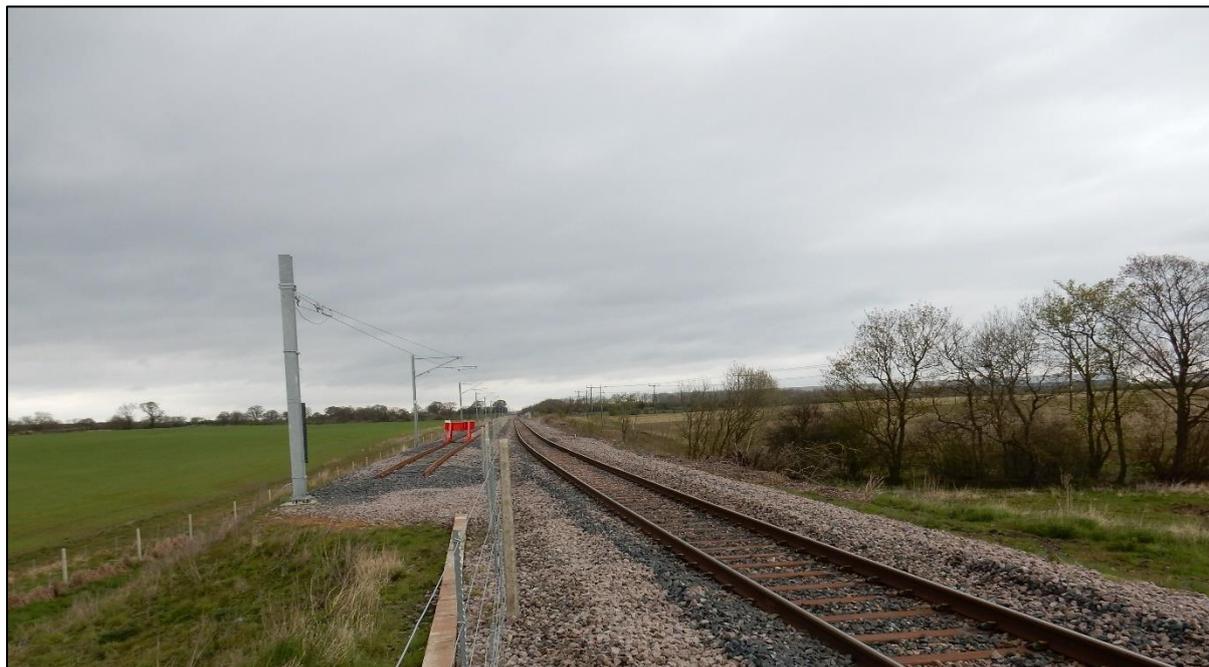
The line south of the administrative boundary can currently only be viewed from a public right of way that runs through Whiley Hill Farm (with some attractive 18<sup>th</sup> century buildings overlooking ridge and furrow). The right of way then overlooks the line before cutting across it. The recent widening of the line can be seen where Hitachi has created an additional track.

*Plate 1. Additional track bed recently built for Hitachi on the left*

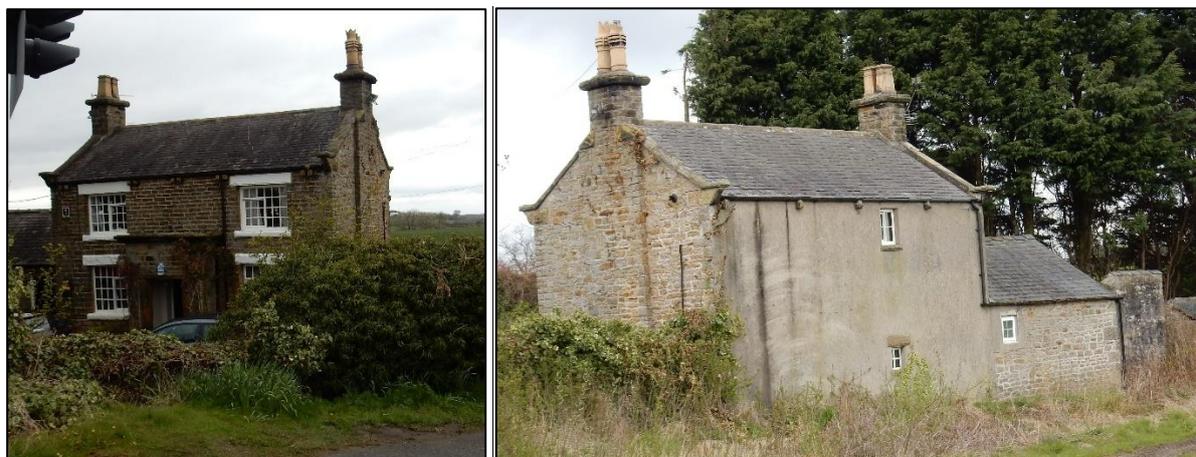
At Whiley Hill the line passes a level crossing which is still overlooked by the delightful Crossing Keeper's Cottage, a listed building (HER 34804). This stone building with kneelers and multi paned casement windows once provided a good view of the line, but intervening trees now prevent this. The rear of the building which overlooks fields has very few windows – clearly the house was designed to view the railway line and nothing else and so this is part of its architectural interest. It has a S&DR black and white ceramic plaque on the front elevation giving the house the number G1. The S&DR instructed their rent collector to install such plaques in 1857 on each group of residential properties. The house had no access to mains services until the 1980s. Prior to that in the first half of the 20<sup>th</sup> century the first train of the day would drop off large containers of water for the keeper's family to use.<sup>1</sup>

*Plate 2. The Crossing Keeper's Cottage at Whiley Hill front elevation facing the line (left) and rear elevation facing fields (right)*

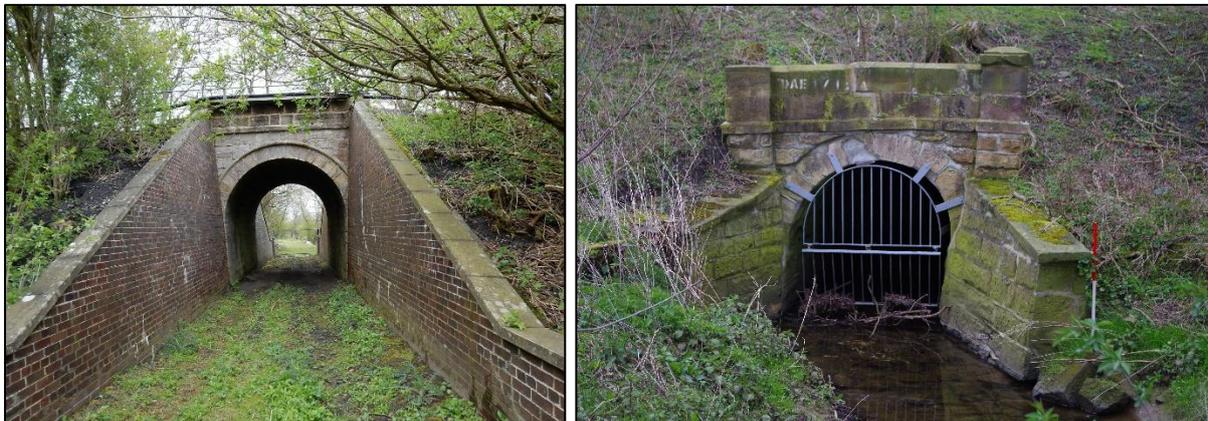
Between Coatham Lane and the A1(M) there is a stretch of 1825 high embankment line where access is possible using a circuitous approach via existing rights of way and a level crossing. An original accommodation bridge (SDR189) and a culvert (SDR335) survive. The accommodation bridge has renewed wing walls in brick and a grassy ramp leading to it from the field on the east which should be included in any designation. The grassy ramp also has round topped wooden gateposts which are typical of those seen along the 1825 route for its entire 26 miles. Some repairs in the 20<sup>th</sup> century have been in cement which is causing a little damage to the stonework. The brick wing wall on the west side appears to have been hit by heavy machinery which has dislodged its capping. The string coursing has a little damage but it is not serious.

The culvert carried the Dene Beck below the embankment – it has a small parapet with terminals on the west side, one of which is missing its capping. The east side has no parapet and old four-hole sleeper blocks have been used to repair it in the past. There are a few large boulders on the boundary of the railway, but they appear to have no markings and may just be boulders rather than boundary stones. However, the area is fenced off and well wooded, so the possibility of boundary stones being present is high.

*Plate 3. Accommodation bridge with renewed wing walls (left) and culvert adjacent carrying Dene Beck (right).*

Any designation needs to include the ramp and the wooden gateposts at the accommodation bridge south of the A1(M) near Dene Beck as well as the formation, ditches and culverts of this stretch of line.

The cope needs replacing on the culvert over Dene Beck.
-

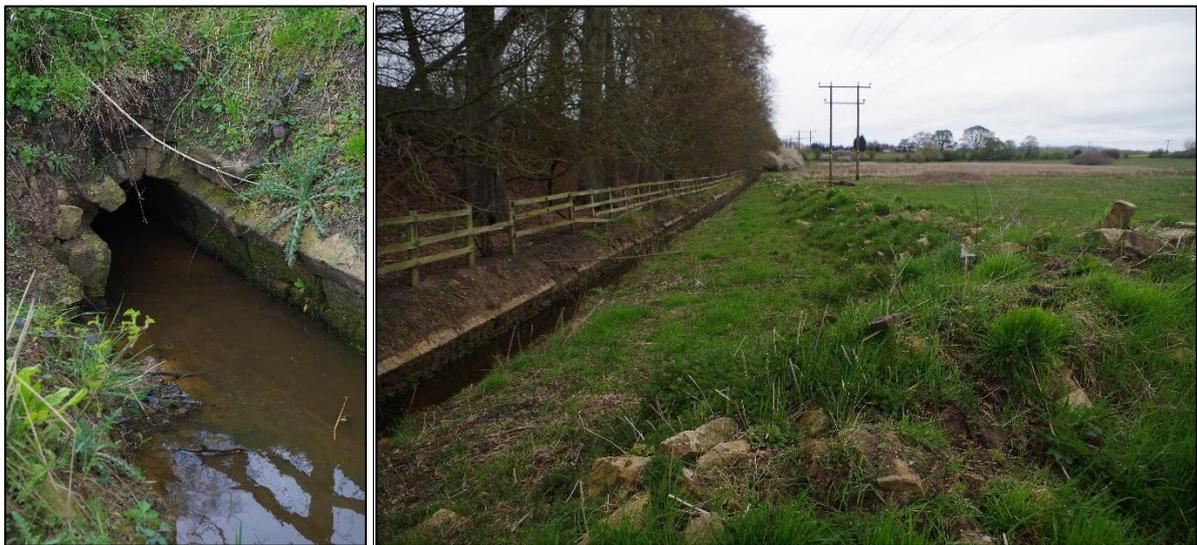
South of the A1(M) at Myers Flatt the line can be approached via rights of way and this 'swampy tract' (Tomlinson 1967 (1914), 88-9) has much of interest. The waterlogged nature of the ground proved problematic for the railway construction and so a massive embankment was built. This had a drain (SDR334) running parallel to it on the east side. Originally this drain was in the form of a continuous enclosed arched culvert of sandstone and was designed to collect run off from the wetland and keep the embankment dry. Sleeper blocks had been used in its repair. The drain survives, but most of it has recently had the top ripped off to expose the drain and the rubble has been left lying alongside the stone lined ditch. It is the same construction as a drain seen running parallel to the line now under the Eastern Transport Corridor in Darlington (SDR 329,330,331,363).

*Plate 4. Left: a piece of intact culvert at Myers Flatt and right: the exposed stone lined ditch without its capping and rubble alongside which includes reused stone sleepers. The 1825 embankment runs along to the left.*

James Potts and his gang of workmen finished their contract on this part of the line on the 11th of June, 1825; and, although the embankment appeared firm enough, it began gradually to subside, and continued to do so for many years. Mr Storey, giving evidence in 1829, declared that it was even then sinking as much as the very first year it was made. Upwards of £300 had been spent the previous year in leading materials to keep up the embankment, and from four to six men had been employed during the winter to keep the rails in order. The whole traffic of the line was sometimes stopped until this short embankment had been put right (Thomas Storey's evidence, Clarence Railway Bill, 1829, p.148.)

The demolition debris at Myers Flatt should be retained on site but the exposed stone sleepers removed for storage in a depot until they can be reused on the line or displayed.

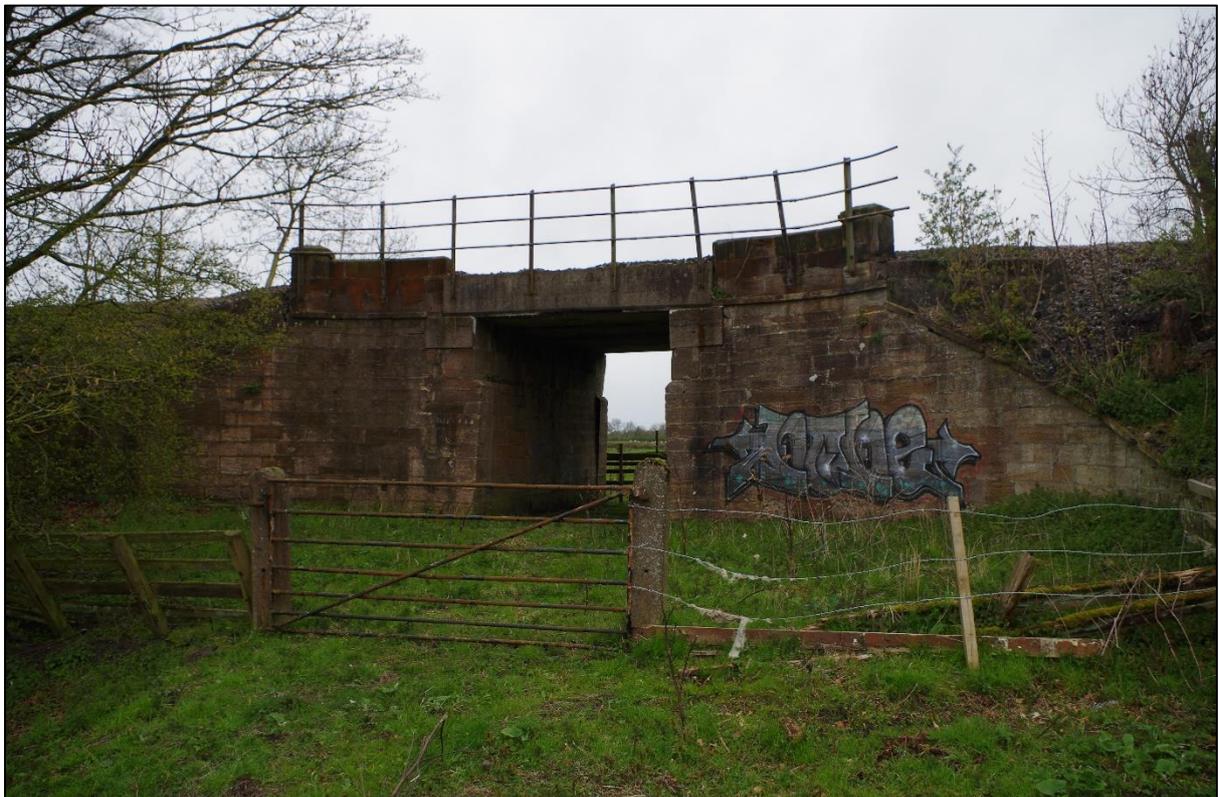
Immediately south of this is an 1825 accommodation bridge (SDR193). It has had its decking replaced in concrete with metal rails instead of the arch – the style and method used is

similar to the replacements seen of about 1901 near West Auckland. It is otherwise intact, but with some unsightly cementitious repointing and a surprising amount of graffiti for a structure far from settlements and in a bog.

Plate 6. Accommodation bridge at Myers Flatt

Some young trees are growing out of accommodation bridge at Myers Flatt.
-

Graffiti needs removing from the accommodation bridge at Myers Flatt.
