# **STATEMENT OF SIGNIFICANCE FOR THE BRUSSELTON INCLINE AND ACCOMMODATION BRIDGE**

**For Blackett Ord  
Conservation**

**November 2015**

**Archaeo-Environment Ltd**

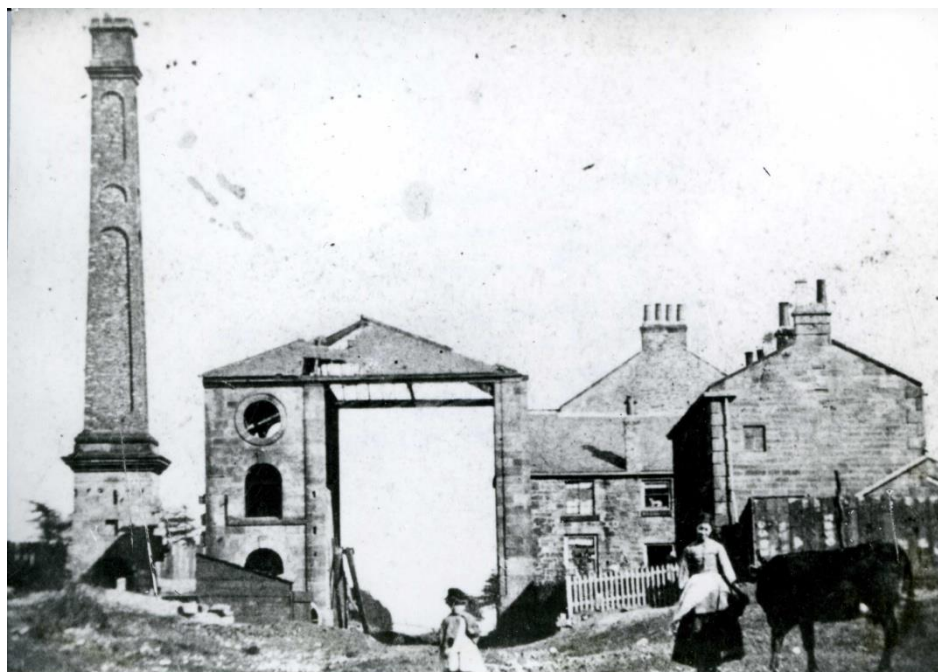
*Plate 3. Brusselton Engine House, now demolished (photo courtesy of the Ken Hoole Collection, undated, but possibly c.1880). The large empty building of 1831 held the winding gear which consisted of large drums which sat above the line, powered by Hackworth's steam engine adjacent. This was a replacement of the first Engine House which still survives partially on site today*

The engine, boilers and winding gear were to be a source of trouble and constantly needed repair. Hackworth carried out major modifications in 1826 and he replaced the engine in 1831 with a more powerful 80 horse power one. Due to its large size, the new engine house and chimney had to be placed on the north side of the track and the drum house spanned the track linking the new engine house and the original one. It is this later arrangement that can be seen in surviving historic photos (see plate 3). The new arrangement was a great success and increased the speed and capacity of the incline.

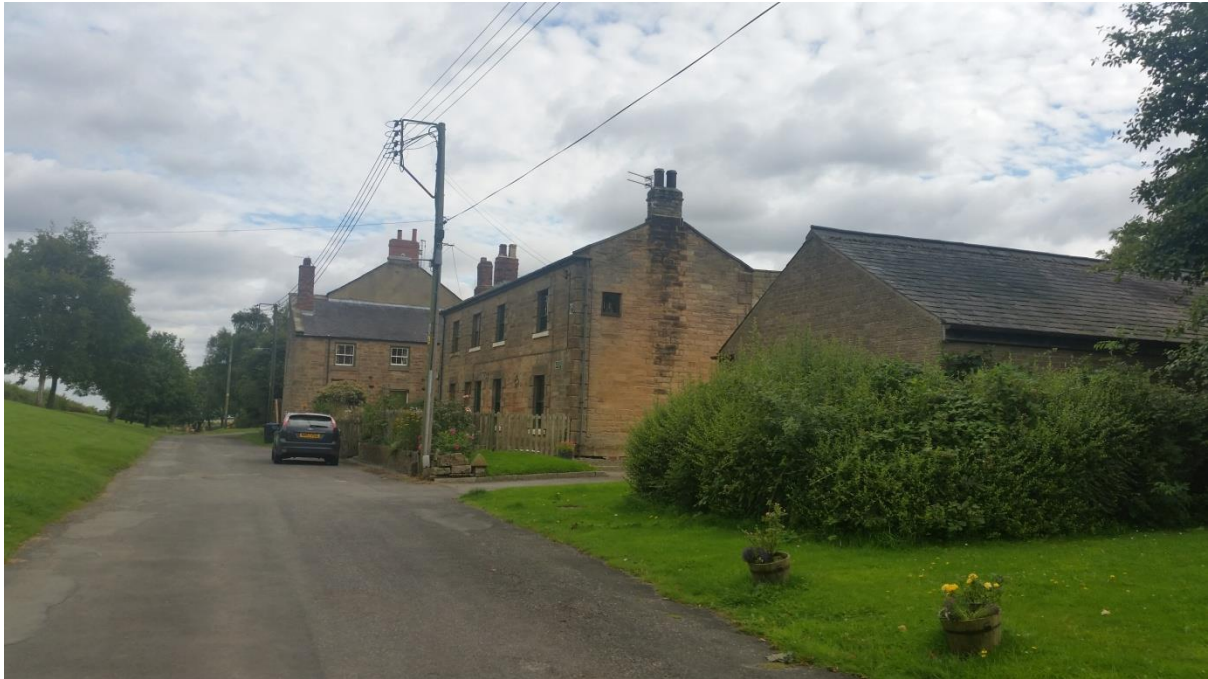
Plate 4. A similar view in 2015 without the winding house and chimney which were demolished at the end of the 19<sup>th</sup> century (Slack and O'Neill 2015, 70), but still with the other 1825 buildings in the picture intact, but extended. The building at right angles to the road is the first engine house.

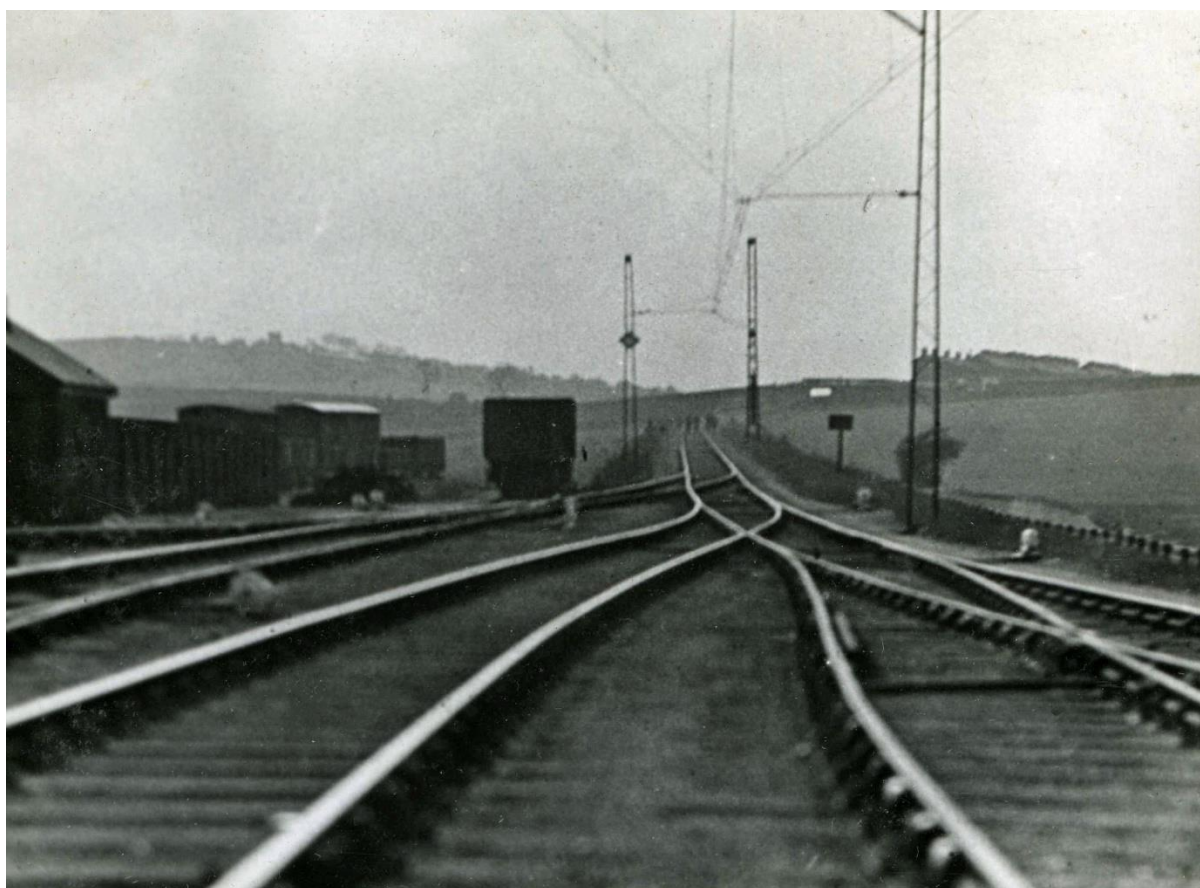
*Plate 5. Brusselton Incline east of the Milk Bridge (and so east of Brusselton village and the Accommodation Bridge) with the village and Milk Bridge in the distance. This shows the Brusselton line electrified when it was used as a repair line between the Milk Bridge and Shildon. Photo: from the Ken Hoole Collection at Head of Steam – Darlington Railway Museum*

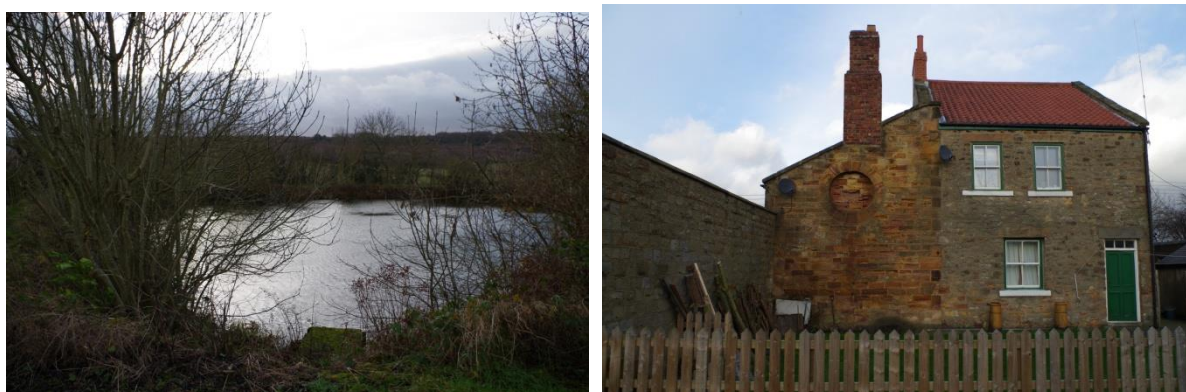
*Plate 6. Left: the reservoir that was constructed to feed the engine house. This currently has no legal protection. Right: the engine house*

After nearly two hundred years, only part of the Brusselton Incline survives, but the level of survival is much better than almost any other stretch of the 26 mile line. The 1831 engine house and winding gear were demolished in the late 19<sup>th</sup> century but the original 1825 cottages including the original engine house survive (although many other houses were constructed later and these too are now mostly demolished). On the incline itself, the embankment survives from Low West Thickley Farm to the engine house and beyond and recent work by the Brusselton Incline Group has exposed the stone sleepers and set ash ballast on the surface. The bridge that carried the railway line over Brusselton Lane, was demolished sometime between 1957 and 1962 apparently for road widening. An accommodation arch survives, but is badly damaged. Architectural fragments, mostly sleepers have been incorporated into adjacent walls.

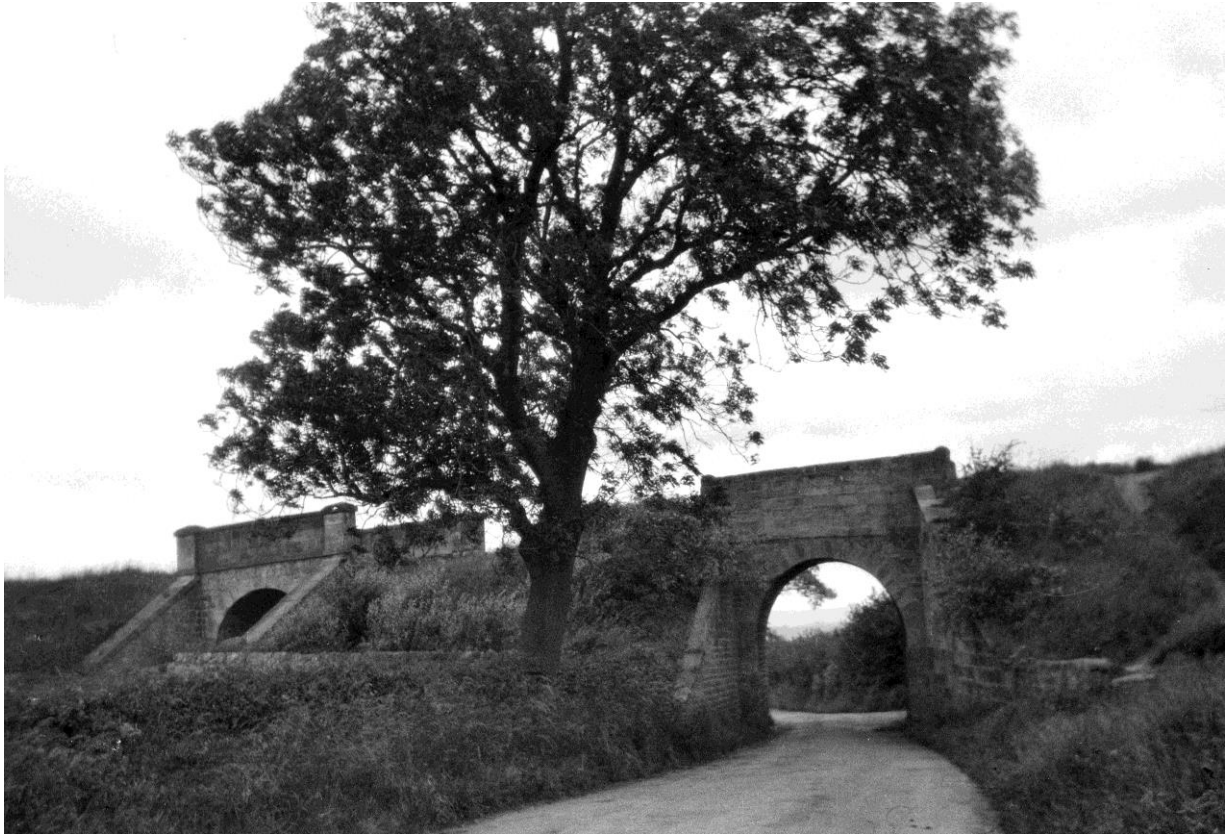
*Plate 7. An undated photo showing both the road bridge (right) and the accommodation bridge (left) intact. The surviving Accommodation Bridge appears to be a grander structure with a capped parapet, while the 1825 road bridge is a simple structure with few architectural pretensions (Photo: J.W Armstrong/ Armstrong Railway Photographic Trust)*

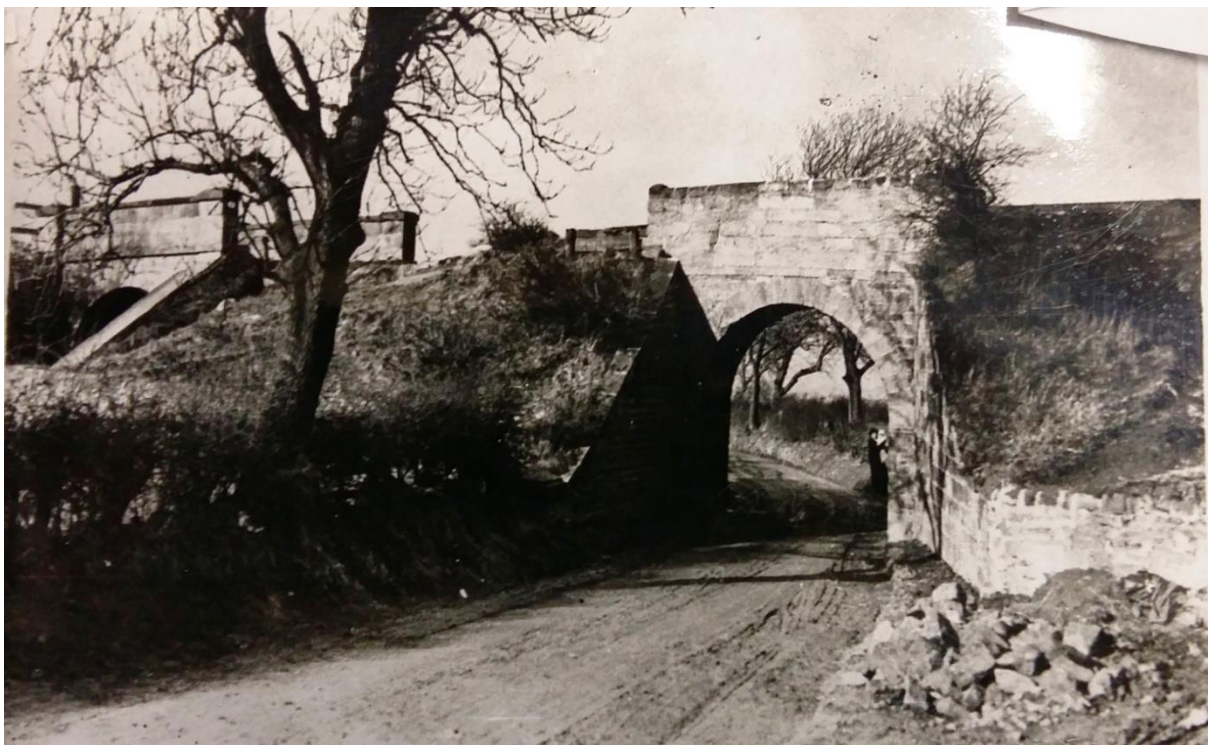
*Plate 8. The bridge built to take the S&DR line over Brusselton Lane; the pile of stones suggest that damage or demolition has already occurred to the road bridge which was demolished in the early 1960s to allow for road widening. (photo courtesy of Jane Hackworth Young)*

The road bridge was skewed to accommodate the angle of the road. This can be seen on the 25 inch OS maps and historic photographs (see figs 10 and 13 and plate 8). It was clearly part of the original design with the railway being shown as passing over it from the 1823 proposals maps by George Stephenson.

Historic photos show a relatively simple bridge parapet, although the skewing of the arch was more complex. The parapet was topped with rounded coping stones with more prominent copes at the ends. Dressed stone retaining walls held back the earth embankment of the incline on both sides of the road. These were terminated with triangular cope stones which match the accommodation arch adjacent. The retaining walls on the east and west sides was different. The east retaining wall stones were better dressed and were made of larger ashlar blocks than the west side. It is not clear why this was the case. Later plans first produced in 1925<sup>22</sup> by the NER measured the height of the arch from the road as 15 feet high with a span of 11 feet 2 inches at road level but a gap of 11 ft 4 inches between the parapets. The same plans were annotated in November 1946 with a note 'said to be the first railway stone arch over a public highway.'

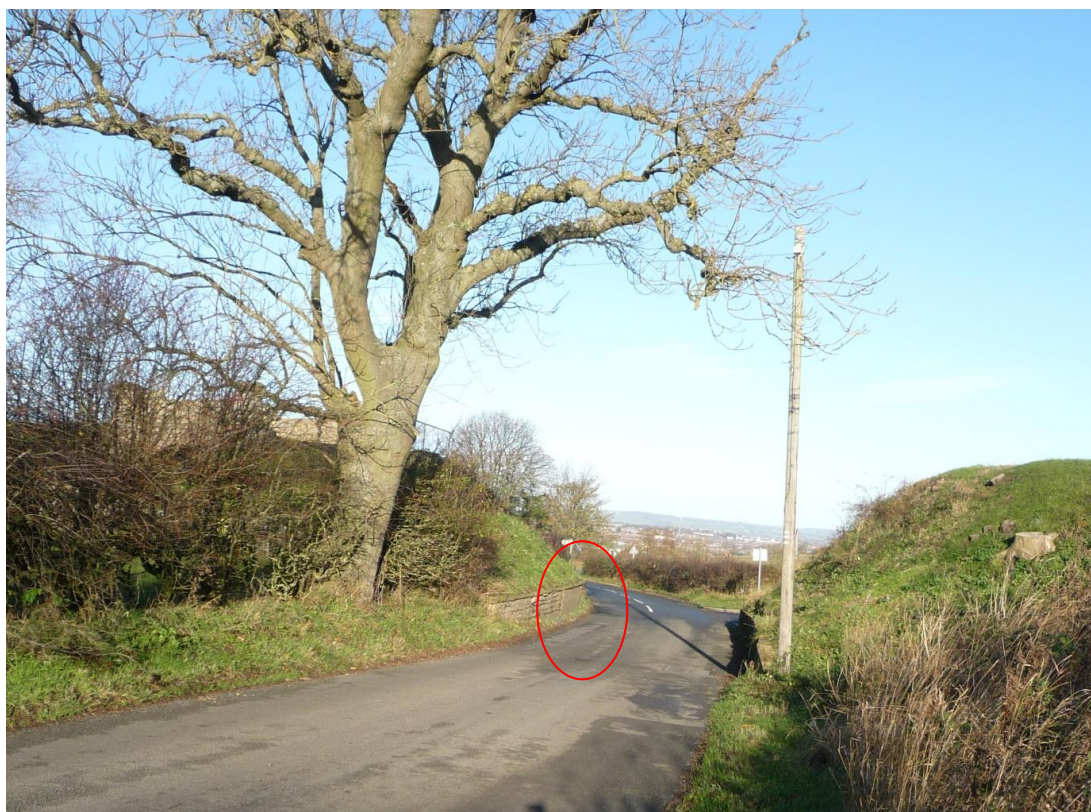
*Plate 9. A similar view in 2015. The only evidence of the road bridge is a strip of concrete render on the retaining wall to the left (west)*

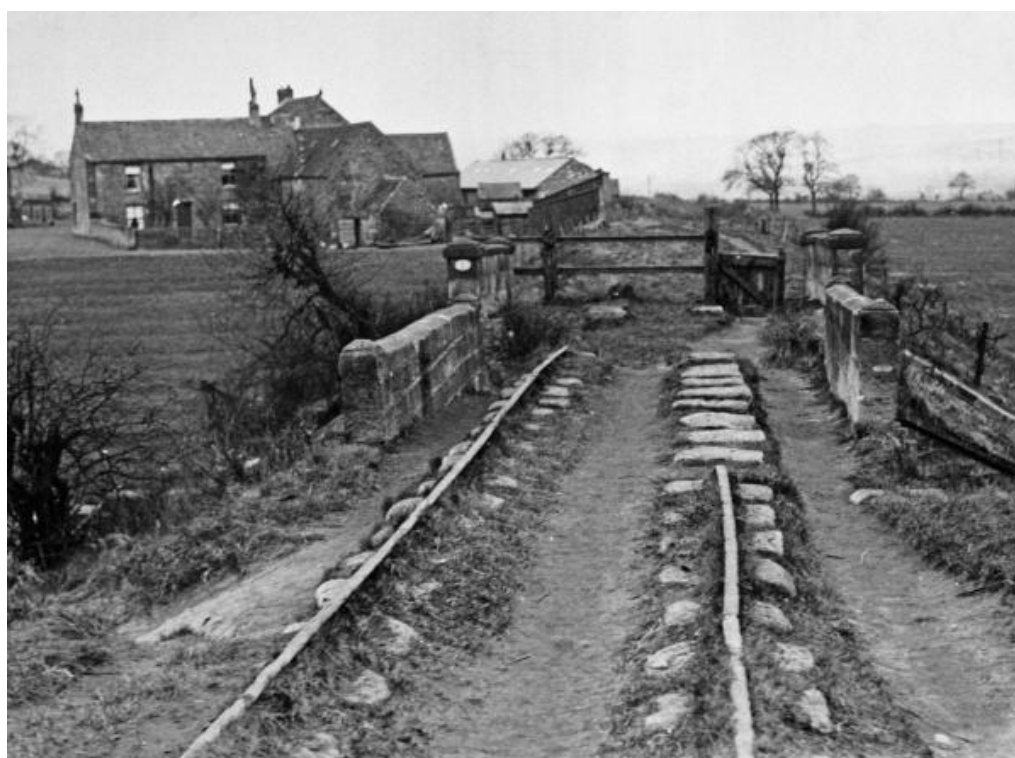
*Plate 10. The decking of the road bridge with the accommodation bridge beyond. Both have metal plaques on them numbering them. (Photo undated but possibly 1925, courtesy of Trevor Horner)*

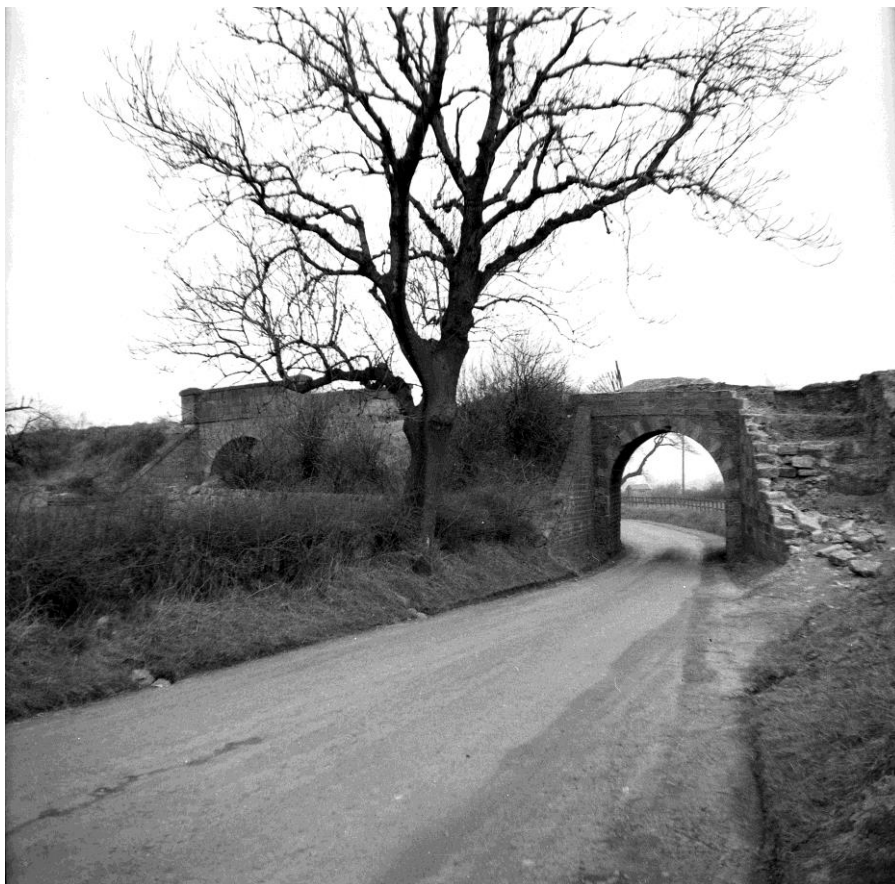
*Plate 11. An undated photo of the demolition of the road bridge underway. The exposed structure of the embankment can be seen and it appears to consist of terracing of stone filled with rubble and earth. (Photo: J.W Armstrong/ Armstrong Railway Photographic Trust)*

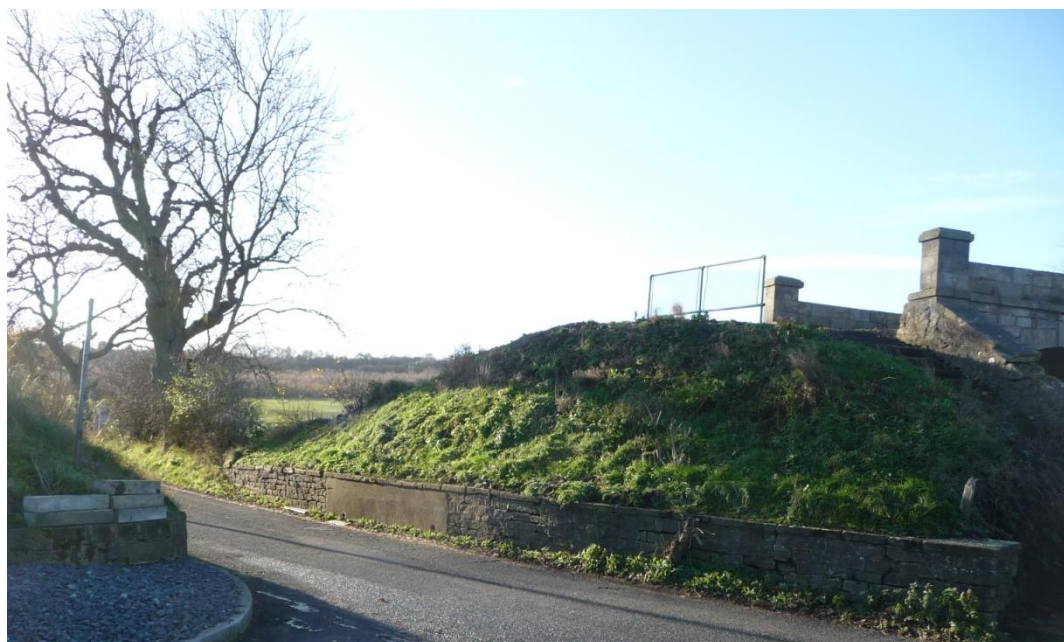
*Plate 12. The only visible remains of the road bridge is concrete render over the join where the bridge abutted the embankment on the west side of the road.*

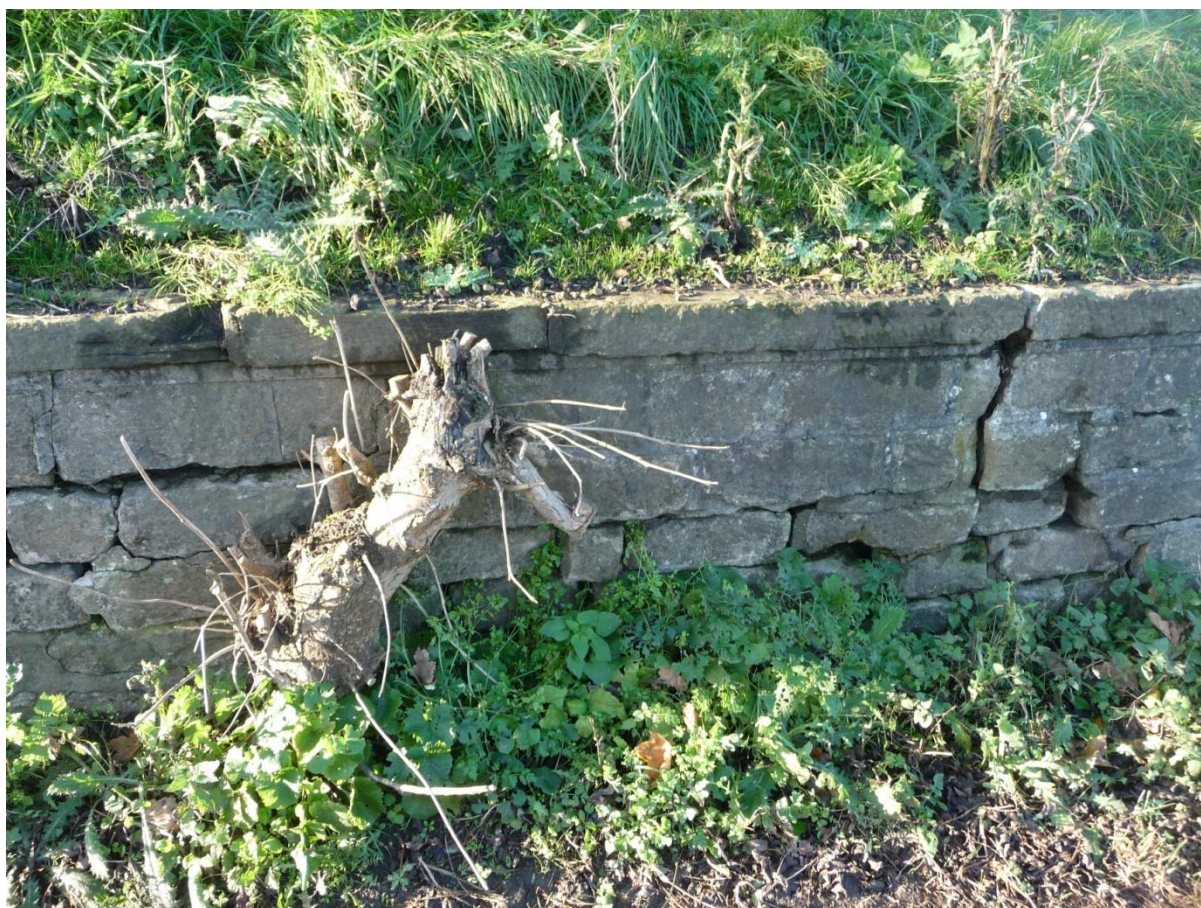
*Plate 13. The retaining walls are bulging and will require consolidation. This may also be an opportunity to remove the cement render on the scarring of the original bridge.*

Given that photographs do exist of the bridge, combined with its measurements, there is already an archaeological record of sorts. However the poor condition of the adjacent retaining walls suggests that these may need to be consolidated. Further, the concrete render may be damaging to any stonework beneath the surface and adjacent to it. There may therefore be a case to remove the concrete render and expose the scarring from the bridge while work is carried out to the retaining walls. This should be recorded archaeologically. The fact that the bridge was struck by a lorry and that the issue of road widening was being discussed from at least 1928, suggests that rebuilding the bridge is not feasible at its original size and if it cannot be rebuilt to match the existing, it is questionable whether any future replacement bridge would need to reflect the design of the original at all. There are no heritage constraints why a new bridge could not be built here to accommodate users of a future rail trail, although some archaeological recording might be required depending on the design.

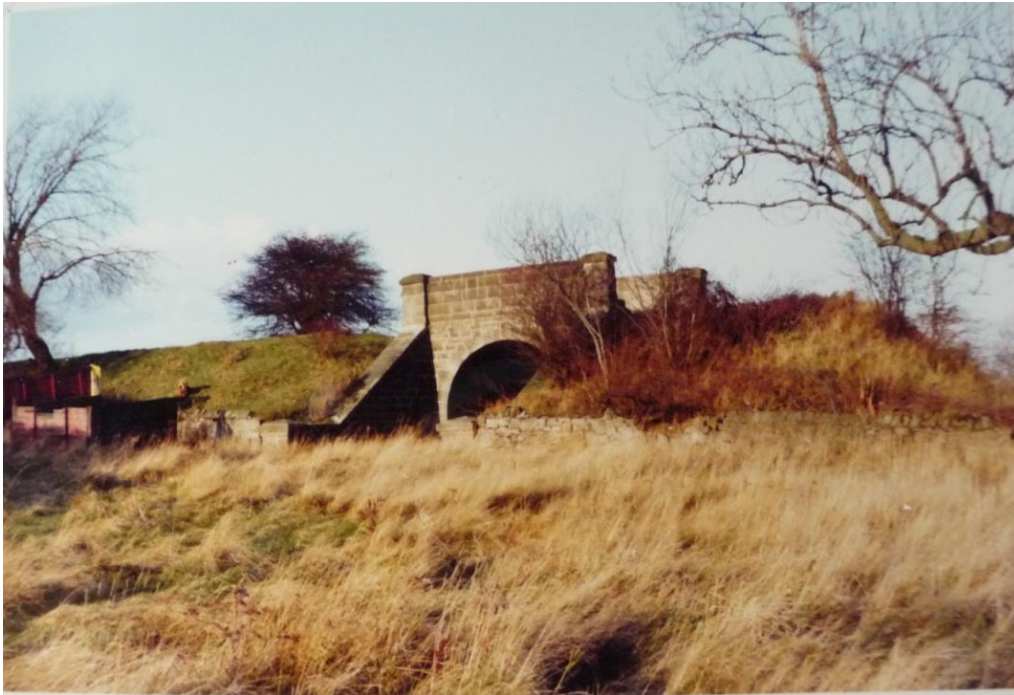
*Plate 15. Photo taken from the south looking north of the Accommodation Arch in 1974 at which time, it was described as being in fine condition (John Proud albums).*

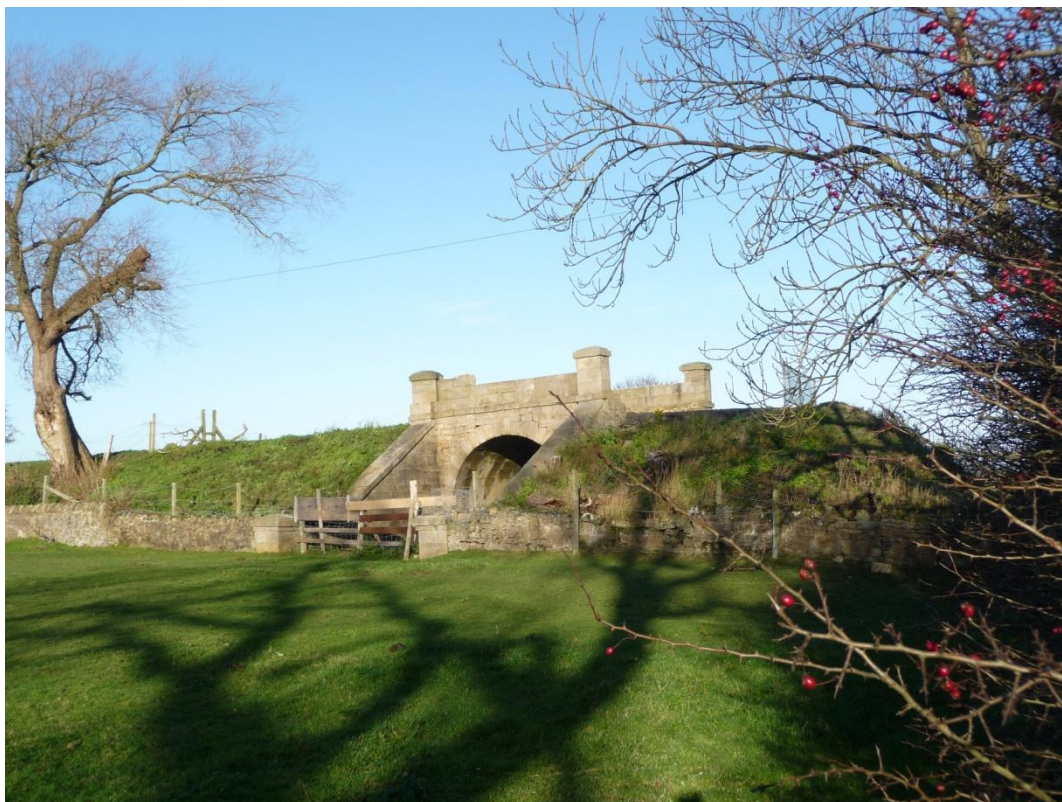
*Plate 16. The same view in 2015*

The bridge parapets today are in poor condition and the decking may also be damaged on the surface. The south parapet has been pushed in an attempt to topple it over and stone sleepers are sliding down off the decking north and southwards. The decking surface is eroding and exposing masonry at the bottom of the parapets that ought to be buried

(although photographs from the 1970s suggests that this has been the case for at least forty years and so may be quite stable). The wing walls are in particularly poor condition on the north side where the coping has been prised off. This has exposed lime pointing suggesting that it is original, or at least 19<sup>th</sup> century, as cement has not been used. However there is evidence of some cementitious pointing elsewhere on the structure, presumably the 1960s repairs.

The bridge requires repair as a matter of urgency. Based on a site visit, it is almost certain that the 1966 repairs were with cement, but the repairs did not extend across the entire bridge; the wing walls appear to be fixed with a lime mix. However some of the cement beneath the arch does not appear to be resulting in any erosion and so could be left. It is likely that local stone from Brusselton quarry was used to build the bridge and so similar sources will need to be found for any missing stonework. The Brusselton Incline Group have been donated stone from two different sources; one from a bridge at Stillington and one from a bridge at Bishop Auckland. The stone has been inspected and approved for use by the conservation officer from Durham County Council and the inspector from Historic England.<sup>31</sup>

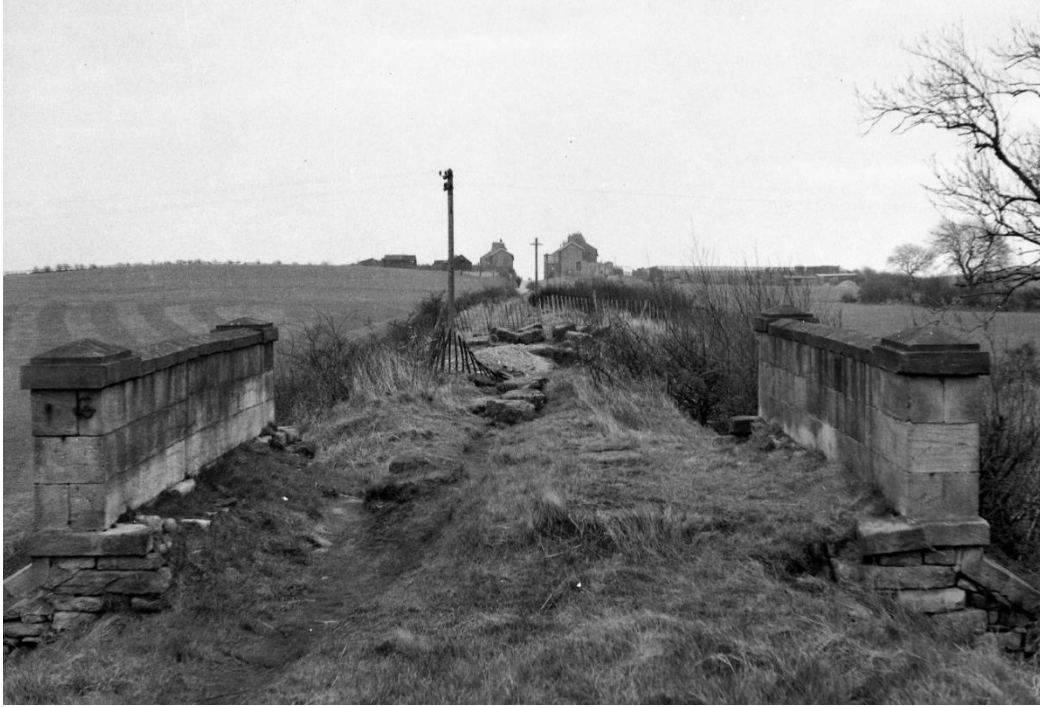
*Plate 17. The decking of the accommodation arch with the road bridge decking beyond. Stone sleepers scatter the surfaces of both structures and the view of the bridge structure below the parapet shows loose stonework needing resetting and pointing. This may have been carried out in 1966, based on Vera Chapman's account (2005, 72). The photograph is undated but the parapet appears to have been removed from the road bridge. The decking stonework appears to be loose and that is still the case today. (Photo: J.W Armstrong/ Armstrong Railway Photographic Trust: 0392-3B)*

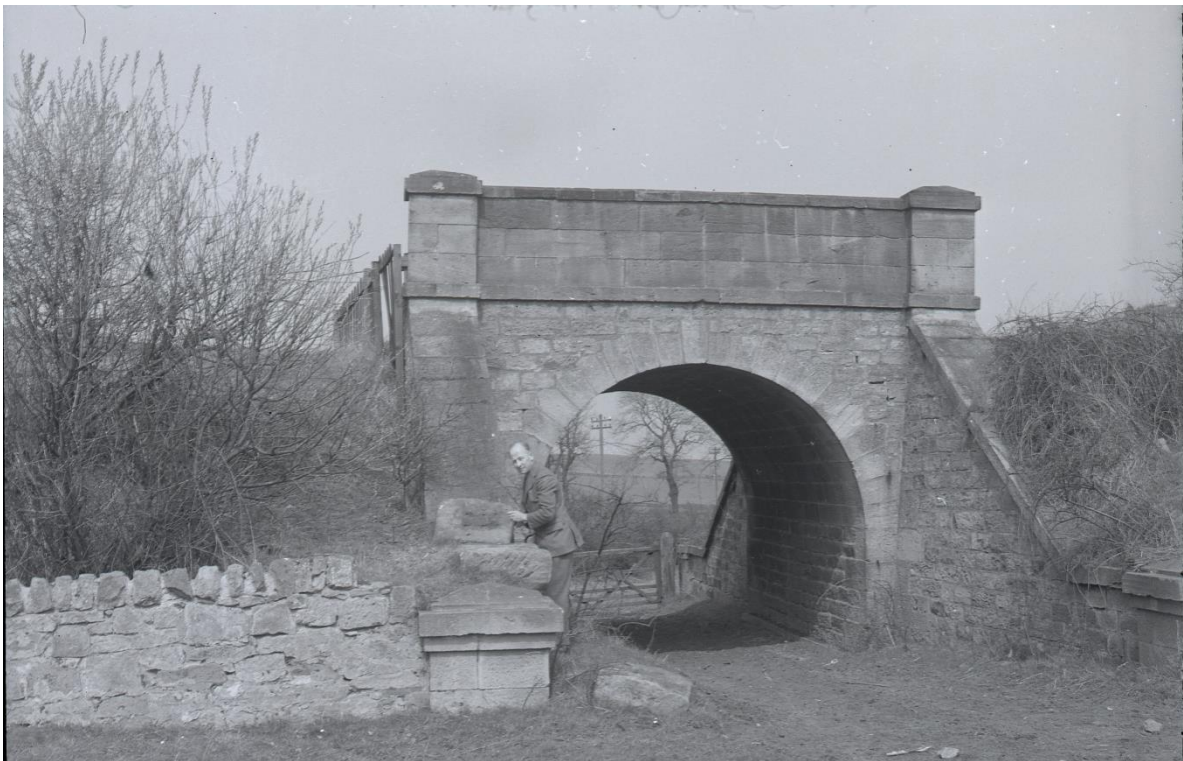
*Plate 18. Photo of the Accommodation Arch possibly in the 1960s showing sleepers ex situ (DRO D/Ph 234/378-9. Not to be reproduced without permission from the DRO)*

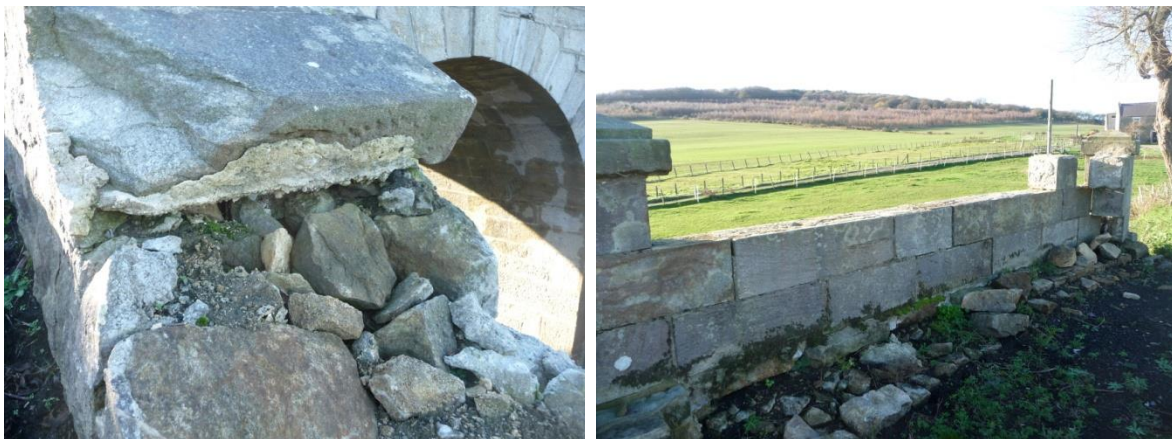
*Plate 19. Left: The damaged retaining walls show that they were made of dressed stone with a rubble core and that lime mortar was used. Right: The south parapet has been partially dismantled and the west end pushed over ready to topple. The foundations of the parapets and the stone decking are also exposed.*

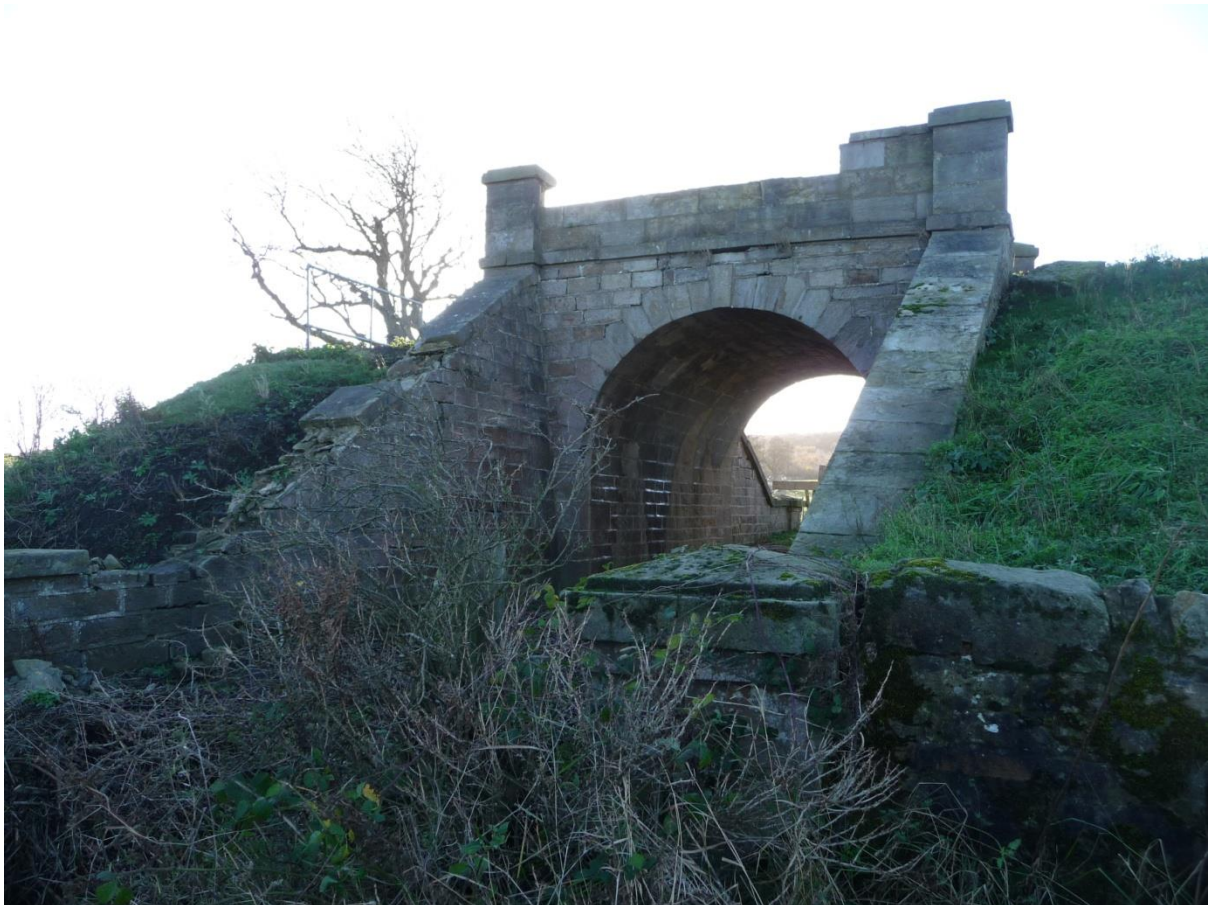
*Plate 20. Part of the parapet has been dislodged and toppled while the coping stones from one of the retaining walls have been removed.*

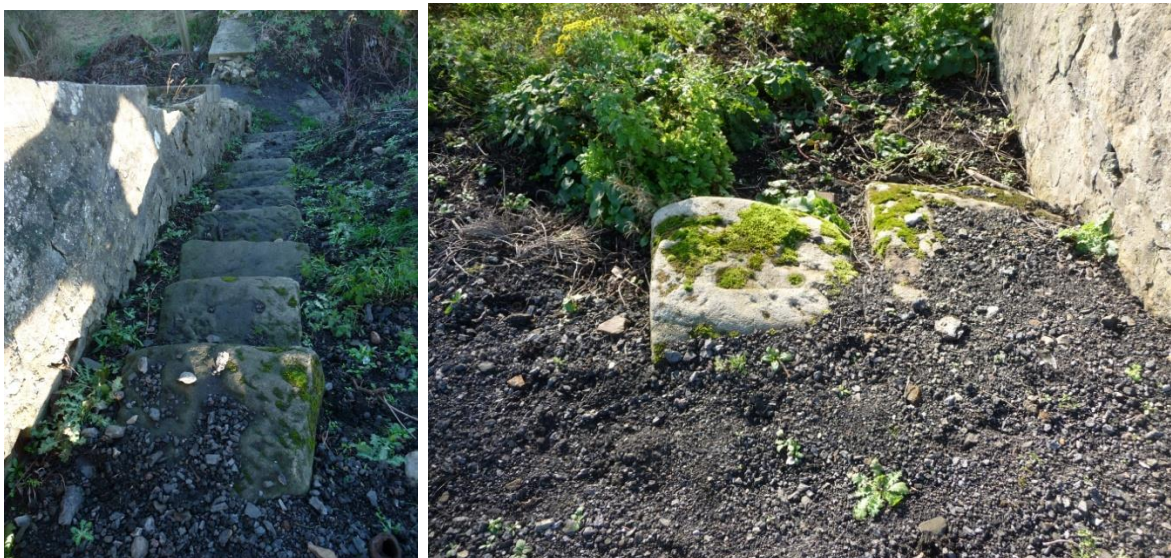
*Plate 21. Left: Sleepers have been reused to form the steps from the bridge to the road. Right: Sleepers have been dislodged and are being pushed to the edge. These were originally designed to be as large as 'one man' could carry and so are vulnerable to theft.*

The sleepers that have been used as steps could remain as steps, or be extracted, replaced and the sleepers restored to the bridge deck. However if vandalism continues to be a problem, they may be better left where they are. If the cycle of vandalism is not to be repeated, consideration needs to be given to avoiding future harm. This is difficult because apart from West Thickly Farm (currently up for sale), there are no houses which overlook the site. If the bridge forms part of a well used national trail, then it may be better protected because it will be in the public eye more often. Alerting the local police to the site and its legal status and encouraging night time drive bys may also help to protect the site. A briefing note for the local police on the legal status of the S&DR generally may be of benefit.

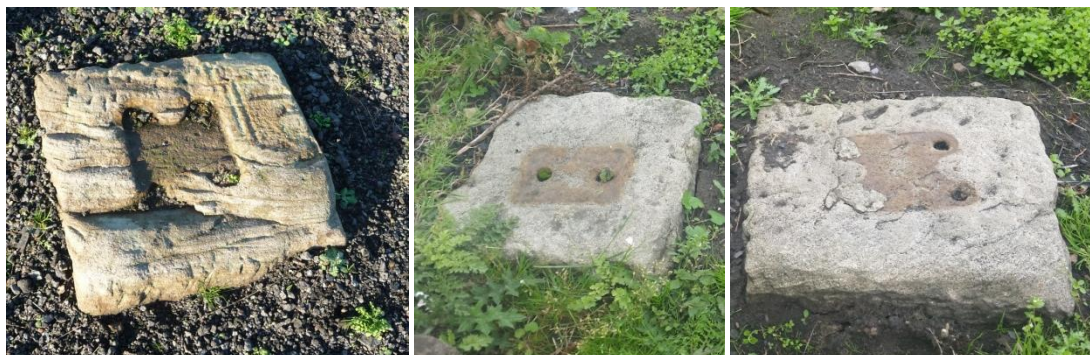
*Plate 22. Left: Some sleepers on the incline show markings caused by the rails. Centre: The earliest two hole sleeper. Right: the second phase four hole sleeper to provide greater stability*

Each sandstone block weighed about 75lbs which was considered the optimum weight for handling by one man, but weighty enough to be robust. In fact, most sleepers are far heavier than can be lifted by one person in the 21<sup>st</sup> century! The rails were attached to the blocks by iron brackets (chairs), double nailed to the blocks. Boys at Brusselton Quarry were paid 8d a day for drilling two holes in 24 blocks.<sup>34</sup> However from the 1830s these blocks were replaced by heavier ones and the chairs were attached with four nails. This was to try to reduce the wobble and bending of the rails when in use. The sleepers on top of the bridge have been excavated and relaid and so may not be in their exact original positions (S&DR 150 R&P Committee 1975); indeed a photo possibly from the 1960s shows sleepers having tumbled down from the arch (see plate 19). Six sleepers are now in the National Railway Museum in York which were excavated from the Brusselton Incline during open cast works. One still has an iron chair attached.<sup>35</sup> These may have been from further down the line towards Broom Mill Farm where the open casting appears to have removed all traces of the Incline, but Hall (1961, 226) reported that the NCB excavated a trench across the incline between the stone bridges and the houses in 1956 and exposed a rail and jointing chair. Neither were typical of the S&DR types and would not fit the stone sleepers still visible on the line. The remains of wooden inserts were visible in the bolt holes. Two other chairs were also identified and these were of the typical type that would fit the stone sleepers. This suggests that beneath the surface, there may be three types of sleeper fixture providing a much more extensive chronology of the evolving railway.

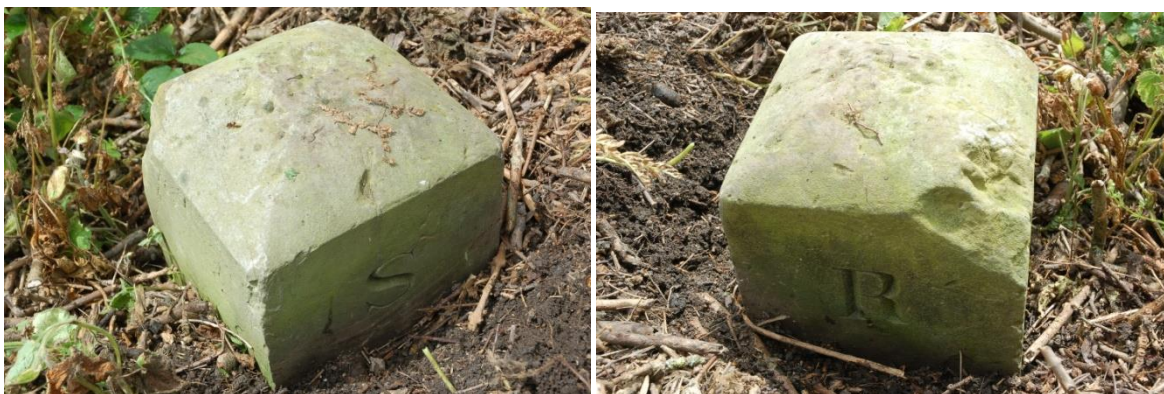
Members of the Brusselton Incline group found a stone on the back of the south wing wall on the east side of the Accommodation Bridge. It is a square shape in plan with a domed top. The letter S is incised on one face and the letter R on the opposite side. The other two opposing faces are blank.

*Plate 23. Boundary stone from the Accommodation Bridge*

The position of the stone in the embankment suggests that it was set here by the railway company to mark the parish boundaries and may be a replacement for an earlier stone or is an earlier stone reset into the embankment. It is therefore very rare and should be considered to be part of the scheduled monument. It is an important aspect of its significance that it is located on the parish boundary with the letters in the correct positions to mark the sides of Redworth and Shildon parishes. It is therefore of **considerable historic interest**.

Care will need to be taken to avoid harming the stone during any future works. There is a drain located next to the site of the stone and this will need regular cleaning out to maintain its function of draining the adjacent field. If the stone needs to be moved for any future works, it should be removed archaeologically so that its fixing can be recorded and then returned to its original position on the parish boundary. Vegetation needs to be controlled around the stone to prevent it becoming hidden which will make it vulnerable to accidental damage.

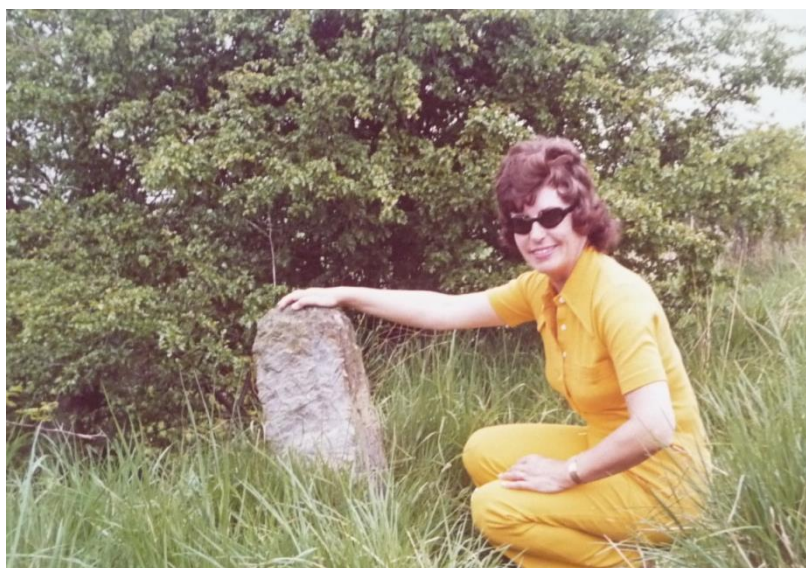
Plate 24. Photo dating to 1973 of the milestone with Win Proud. (Photo John Proud)

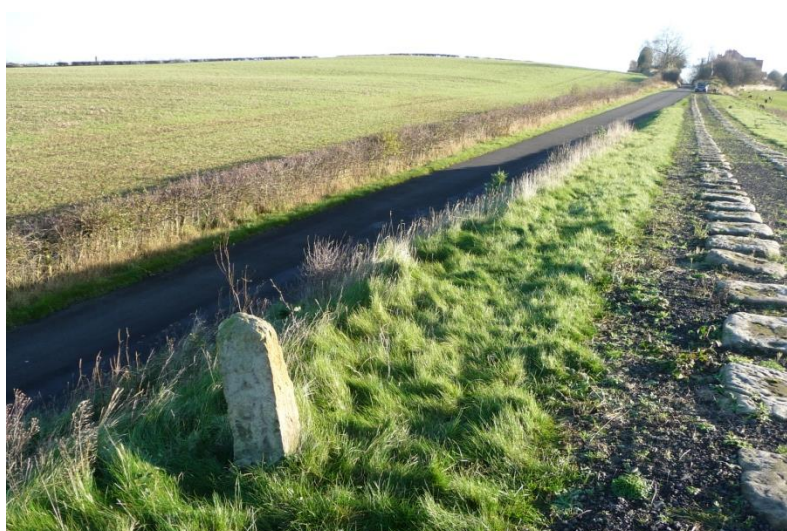
Plate 25. The milestone in 2015. Recent clearance works on the incline have restored its relationship with the stone sleepers

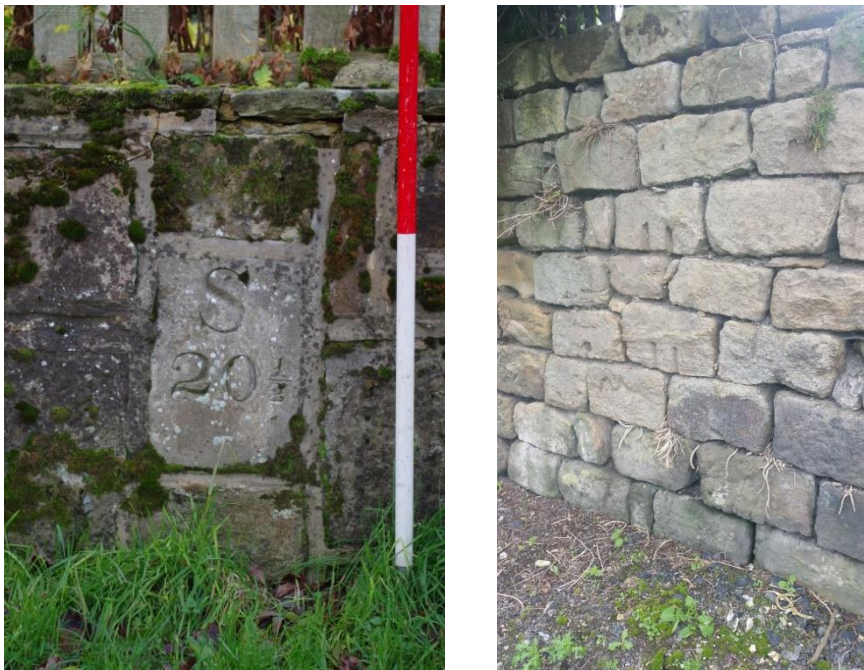
*Plate 26. Left: milestone built into a garden wall. Right: sleepers have been split and reused in the garden walls*

A milestone has been rebuilt into a garden wall near Brusselton Engine House. It is incised on one side with the letter S over the number 20 ½ and presumably marked the point 20 ½ miles from Stockton. Its current location is 20 ½ miles from Stockton and so has not travelled far from its original position. There are also a number of stone sleepers incorporated into the stone walls east of the cottages which may also include demolition material from the 1831 engine house and possibly North Row Cottages. The sleepers have been split through the middle so that the pin holes can be seen in section.
