# Stockton and Darlington Railway Heritage Action Zone Aerial Investigation & Mapping Report

**STOCKTON AND DARLINGTON RAILWAY  
HERITAGE ACTION ZONE**

**Aerial Investigation & Mapping Report**

NGR: NZ 290 156

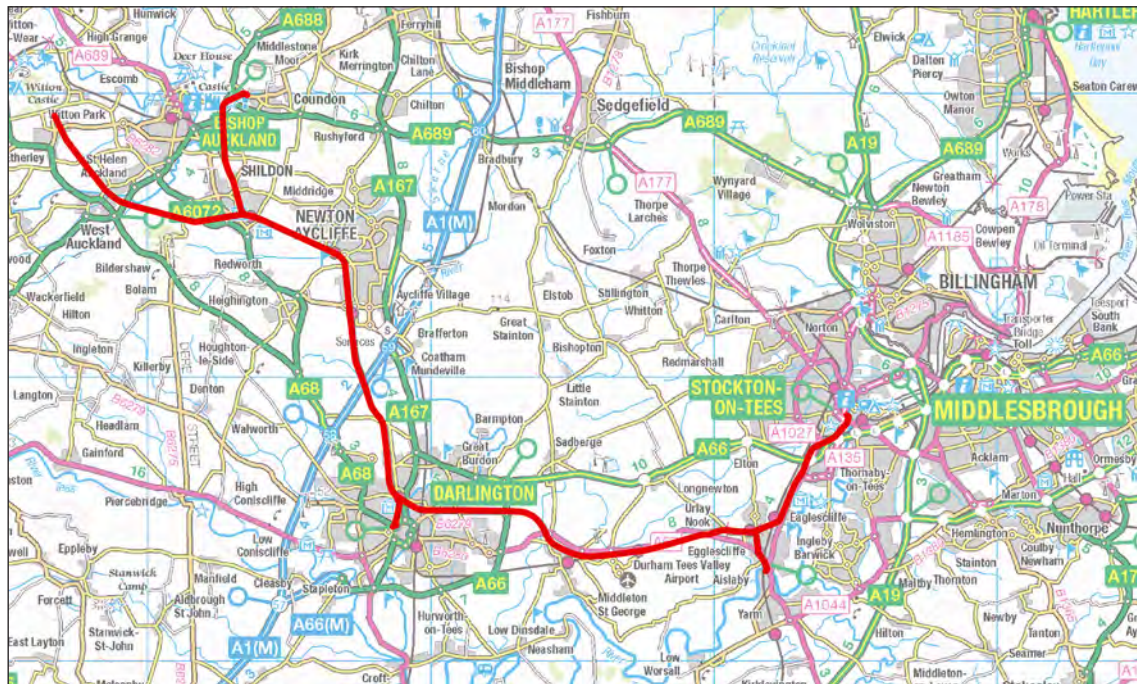
Fig 1: George Stephenson's 1822 proposed line for a railway between Witton Park and Stockton-on-Tees. Base map © Crown Copyright and database right 2019. All rights reserved. Ordnance Survey Licence number 100019088.

Along a route devised and built by George Stephenson (Fig 1), the S&DR opened with great ceremony on 27 September 1825. A train of 12 wagons of coal was hauled by horses from Phoenix Pit, Etherley, to the foot of the Etherley North Incline. The train was pulled up the Incline by a stationary steam engine and lowered down the South Incline to West Auckland where another wagon was hitched to the convoy. The train was again pulled by horses to the foot of the Brusselton Incline, where the process was repeated. By this point, there were thousands of onlookers – some hopping aboard. Once the train had been lowered down the Brusselton Incline to Shildon, it was hitched to a further 21 wagons, laden with passengers, and to the steam locomotive, *Locomotion No. 1*. With Stephenson as the driver, the train began its slow journey to Stockton and into the annals of history (Semmens 1976, 121; Archaeo-Environment Ltd 2016b, 2).

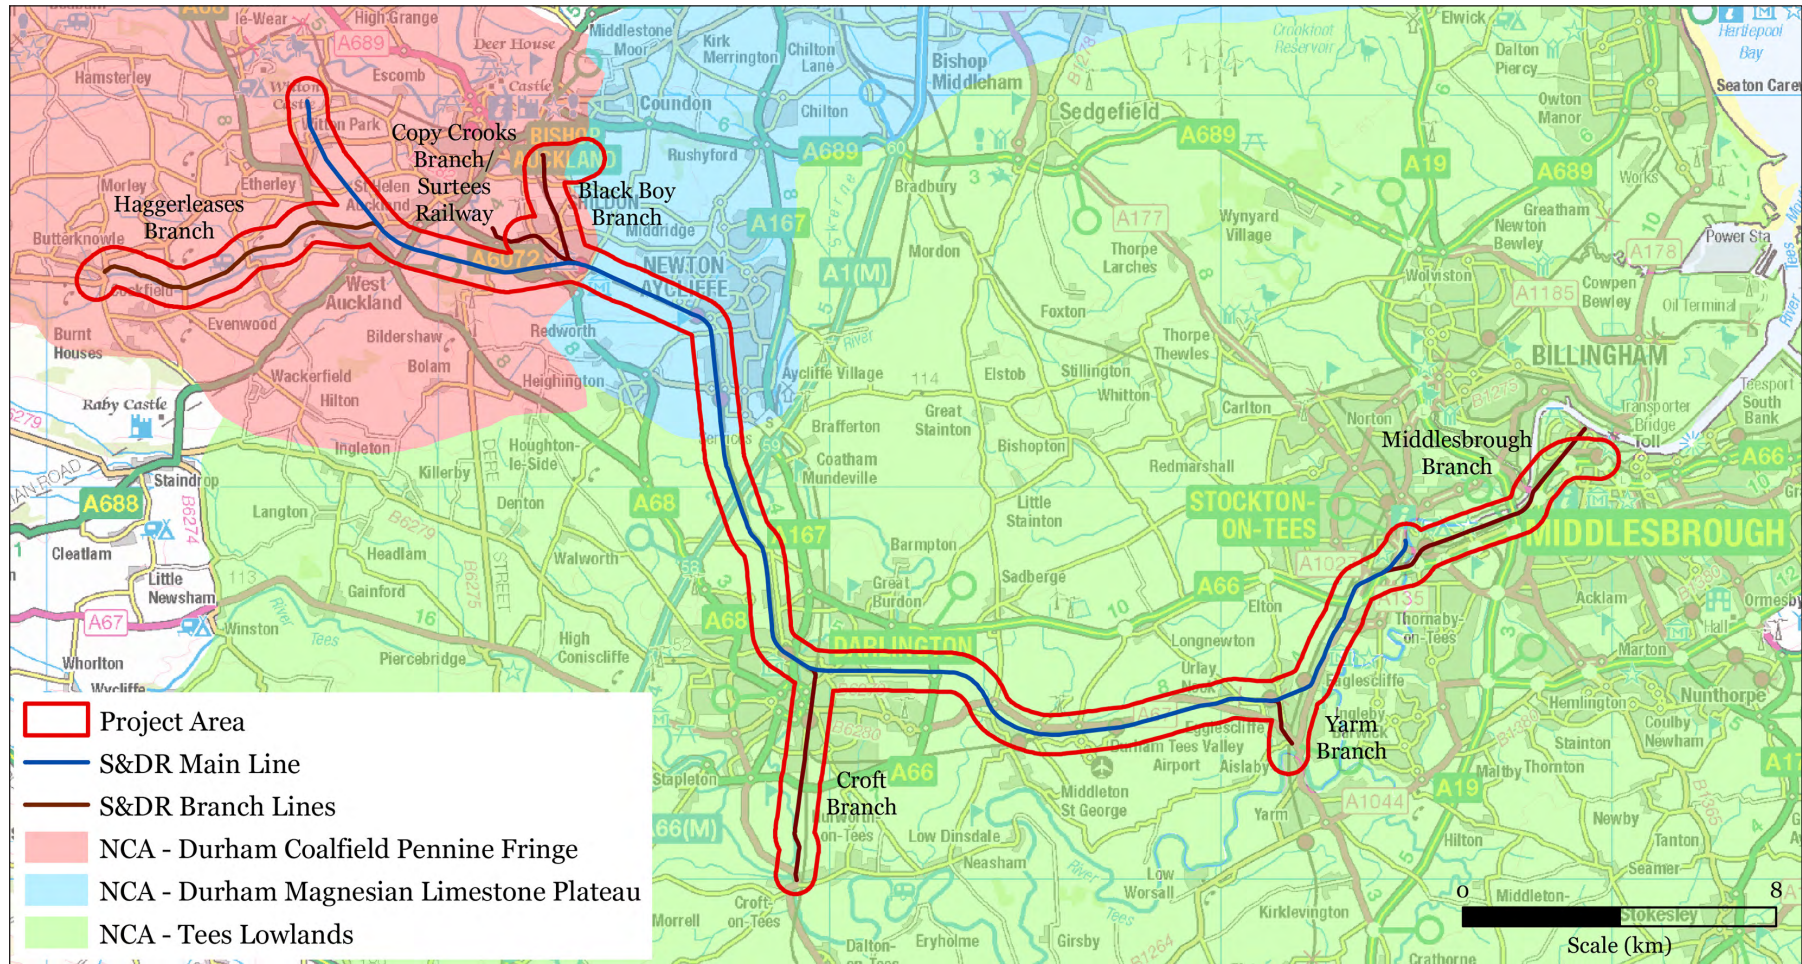
Fig 2: The core S&DR network comprised the 1825 main line and a series of branch lines, constructed up to 1831. NCA data © Natural England; Base map © Crown Copyright and database right 2019. All rights reserved. Ordnance Survey Licence number 100019088.

The opening of the railway between Witton Park Colliery in the west and Stockton in the east in 1825 marked an important point in the history of industrialisation and transport. The line was devised in response to the need for a cost-effective way to transport coal from the mines located on the Pennine-fringe to staithes on the River Tees from where it could be shipped to non-local markets. From the outset, the railway also operated a passenger service which laid the foundations for the public rail network across the country. By 1830, the line had been extended to Middlesbrough, and by 1831 the last of a number of short branch lines, mainly connecting additional collieries in to the railway (namely the Haggerleases Branch, Black Boy Branch, Copy Crooks Branch/Surtees Railway, Croft Branch and Yarm Branch), had also been completed (Fig 2).

The project area stretches over a length of 66.5km of former and current railway, between Butterknowle and Middlesbrough (Figs 2-3). It includes the length of the 1825 main line and principal early subsidiary lines, namely the Haggerleases Branch (1830), Black Boy Branch (1827), Copy Crooks Branch/Surtees Railway (1831), Croft Branch (1829), Yarm Branch (1825) and the Middlesbrough Extension (1830) (Fig 2). The project includes a 1km-wide mapping corridor along the railway covering a broad range of landscapes. These are here outlined using Natural England's National Character Area (NCA) profiles, which are defined by topographical boundaries, but also include cultural and economic aspects of the environment (Fig 2).

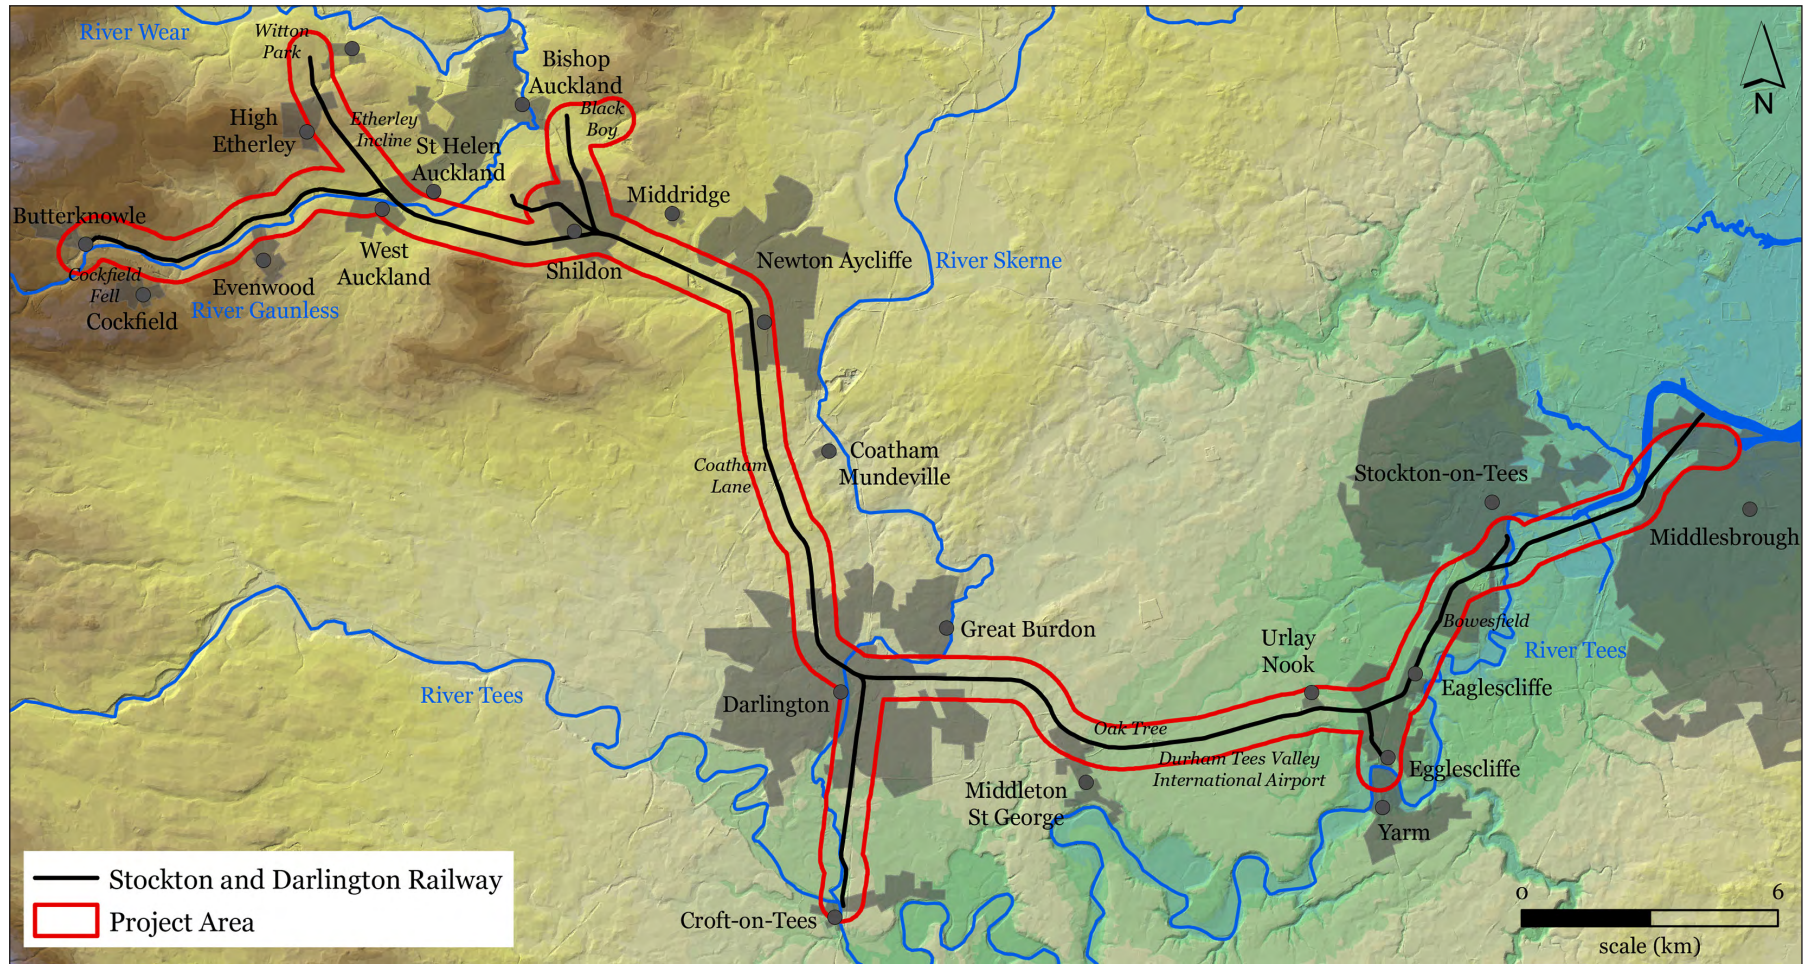
Fig 3: The project area covers a broad transect of landscape stretching from the Pennine fringe to Teesmouth. Height data ©Bluesky International/Getmapping PLC.

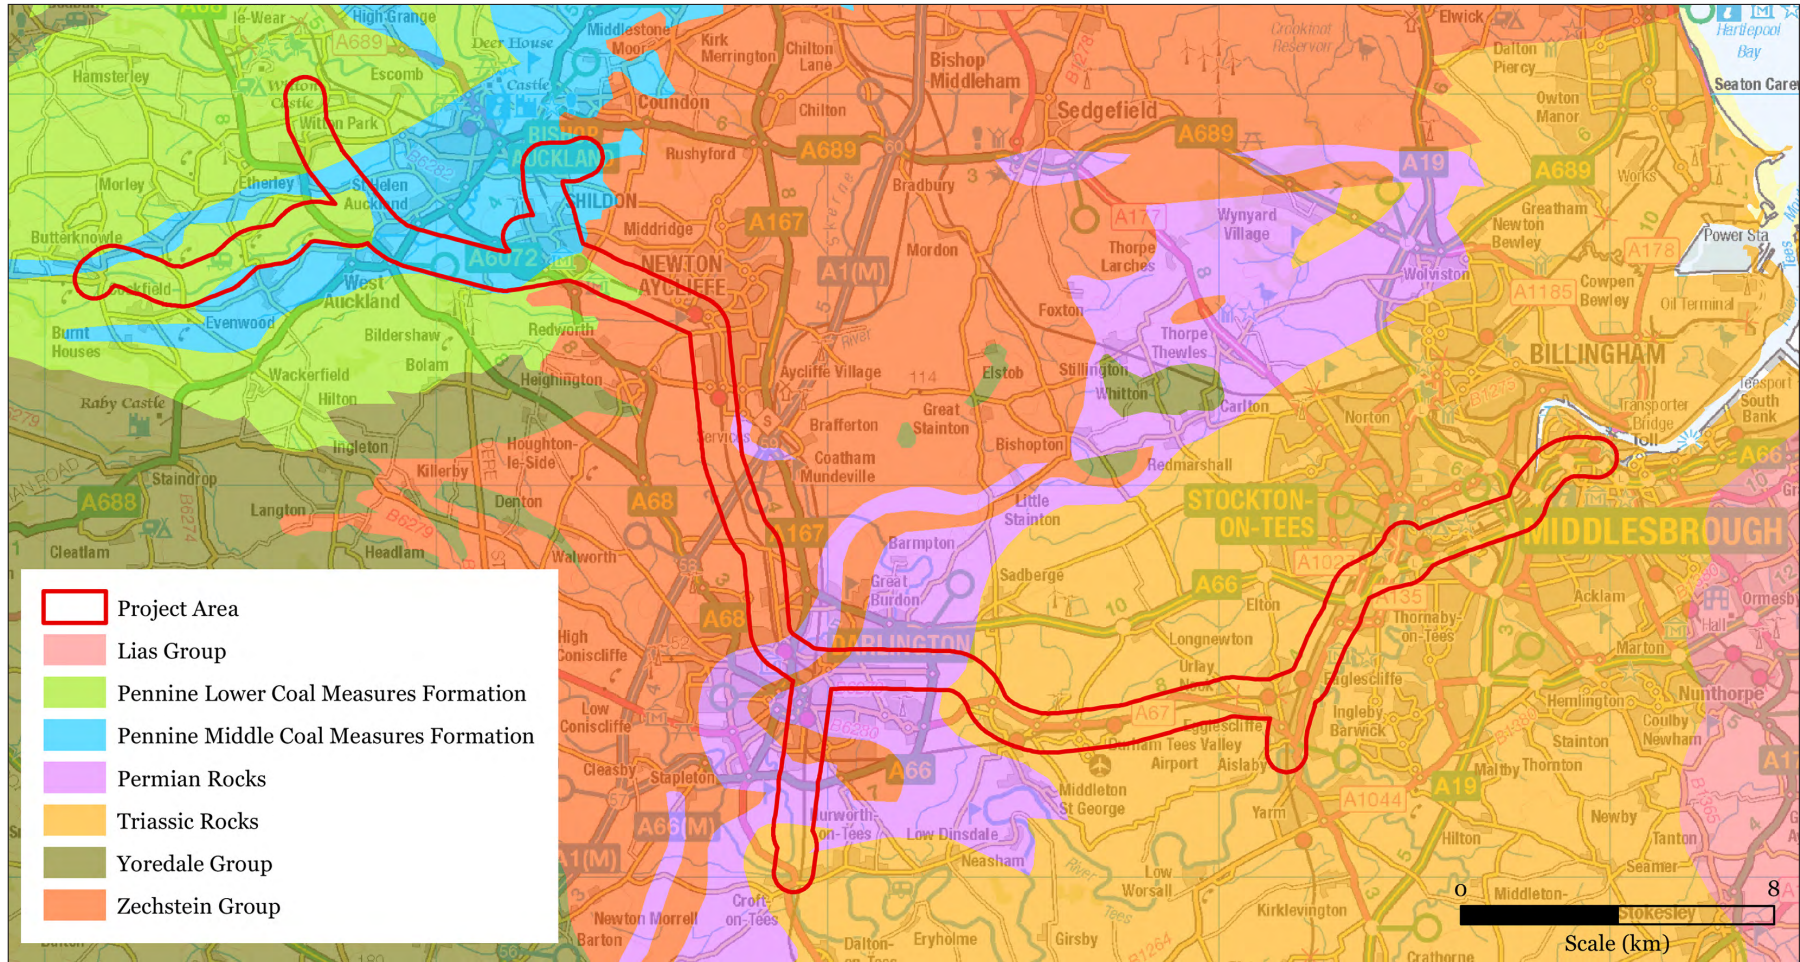
Fig 4: The geology of the Stockton and Darlington Railway. Contains British Geological Survey materials © UKRI 2019; Base map © Crown Copyright and database right 2019. All rights reserved. Ordnance Survey Licence number 100019088.

The highest point, at 215m above sea level, is in the extreme west of the project area, on Cockfield Fell – open moorland formed on sandstones of the Pennine Lower Coal Measures overlain by slowly permeable and seasonally wet acid loamy and clayey soils. The Lower and Middle Coal Measures (Fig 4) – a mixture of mudstones, siltstones and sandstones – extend as far east as Shildon and define the industrial heart of the project area. The coal mines were directly responsible for the construction of the S&DR, to transport the coal to market via staithes on the Tees. The Haggerleases branch line for example, the most westerly element of the railway, was built to serve the collieries around Cockfield Fell. The topographic relief of the landscape falls away to the east of Shildon, and pastoral land-use increasingly gives way to arable farming. The solid geology is dominated by dolostones, mudstones and limestones between Shildon and Darlington, with sandstone further to the east, and an outcrop of mudstone around Middlesbrough.

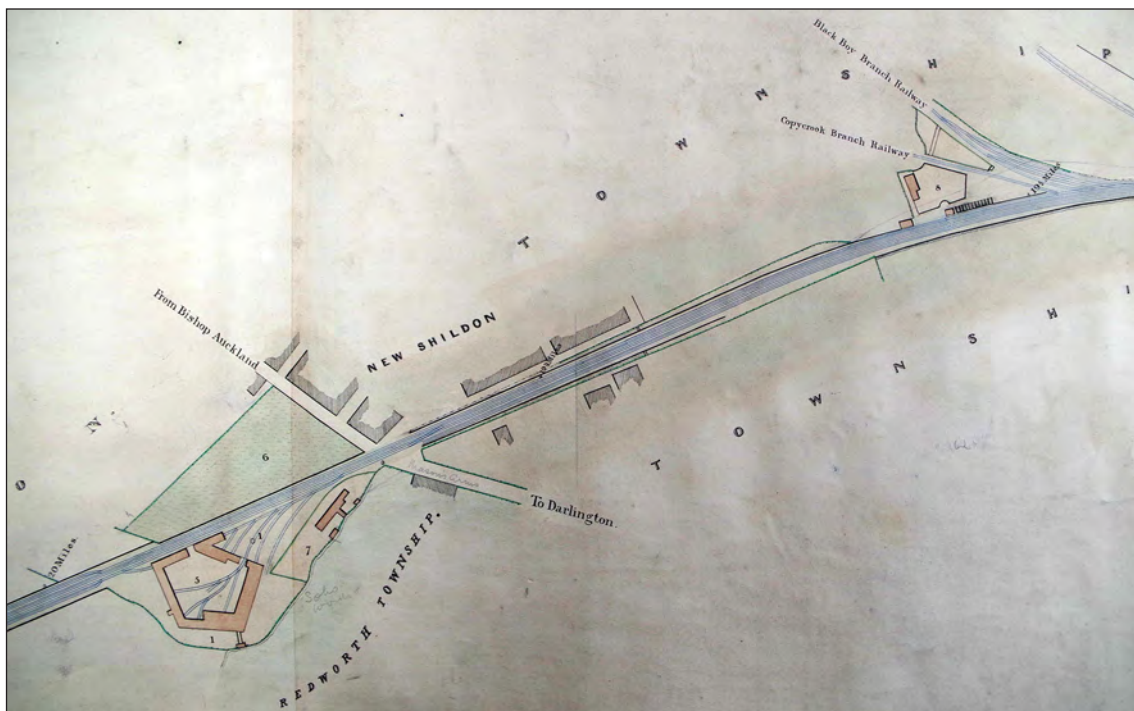
*Fig 5: Extract from the 1839 Thomas Dixon plan of the S&DR between St Helens Auckland and Simpasture Junction. The detail and accuracy of the survey was invaluable for identification of features visible on aerial photographs. Source: Archaeo-Environment Ltd. Reproduced with kind permission of The National Archives, ref. RAIL 1037/453.*

The Thomas Dixon survey of 1838-40 (Fig 5) was used as the guide for identifying remains of the original railway and to distinguish them from the many later changes to the line and associated infrastructure. The Dixon survey was drawn up as a series of plans, each covering a particular section of line. All the main railway features are depicted, including the permanent way, boundaries, buildings, mileposts, signal posts, gates and crossings, and bridges, but not major landscaping such as cuttings and embankments. The Dixon plan for the area between Yarm and Bowesfield is missing, so the 1850s first edition OS maps were used as a proxy to identify original features. By the 1850s this part of the line was disused, but elements were still mapped, so the OS map is probably the most accurate record we possess of the line's original extent and form.

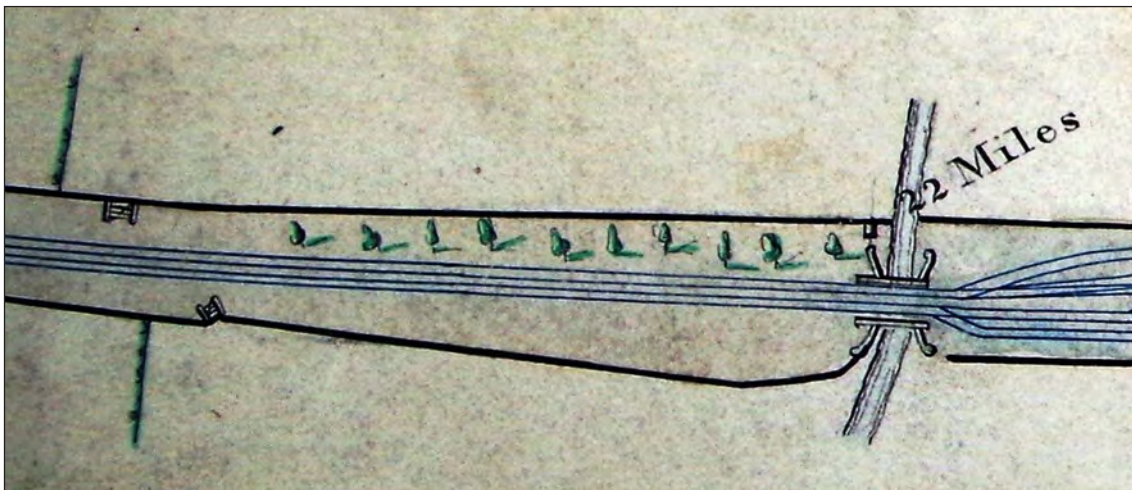
*Fig 6: This extract illustrates some of the detail of railway features included in the Dixon survey including bridges, milestones and occupation crossings. The latter is shown schematically on the left as opposed gates. Detail of 1839 Thomas Dixon map of the S&DR between St Helens Auckland and Simpasture Junction. Source: Archaeo-Environment Ltd. Reproduced with kind permission of The National Archives, ref. RAIL 1037/453.*

Occupation crossings are depicted on the Dixon surveys by schematic gate symbols (Fig 6). These often correspond to gaps in the lineside boundary identifiable on early aerial photographs. As the gates would have had structural elements, for the purposes of the current project they were mapped as points. According to Whishaw's survey of British railways in 1839 (Whishaw 1969, 416), level crossings at that time were not gated – they were served by signal-posts. As a result, structural elements visible on aerial photographs cannot be original but these crossings (where still in use or visible on aerial photographs) were still mapped as a point.

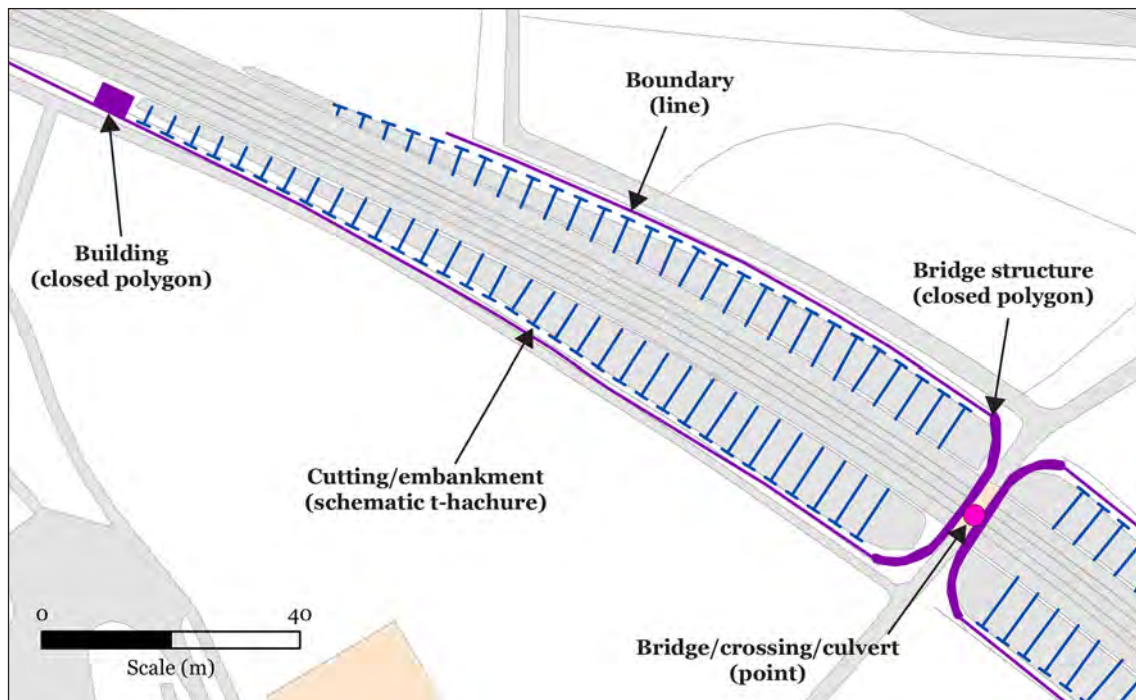
Fig 7: Mapping symbology used points, lines and polygons to depict the railway infrastructure. Archaeological mapping © Historic England; Base map © Crown Copyright and database right 2019.

For the purpose of the mapping, railway buildings were depicted as closed polygons. Bridges were mapped as points except where structural elements were visible, in which case these were mapped as closed polygons. All culverts and crossings, where visible, were marked by a central point. Where stretches of railway boundary were visible, these were depicted as single lines. Earthwork cuttings and embankments were illustrated by schematic t-hachures depicting the extent and direction of the slope (Fig 7).

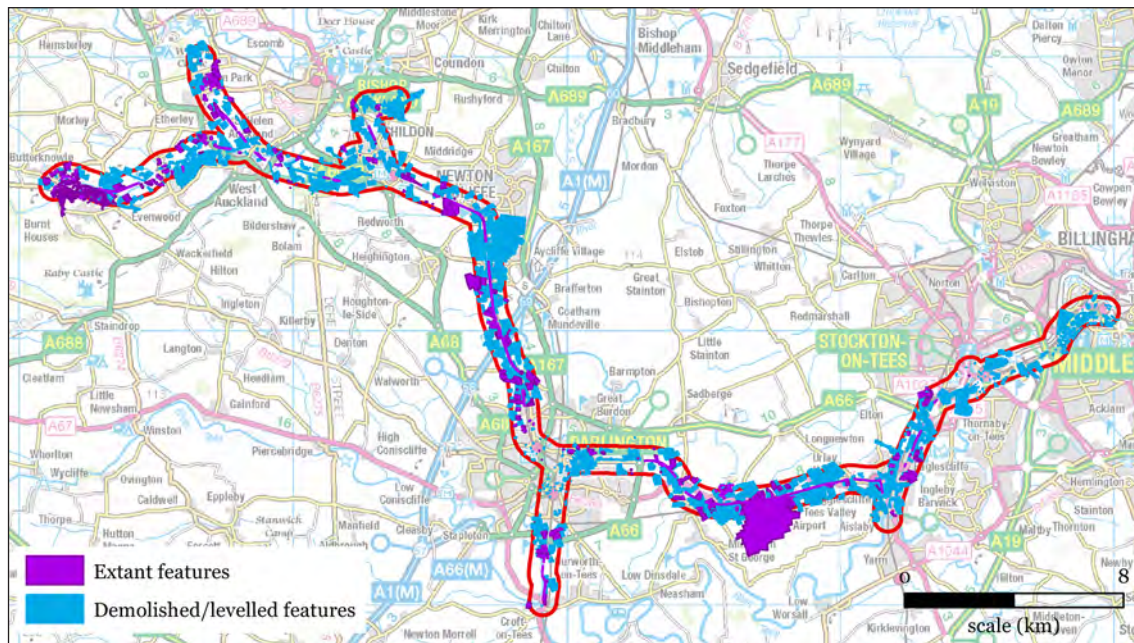
*Fig 8: Only approximately one third of features mapped from historical aerial photographs are extant on the latest imagery. Archaeological mapping © Historic England; Base map © Crown Copyright and database right 2019.*

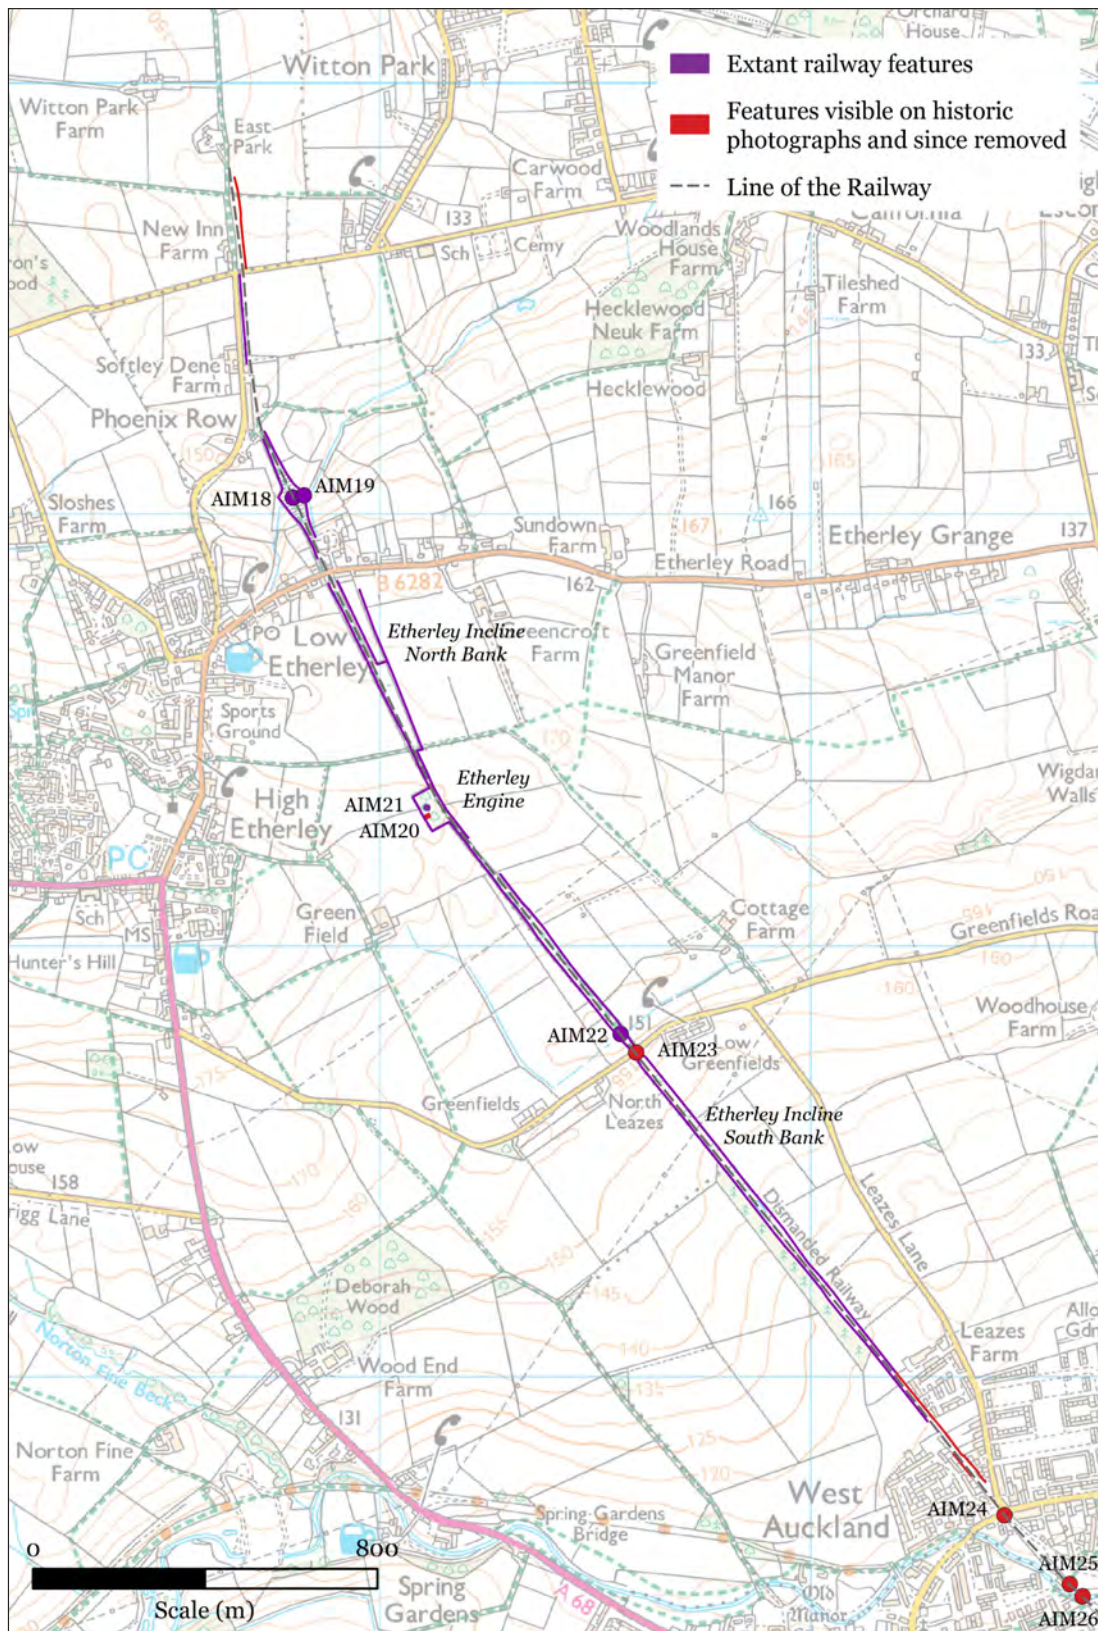
Fig 9: Features visible on historic aerial photographs relating to the original S&DR railway between Witton Park and the Gaunless Bridge. Cuttings and embankments are not depicted. Archaeological mapping © Historic England; Base map © Crown Copyright and database right 2019.

A number of buildings relating to Witton Park Colliery are visible on 1940s aerial photographs, but nothing of the railway infrastructure itself. The Historic Environment Audit (HEA) identified earthworks relating to the railway to the south of the colliery site, but these could not be discerned on aerial photographs. However, the eastern boundary wall between East Park and New Inn Farm remained extant into at least the 1940s. Sloshes Lane, immediately to the south of New Inn Farm, crossed the railway by an overbridge, though this was removed before 1859 – presumably when or shortly after this section of the railway went out of use in 1842 (ibid). South of the farm, the original western boundary to the railway would have followed the course of the current hedgerow bounding the east side of the road, opposite Softley Dene Farm, but it would appear that the original boundary wall has been removed.

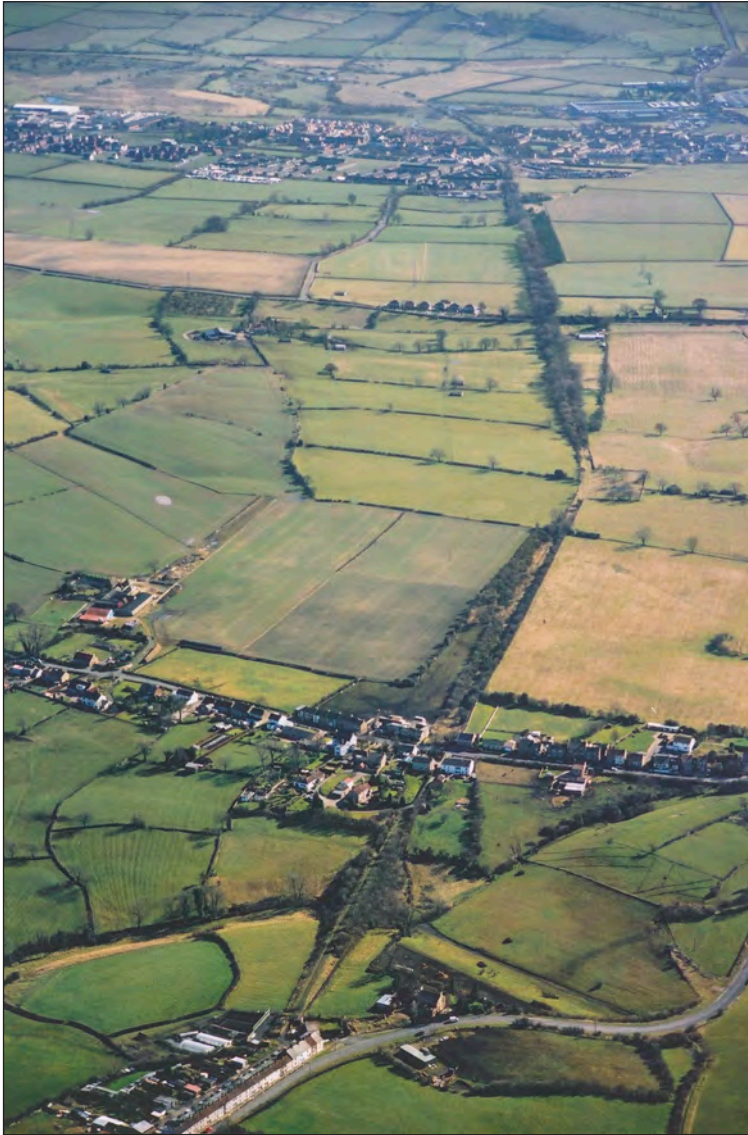
*Fig 10: Etherley Incline as viewed from Low Etherley looking south-east. The site of Etherley Engine is at centre-right, inside the rectangular enclosure that adjoins the kink in the line of the railway at the summit of the incline. 17712/33 13-MAR-2002 © Historic England Archive.*

South of Phoenix Row, the railway deviated to the south-east to pass through Low Etherley. This marks the start of the inclined section (Fig 10). Here, the course of the railway is well preserved, first as a broad tree-covered earthwork embankment extending almost to the modern B6282 road, and south of the road as a shallow cutting as far as the engine house at the incline summit. The B6282 formerly crossed the railway by an overbridge, but the bridge was removed with the closure of the incline in the mid-19th century. The line of the railway boundary is also visible along most of this stretch as hedgerows, which may cover original wall foundations beneath.

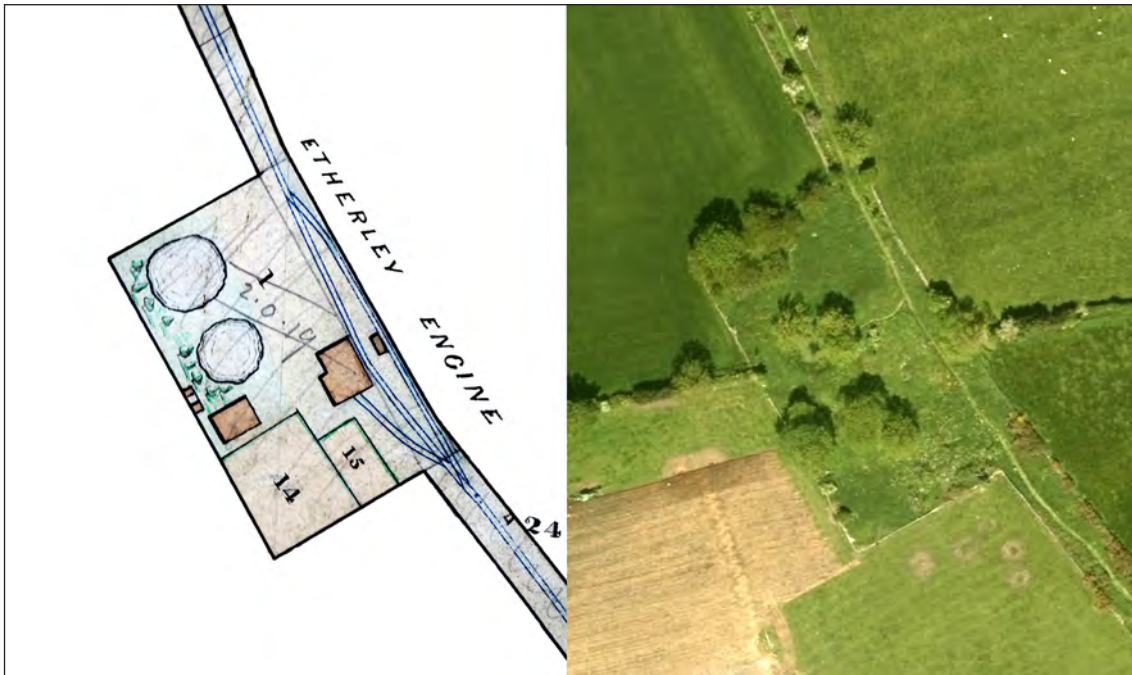
*Fig 11: The Etherley Engine consisted of the Engine House, the Engineman's House and two ponds to supply the water for the steam engine. All that is visible on modern aerial photographs are the partly levelled earthworks of the southern pond and the enclosure wall. Left: 1839 Thomas Dixon plan. Source: Archaeo-Environment Ltd. Reproduced with kind permission of The National Archives, ref. RAIL 1037/451; Right: NZ1728 11-JUN-2015 © Bluesky International/Getmapping PLC.*

The remains of the boundary wall around Etherley Engine are visible (Figs 11-12), although the engine house seems to have been mostly ruinous before 1896 (Ordnance Survey 1897). One of two ponds that provided water for the engine is also visible on aerial photographs as a shallow earthwork (AIM21; HEA27; Grade II listed as NHLE 1159141), though now partly obscured by tree cover. The second pond (HEA 28) is not visible from the air although still traceable on the ground as a shallow depression (Marcus Jecock, pers comm). The Engineman's House (AIM20; HEA506) was still standing and was mapped from 1948 vertical aerial photographs; it reportedly remained intact in to the 1980s (Archaeo-Environment Ltd 2016b, 13-14), but has since been demolished.

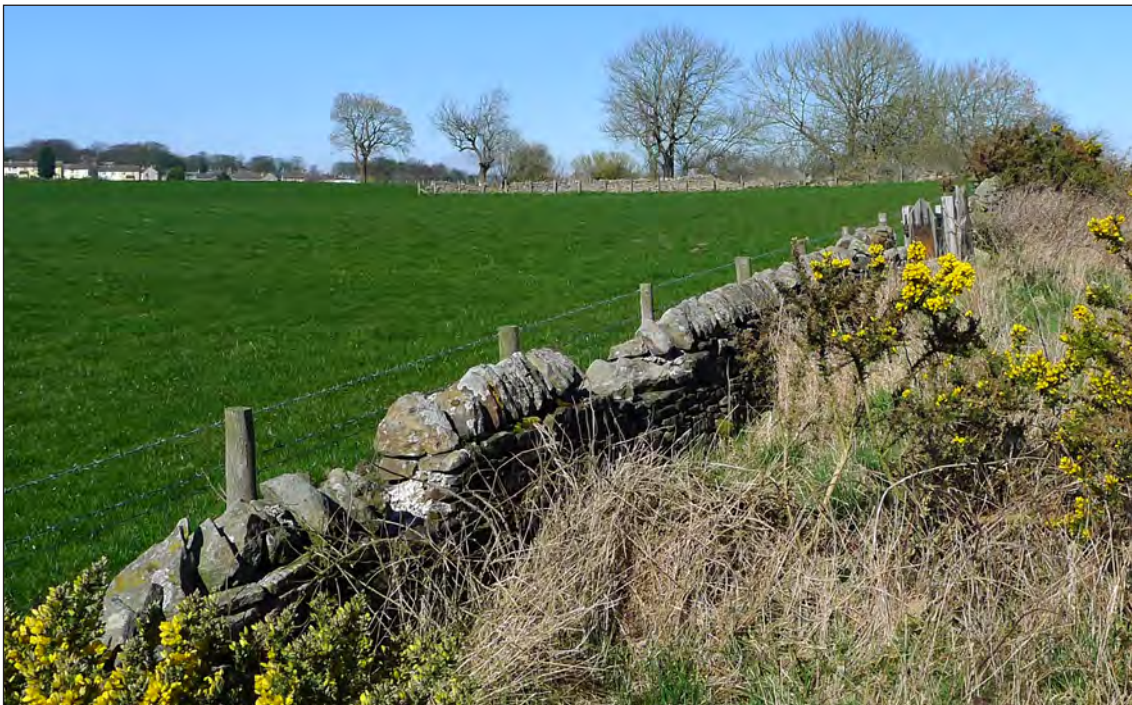
*Fig 12: The original railway boundary wall to the south of the Etherley Engine. Ground inspection revealed most of the coping stones are in place. March 2019 © Historic England.*

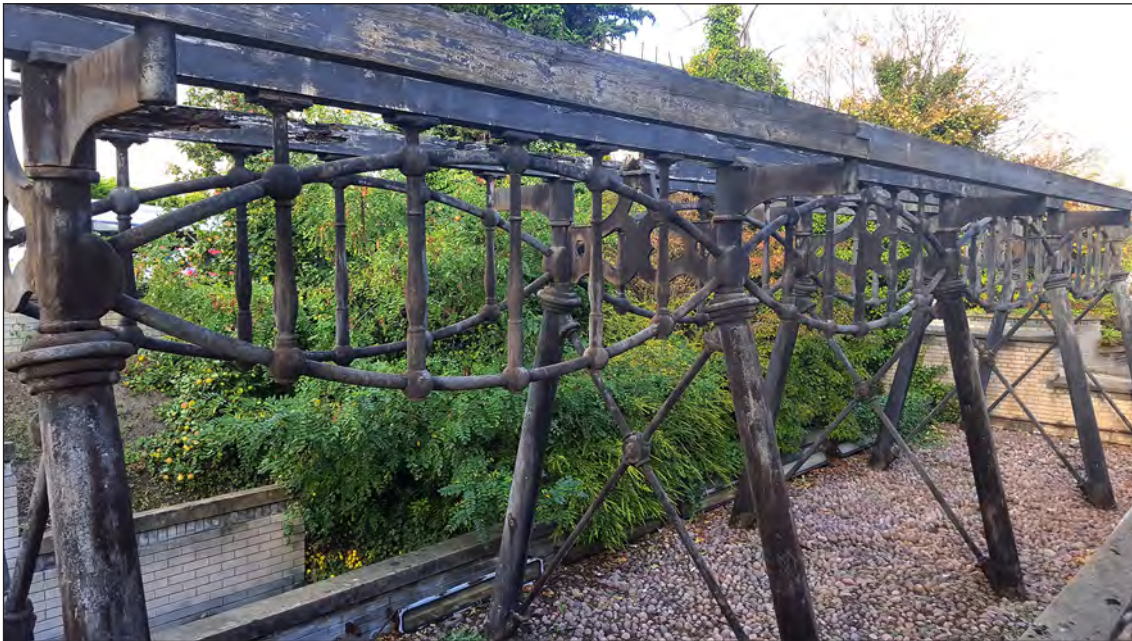
*Fig 13: The bridge over the River Gaunless was the world's first iron railway bridge. It is now preserved at the National Railway Museum, York. October 2018 © Historic England.*

The railway crossed the river by an underbridge; one of the world's first iron railway bridges and the first to use an iron truss (Chrimes 1991, 45) (AIM26; Fig 13). This section of railway, to the east of West Auckland, fell into disuse following the opening of the West Auckland (Tunnel) Branch Railway in 1856, which linked West Auckland to Shildon by a more level approach via the Shildon Tunnel, part of the Bishop Auckland and Weardale Railway (Hoole 1975, 38). The Gaunless

bridge survived however until 1901 when the iron deck was replaced by a stronger structure with the re-opening of part of the line to serve Brusselton Colliery (ibid, 11). The old superstructure was then removed, though the original stone abutments were retained (Archaeo-Environment Ltd 2016b, 27). The original deck structure is now preserved at the National Railway Museum, York (Hoole 1975, 38).

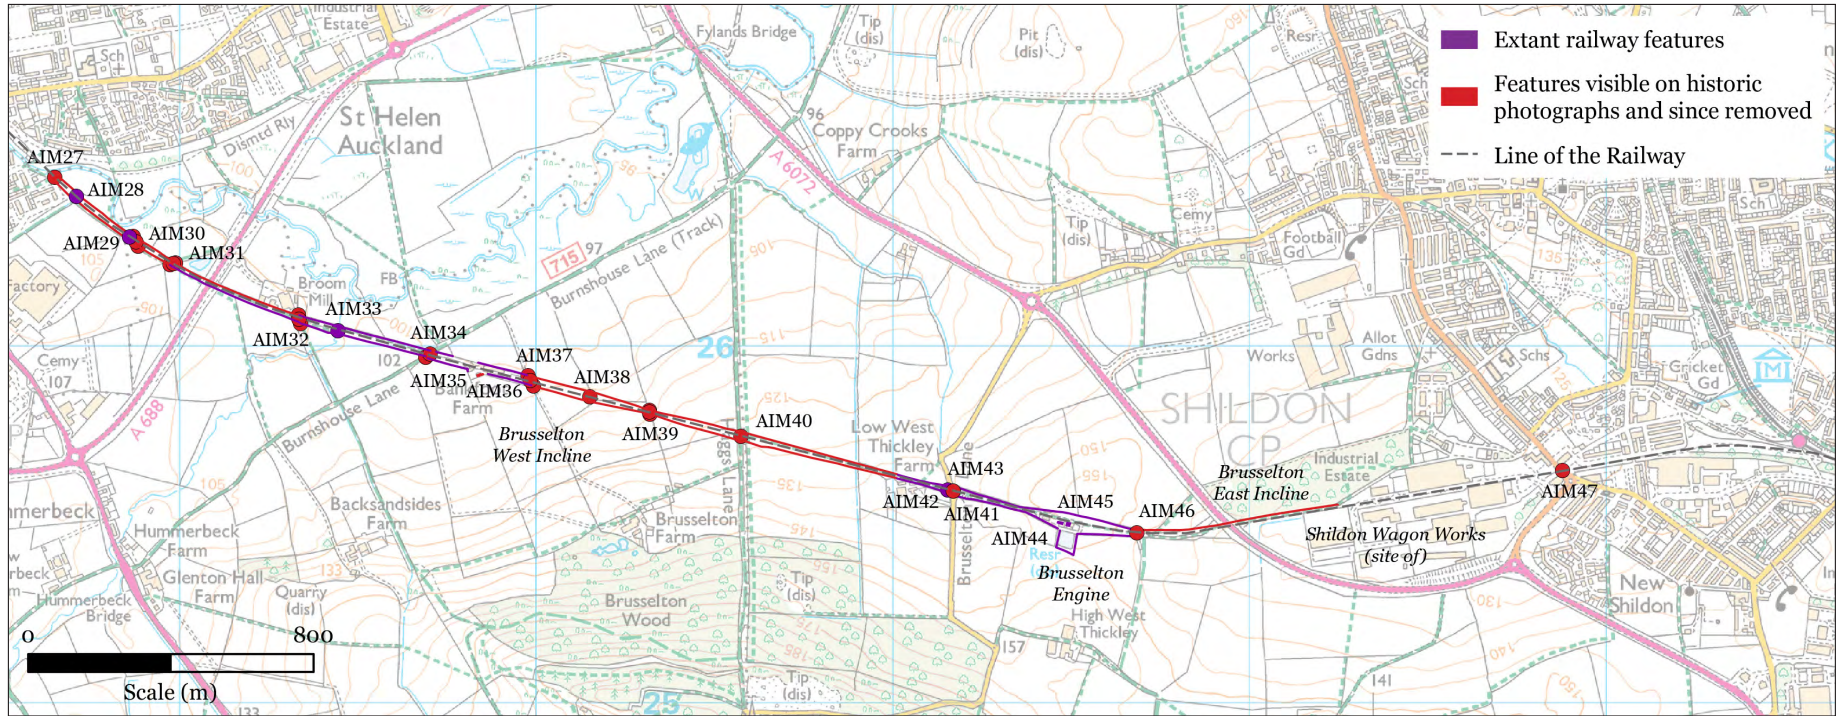
Fig 14: Features relating to the original S&DR railway mapped from aerial photographs between Gaunless Bridge and Shildon. Cuttings and embankments are not depicted. Archaeological mapping © Historic England; Base map © Crown Copyright and database right 2019.

From the river, the railway ran east-south-east, ascending the south-east side of the Gaunless valley via the Brusselton West Incline to the summit at Brusselton Engine, north of High West Thickley. From here the railway descended eastwards towards Shildon where it was joined by the Black Boy Branch line coming in from the eponymously named colliery to the north. Lengths of this section, from the River Gaunless to Burnhouse Lane, and immediately adjacent to Low West Thickley Farm, are currently included in the same scheduling as the Etherley Incline, under NHLE 1002315.

Because of the complex history and early closure of part of this section of the S&DR main line, the survival of features to the east of the River Gaunless is variable because of later land-use. After crossing the river, the railway ran along an embankment, which remains visible as earthworks for over 400m. Immediately east of the Gaunless, a narrow underbridge is visible on 1940s photographs (AIM27; HEA16; Fig 15), although the HEA lists this feature as partially destroyed by 2015. 80m to the south-east, Oakley Cross Beck flows beneath the railway embankment via a culvert (AIM28; HEA87; Fig 15). Another accommodation underbridge lay 190m east of the culvert (AIM29; HEA78; Fig 15), and although recorded on historic aerial photographs, is reportedly now buried (Archaeo-Environment Ltd 2016c, 5). This section of the line is included in scheduling NHLE 1002315.

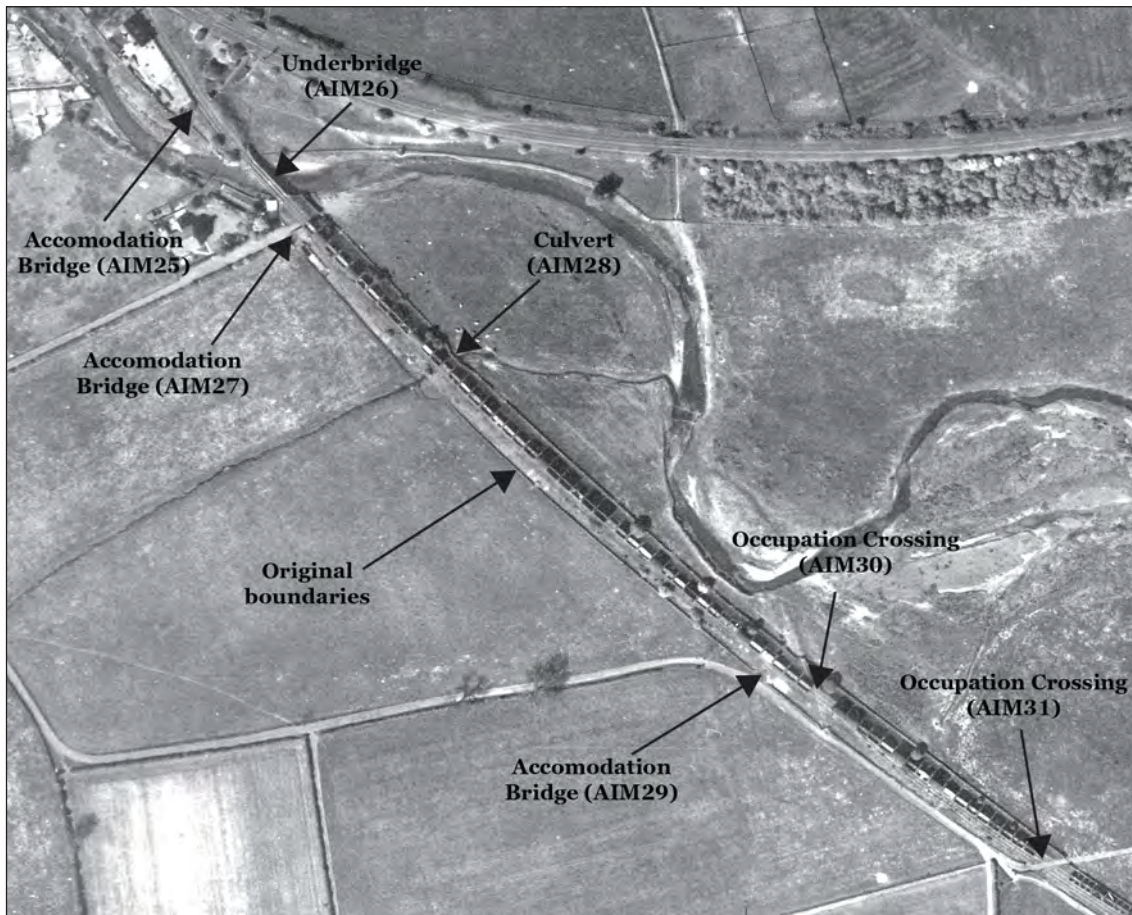
*Fig 15: The railway to the east of West Auckland went out of use as the main line by 1856, but reopened in 1901 as a branch line to Brusselton Colliery (coal wagons are visible on the track). Detail of RAF/58/B/37 V 5192 17-MAY-1948 Historic England Archive (RAF Photography).*

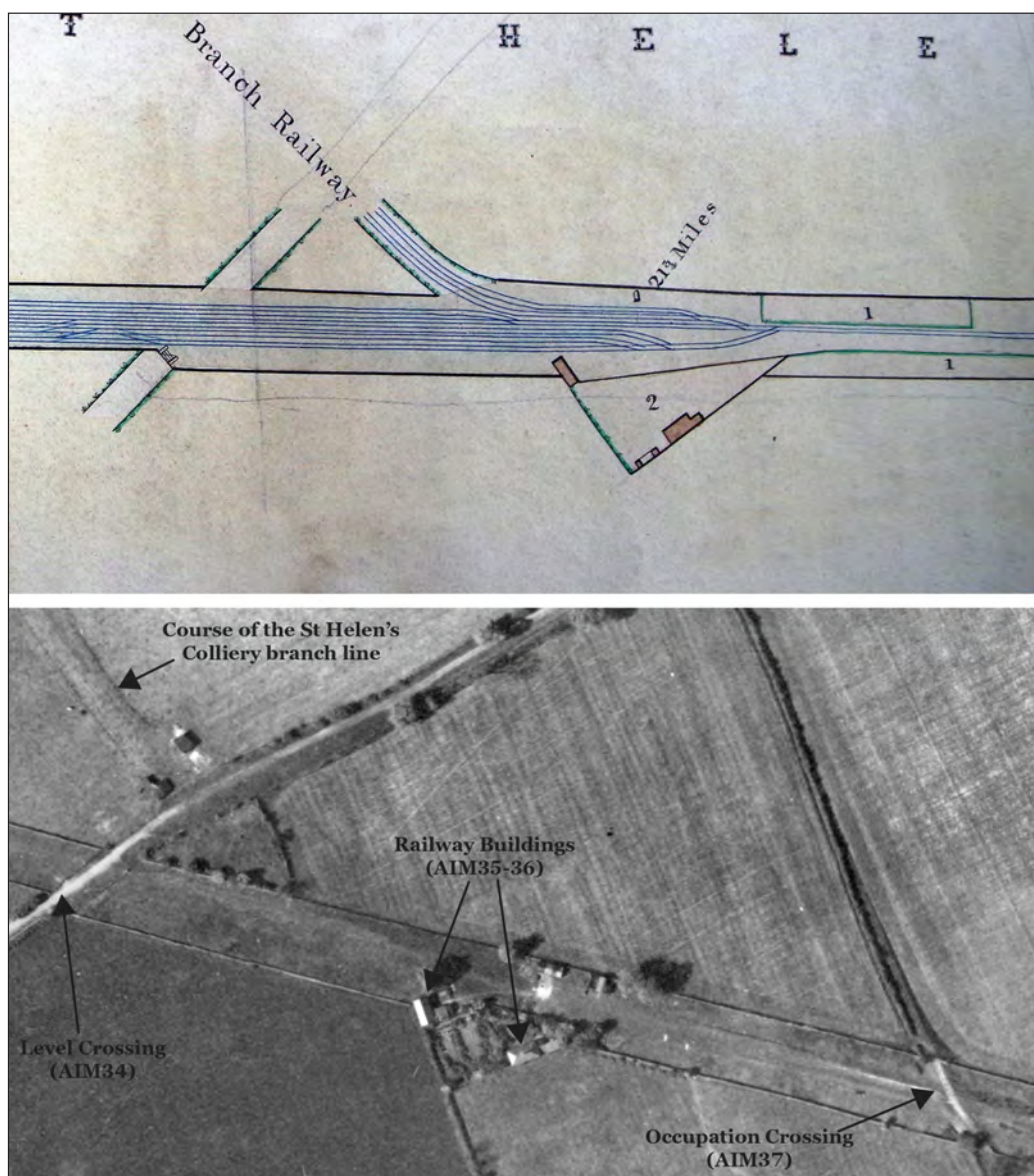
Fig 16: Bankfoot Farm marks the western base of the Brusselton Incline. The railway track had been removed by the end of the 19th century, but the boundaries and buildings remained intact. One of these buildings, although modified and extended, appears to remain occupied today. Top: 1839 Thomas Dixon plan. Source: Archaeo-Environment Ltd. Reproduced with kind permission of The National Archives, ref. RAIL 1037/453; Bottom: Detail of Sfm RAF/58/B/37 V 5029-5379 17-MAY-1948 Historic England Archive (RAF Photography).

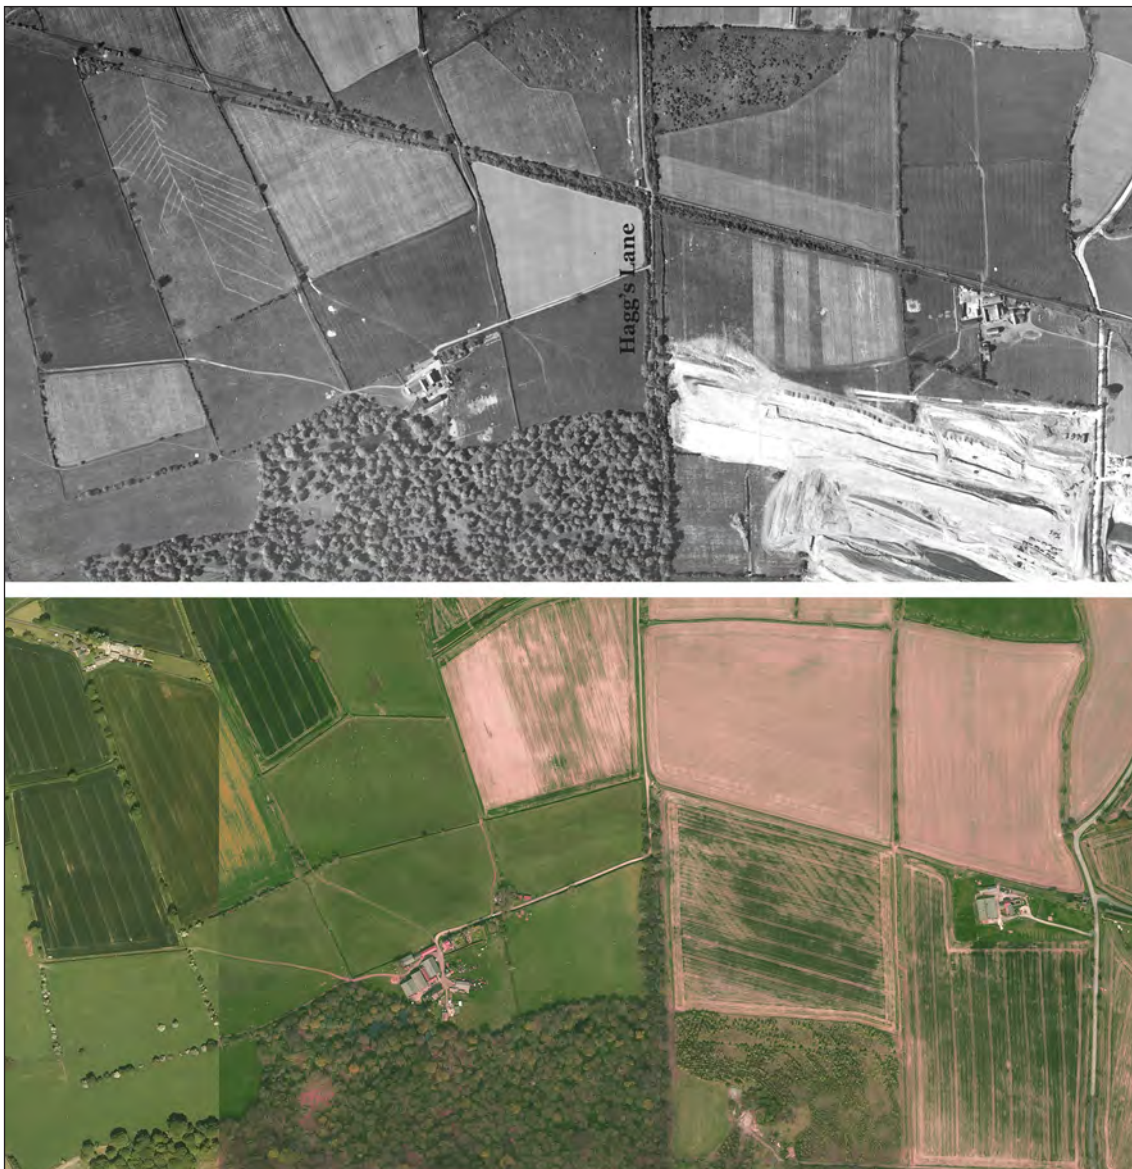
*Fig 17: Much of the Brusselton West Incline west of Hagg's Lane/Dere Street has disappeared from the landscape, either destroyed by opencast coal mining or simply levelled. Top: Detail of Sfm RAF/58/B/37 V 5029-5379 17-MAY-1948 Historic England Archive (RAF Photography); Bottom: NZ1925-2126 11-JUN-2015 – 06-MAY-2016 © Bluesky International/Getmapping PLC.*
