# Stockton and Darlington Railway Heritage Action Zone Aerial Investigation & Mapping Report

**STOCKTON AND DARLINGTON RAILWAY  
HERITAGE ACTION ZONE**

**Aerial Investigation & Mapping Report**

NGR: NZ 290 156

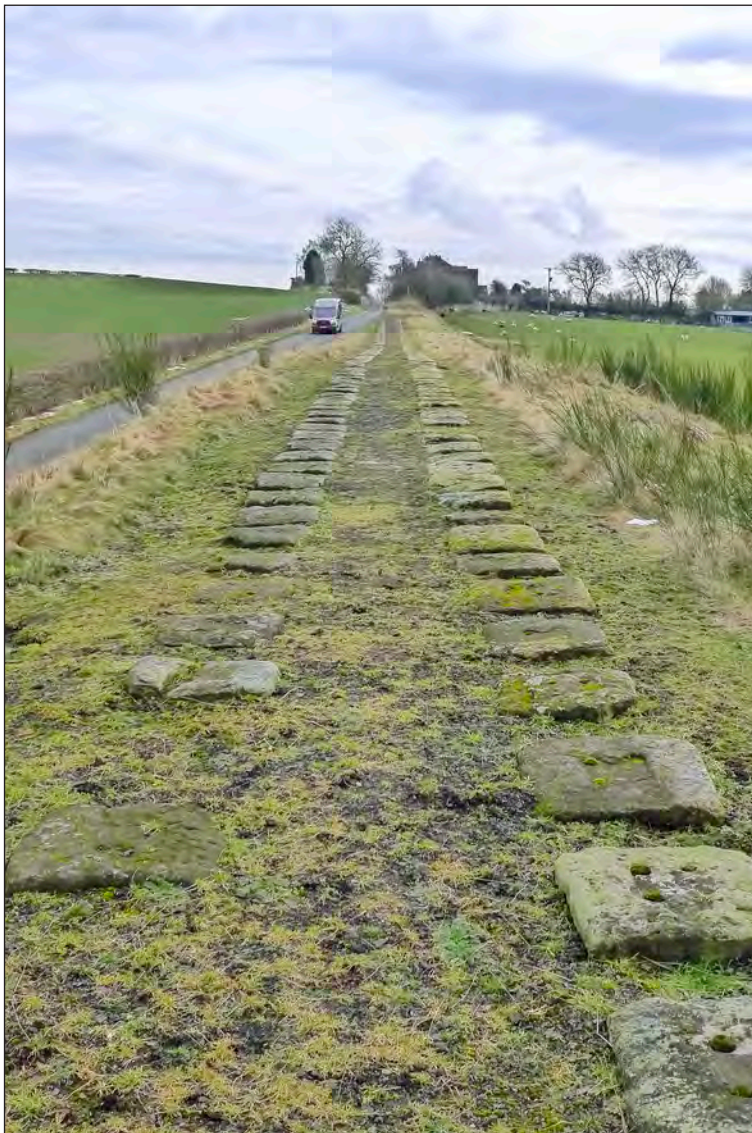
*Fig 18: Original stone sleepers from the 1825 railway along the Brusselton West Incline. March 2019 © Historic England.*

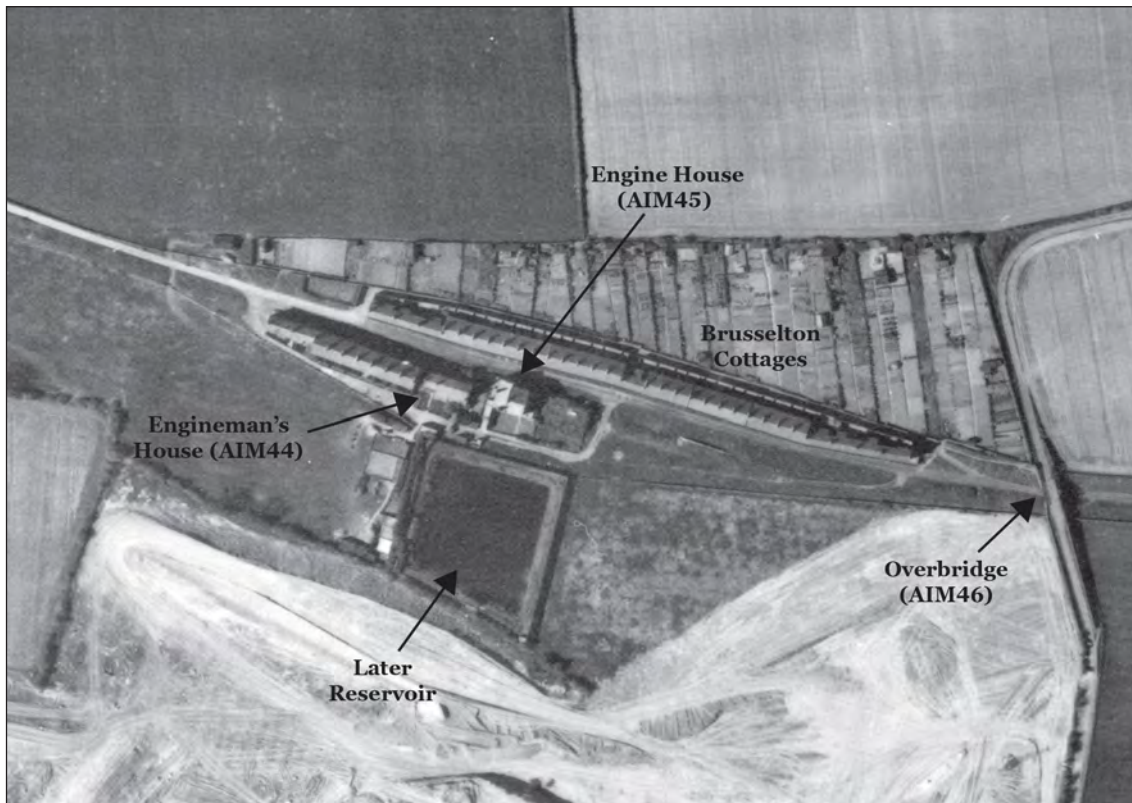
*Fig 19: In 1825, Brusselton Engine comprised the Engineman's House, the Engine House and two circular ponds. By the end of the century, two terraces of houses, named Brusselton Cottages, had been added and the ponds enlarged into a single, square, reservoir. The Engineman's House, parts of the Engine House, the later reservoir and a number of the cottages are still there. Opencast coal mining can be seen to the south of the reservoir. Detail of RAF/58/B/37 V 5277 17-MAY-1948 Historic England Archive (RAF Photography).*

The Brusselton Engine was located 300m to the east of this crossing (Fig 19). Much of the associated infrastructure remains intact, including the boundaries, the cutting in which the engine and associated features lay and elements of both of the original buildings. The engine was originally fed from two circular ponds, but these were quickly replaced by the present, much larger, square reservoir (not mapped by this project as it does not relate to the original railway). The Engineman's House (AIM44; HEA111; Grade II listed as NHLE 1121494) is now converted to a modern dwelling. The Engine House (AIM45; HEA111; Grade II listed as NHLE 1160153 and 1121493), though much reduced in size from the building illustrated on the 1839 map (which was an 1831 upgrade to the original engine house), is also now a residential dwelling.

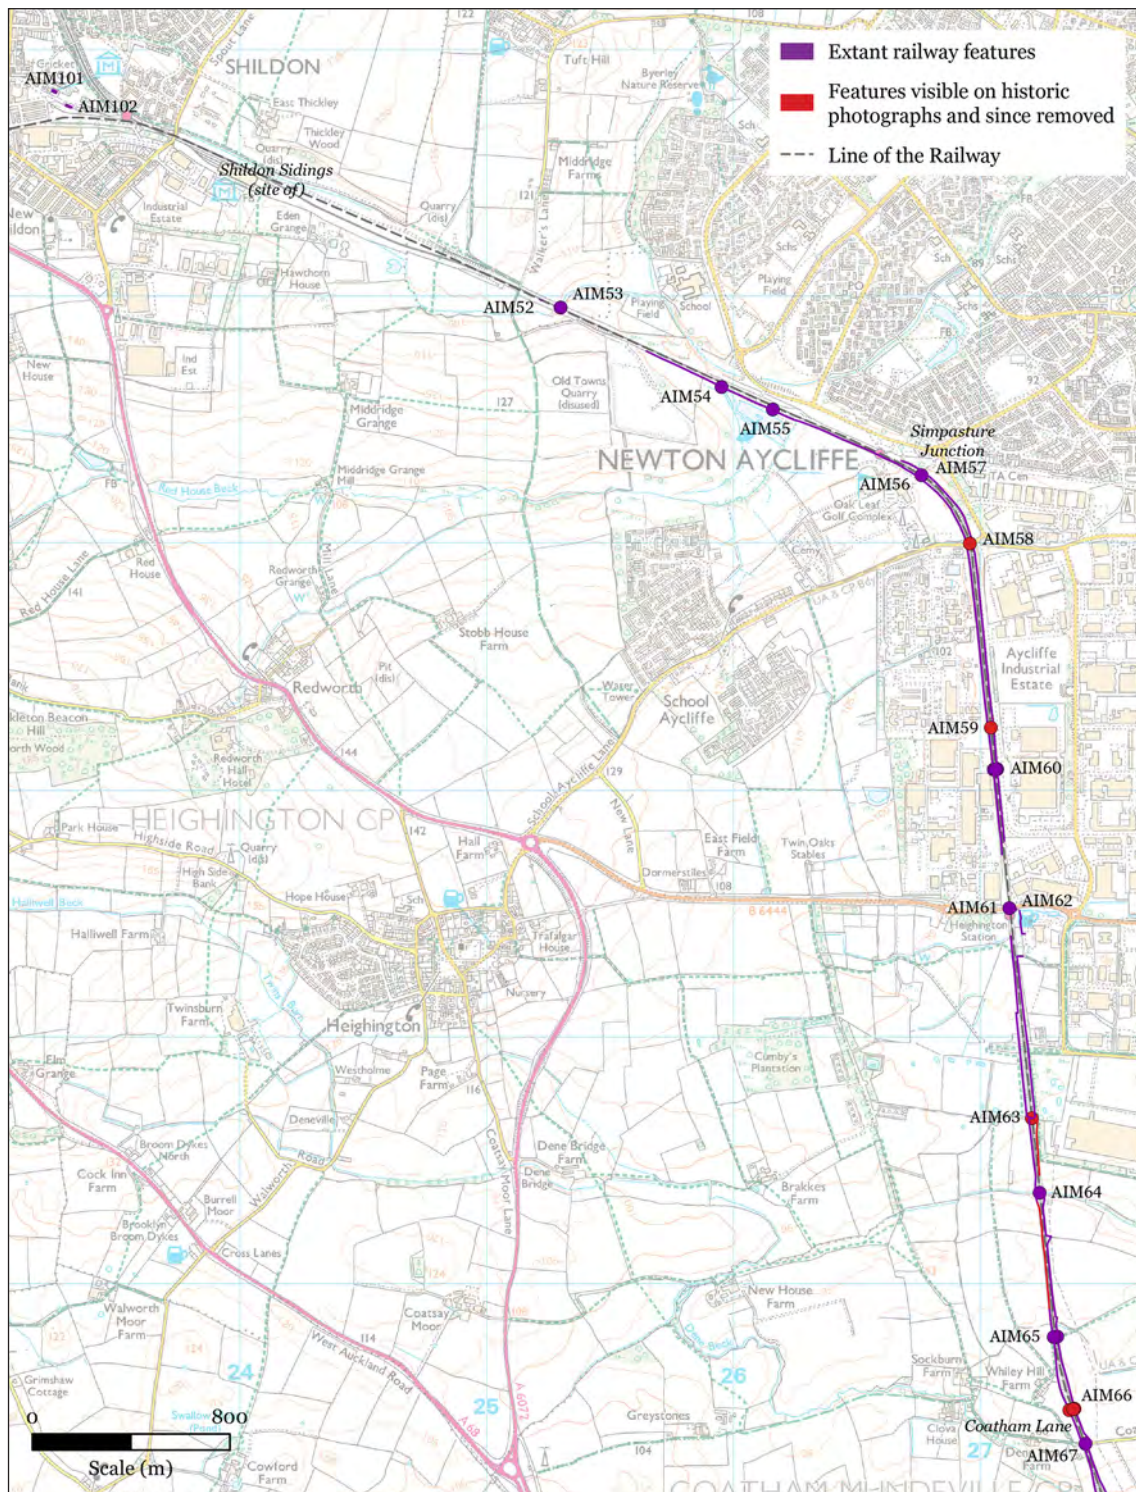
Fig 20: Features relating to the original S&DR railway mapped from aerial photographs between Shildon and Coatham Lane. Cuttings and embankments are not depicted. Archaeological mapping © Historic England; Base map © Crown Copyright and database right 2019.

New Shildon developed as the home to major railway works over the century that followed. The first of these was the Shildon Works (Fig 21), which opened in 1825, later becoming the Wagon Works. By the late 19th century, the works comprised several large workshops and an extensive area of railway sidings. This later development removed any vestiges of the pre-1831 railway. The works were the initial home of the S&DR Locomotive Department (Archaeo-Environment Ltd 2016d, 4).

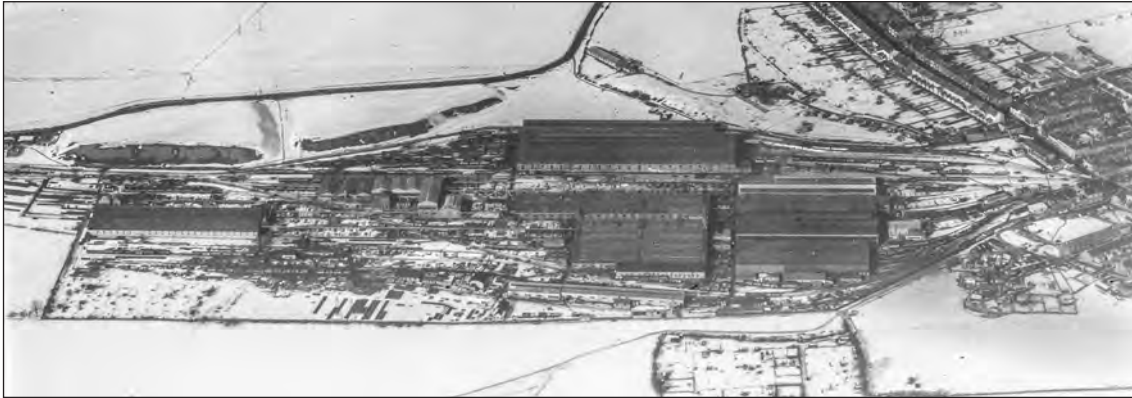
Fig 21: The Shildon Wagon Works operated from 1825 to 1984. Detail of RAF/58/5640/PSFO-0066 01-MAR-1963 Historic England Archive (RAF Photography).

The railway originally entered Shildon from the west via the Brusselton Incline. This section of the railway was however removed by the late 19th century and the line stopped at Brusselton Cottages. OS mapping surveyed in 1939 suggests that the railway track between Brusselton Cottages and the Shildon Wagon Works was still intact, but 1948 vertical aerial photographs shows that the track west of the works had been removed by then. The Shildon Works remained in operation until the 1980s and had rail access until this point.

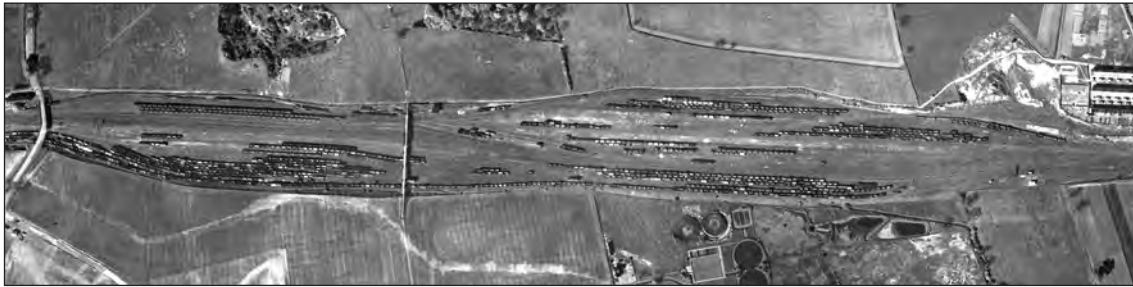
*Fig 22: The construction of the Shildon Sidings removed all traces of the 1825 railway. Detail of SfM RAF/58/B/37 V 5029-5379 17-MAY-1948 Historic England Archive (RAF Photography).*

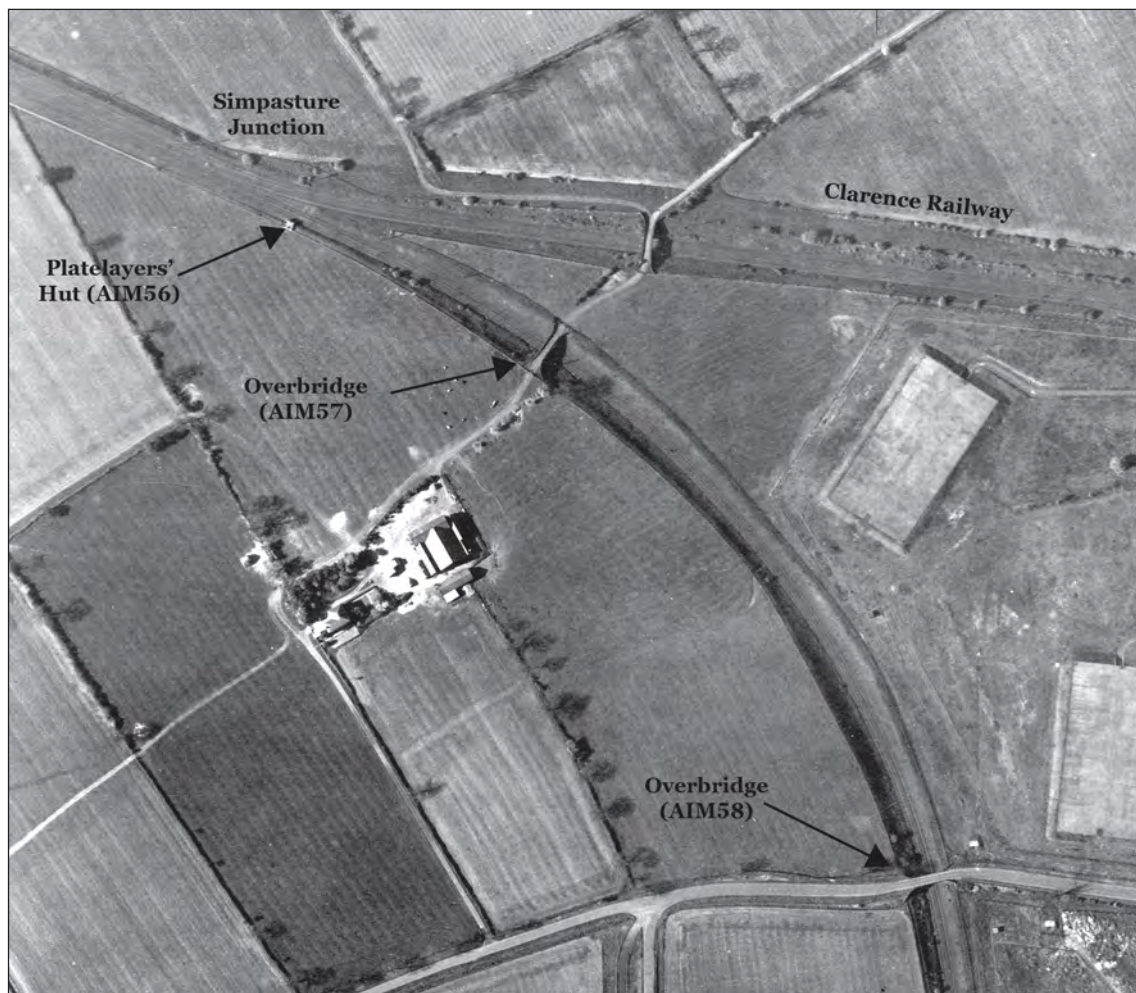
*Fig 23: Simpasture Junction is where the Clarence Railway joined the S&DR. To the south of the junction, the overbridge abutments remain intact, although the decking has been replaced. Detail of RAF/58/B/37 V 5379 17-MAY-1948 Historic England Archive (RAF Photography).*

Simpasture Junction formed the point at which the Clarence Railway (opened 1833) joined the S&DR. To the immediate east of the junction there is a narrow accommodation underbridge (AIM57; HEA227; Fig 23). Although the decking has been replaced at least twice (ibid, 28), the abutments are thought to be original to the 1825 railway. It still carries foot traffic between Newton Aycliffe and the OakLeaf Sports Complex.

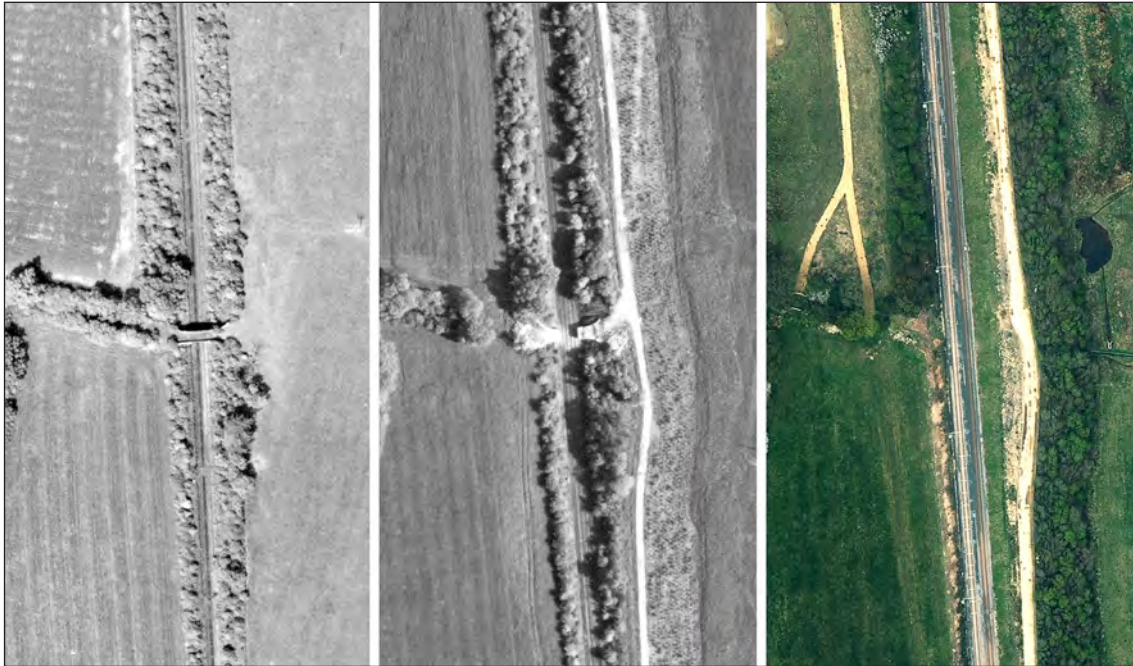
*Fig 24: The bridge adjacent to Moordale Park (AIM63) was intact in the 1980s (left). By the mid-1990s, the decking had been removed (middle), but the stonework abutments were intact. The entire structure was then demolished in around 2014 in connection with track improvements (right). Detail of OS/89263 V 39 11-JUN-1989; Detail of OS/93209 V 77 06-JUN-1993 © Crown copyright. Ordnance Survey; Detail of NZ2721 06-MAY-2016 © Bluesky International/Getmapping PLC.*

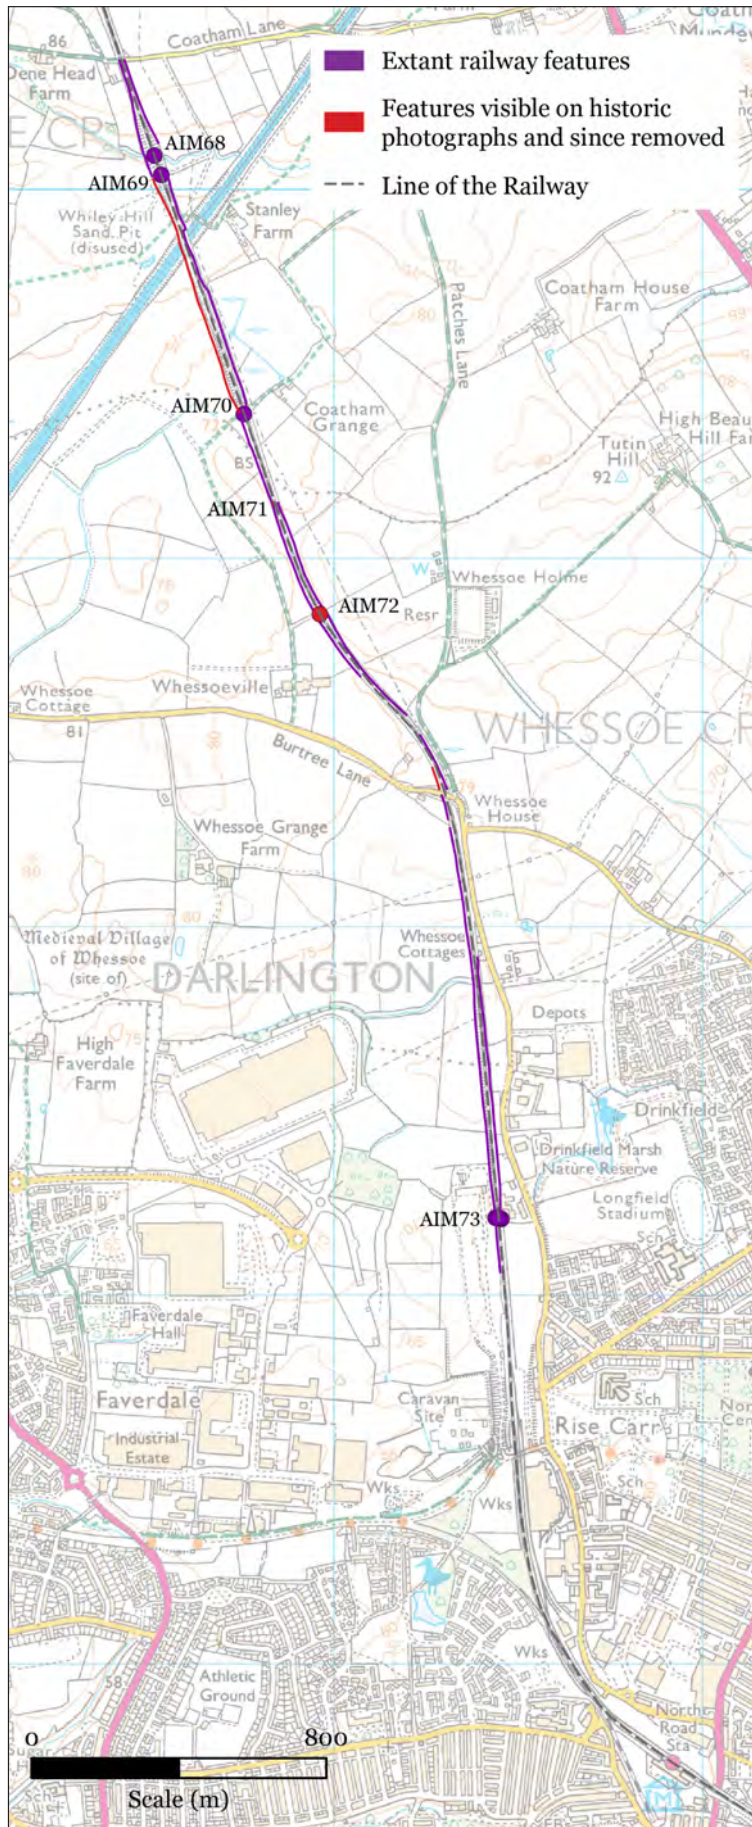
Fig 25: Original features of the S&DR railway visible on aerial photographs between Coatham Lane and Darlington North Road Station. Cuttings and embankments are not depicted. Archaeological mapping © Historic England; Base map © Crown Copyright and database right 2019.

### **Coatham Lane to Darlington North Road Station (Fig 25)**

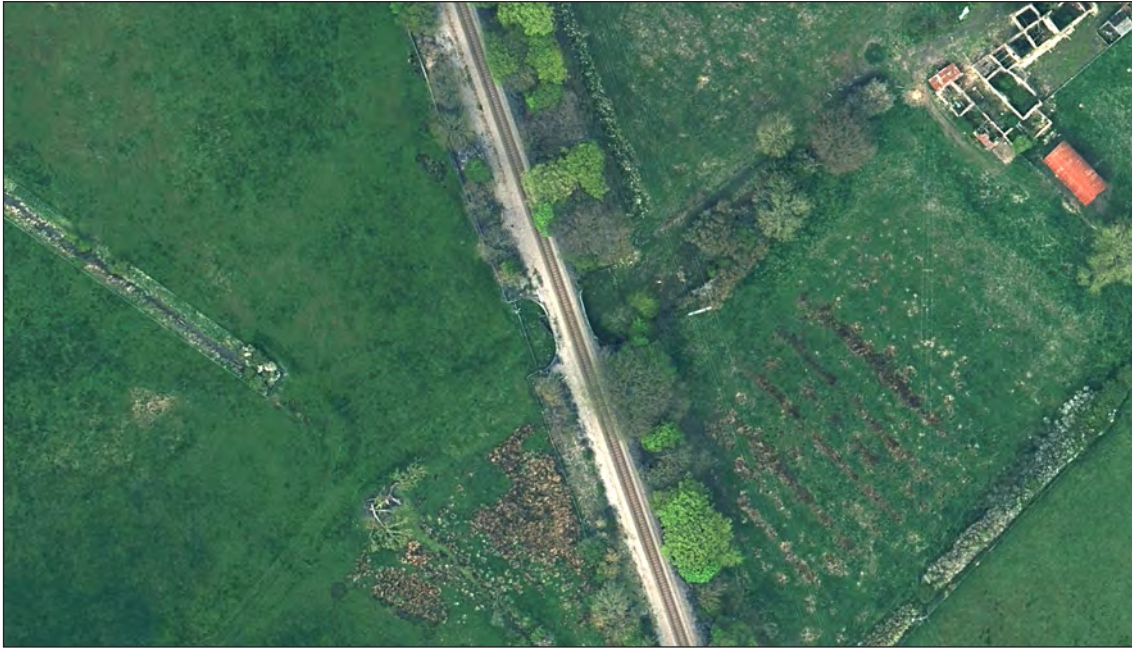
*Fig 26: The underbridge that served access to Coatham Grange/Myers Flat (seen in ruins to the right) retains its original curved abutments, though the decking has been replaced (AIM70; HEA194). Detail of NZ2719 06-MAY-2016 © Bluesky International/Getmapping PLC.*

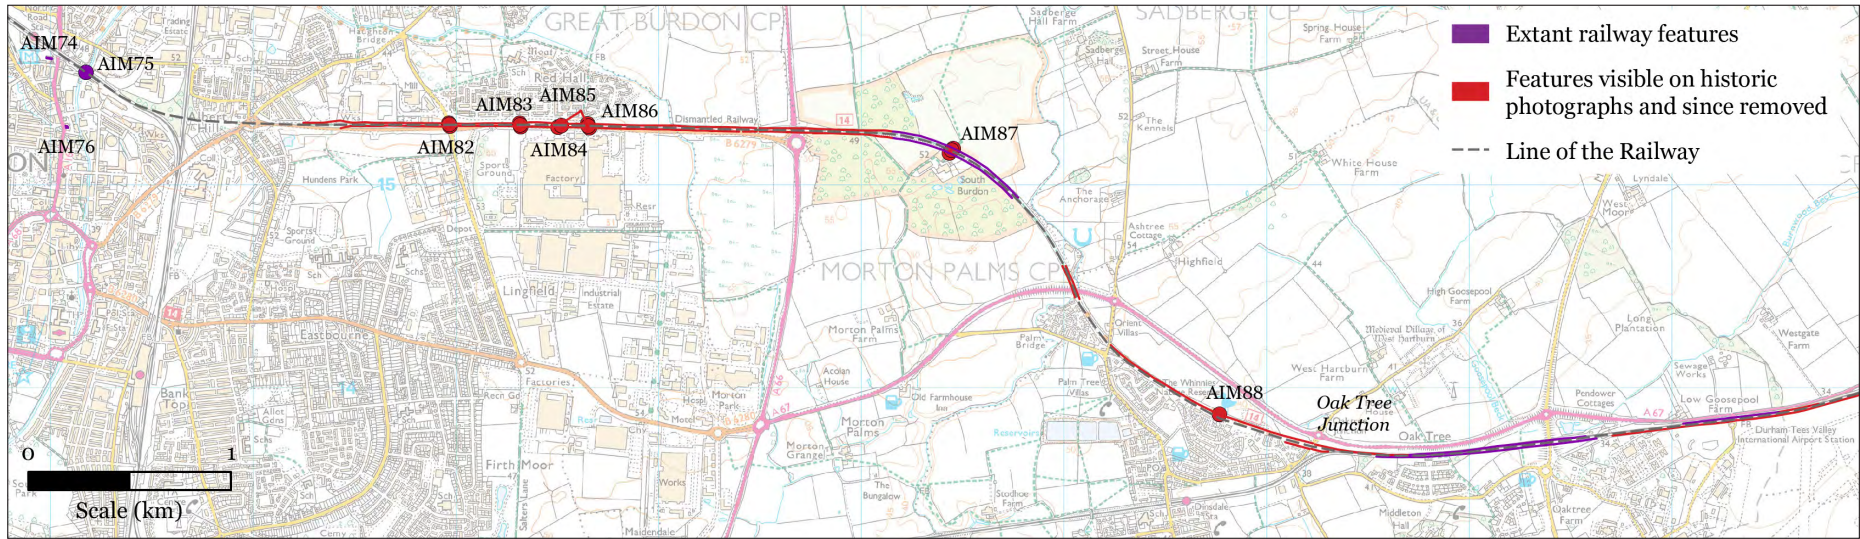
Fig 27: Original S&DR railway visible on aerial photographs between Darlington North Road Station and Low Goosepool Farm. Cuttings and embankments are not depicted. Archaeological mapping © Historic England; Base map © Crown Copyright and database right 2019.

### **Darlington to Low Goosepool Farm (Fig 27)**

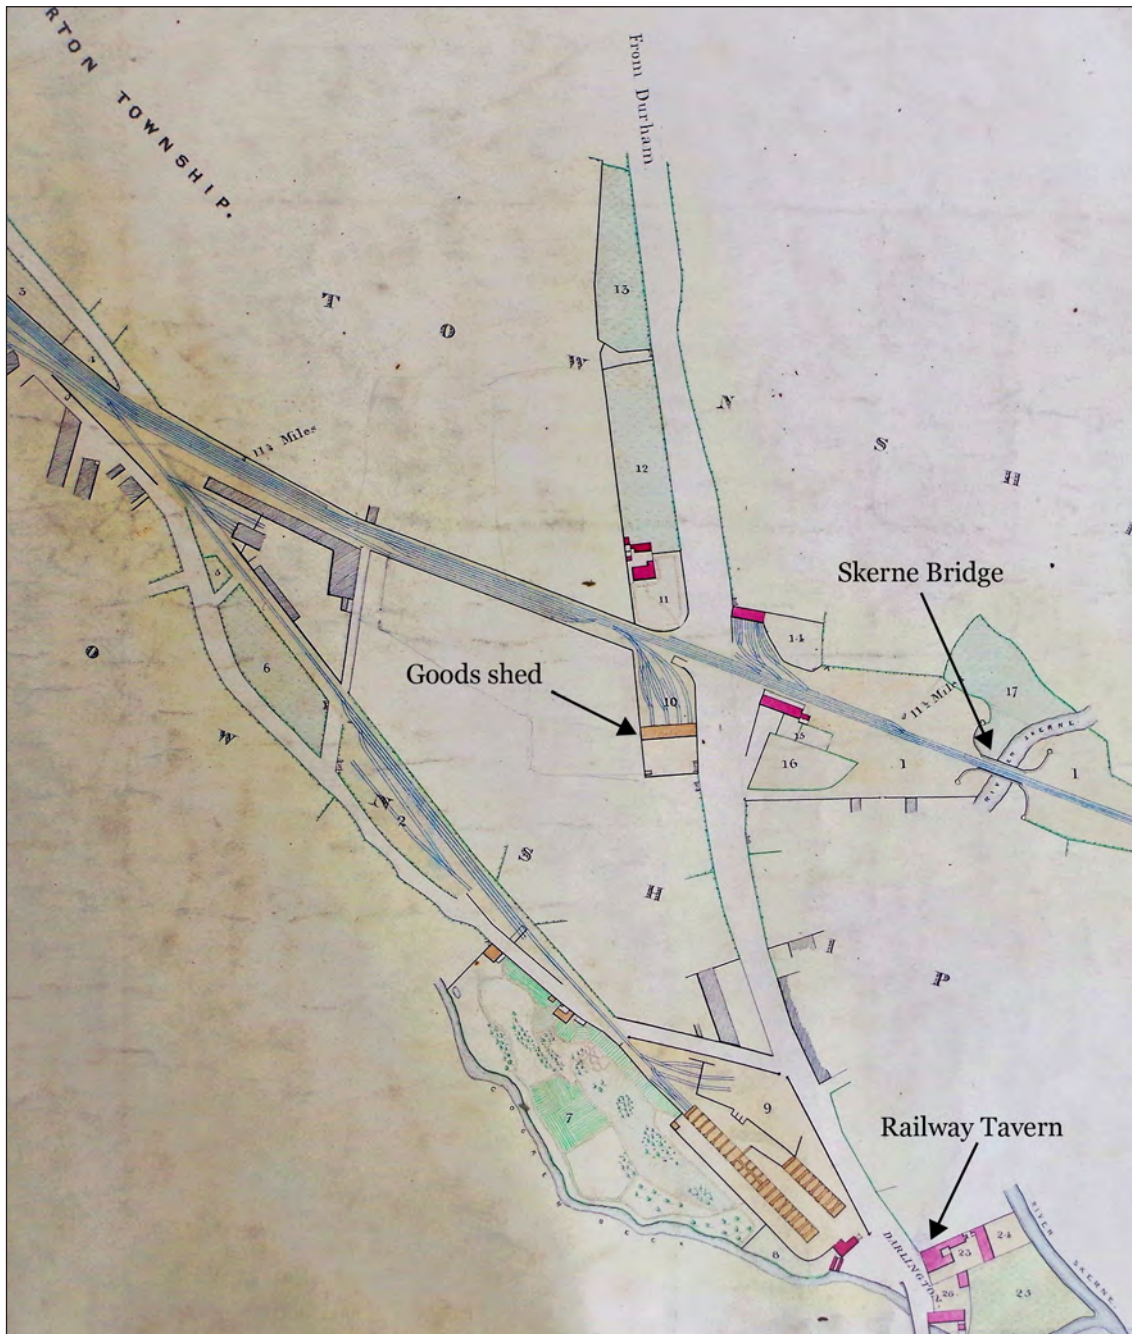
Fig 28: Darlington was an important centre for the S&DR. Of the original infrastructure, as illustrated on Thomas Dixon's 1839 plan, the goods shed, the Railway Tavern and Skerne Bridge remain extant. Source: Archaeo-Environment Ltd. Reproduced with kind permission of The National Archives, ref. RAIL 1037/456.

Nothing of the railway earthworks or boundaries in the centre of Darlington can be identified as original from the air, but a number of important early railway buildings do survive (Fig 28). These include the Goods Shed (Grade II\* listed as NHLE 1121262), which was built in 1833 (AIM74) and is now owned by Darlington Borough Council and is home to the Darlington Railway Preservation Society (Archaeo-Environment Ltd 2016f, 10-11) and the Railway Tavern (AIM76), one of three taverns/ticket offices constructed on the line, which still functions as a public house today. Other early railway buildings shown on Dixon's map (coloured red on Fig 28) that no longer survive include: to the south of the line, the original Goods Depot of 1827 (demolished 1864); and to its immediate north, a building of uncertain purpose entered by six rail spurs, which OS maps show had been demolished before the turn of the century.

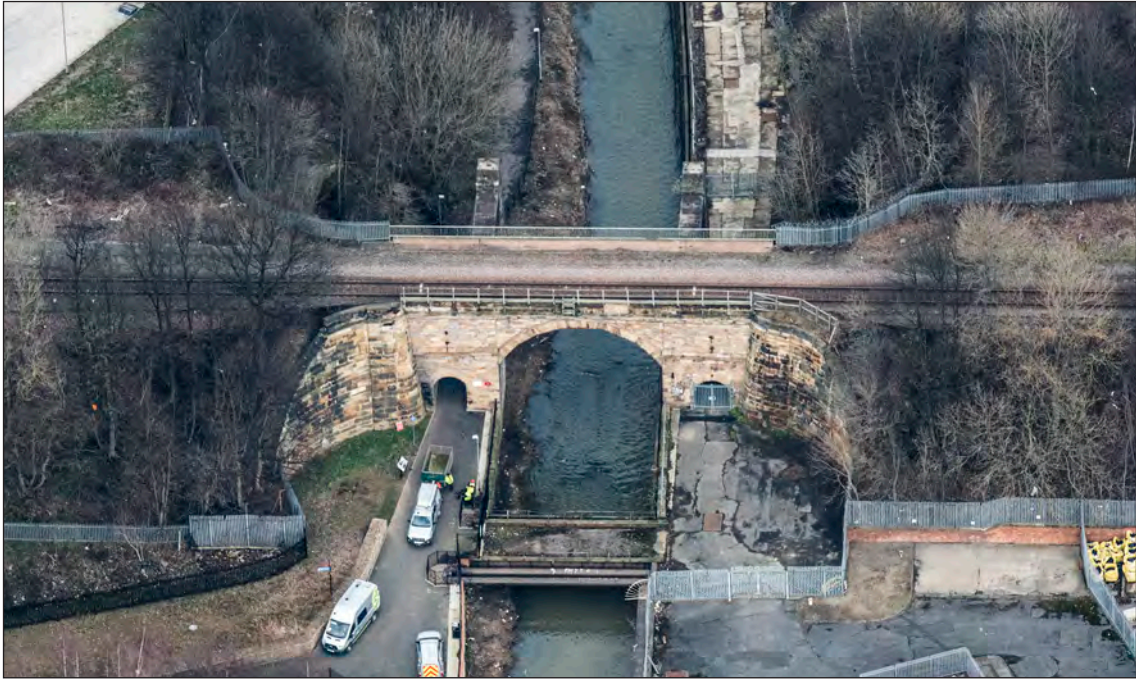
Fig 29: The Skerne Bridge (AIM75) is the oldest purpose-built railway bridge in the world to remain in use. It featured in a series of prints and paintings depicting the opening of the railway in 1825 (see front cover). Detail of 28985\_002 22-FEB-2018 © Historic England.

Less than 200m to the east of these buildings is Skerne Bridge (AIM75) – the oldest purpose-built railway bridge in the world still in use (ibid, 14), which is scheduled as NHLE 1002331 (Figs 29-30). This bridge featured in many paintings and engravings of the inaugural opening of the railway in 1825 (see cover image), although comparison of these with the present southern elevation of the structure (Fig 29) suggests the existing wing walls are a later rebuild. The north elevation of the bridge is disfigured by later track and bridge widening, since removed (Fig 30).

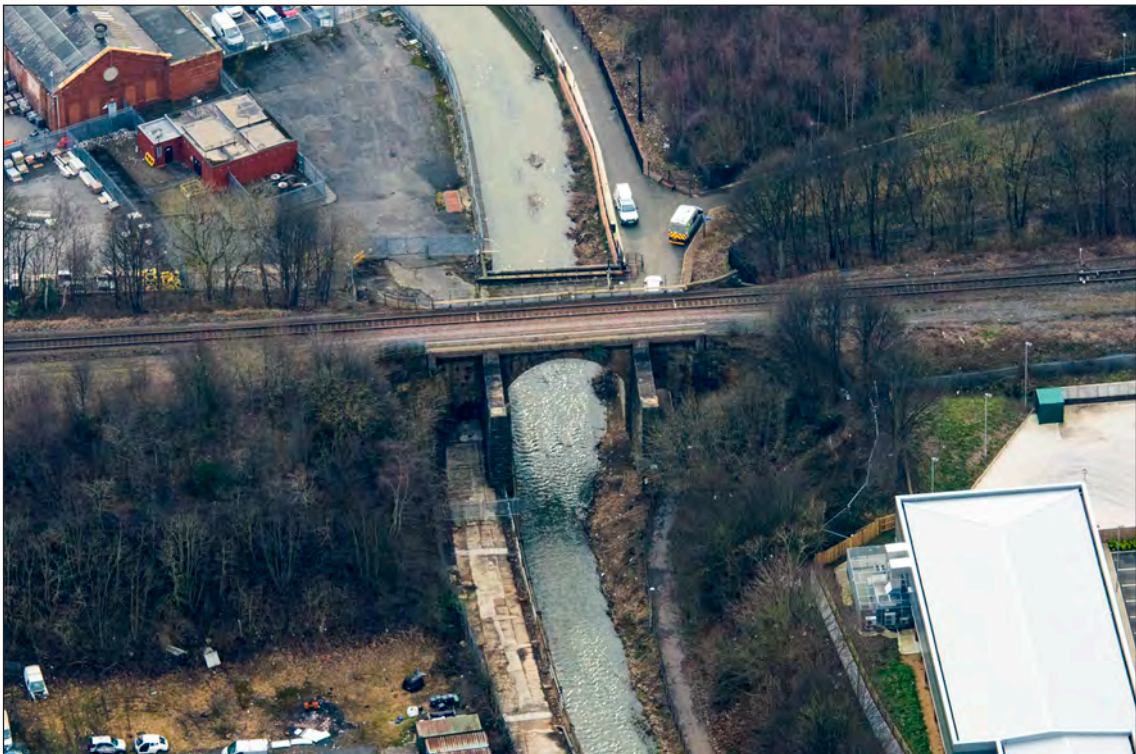
Fig 30: The north elevation of the Skerne Bridge (AIM75) shows late 19th century supports for the widening of the bridge. Detail of 28985\_009 22-FEB-2018 © Historic England.

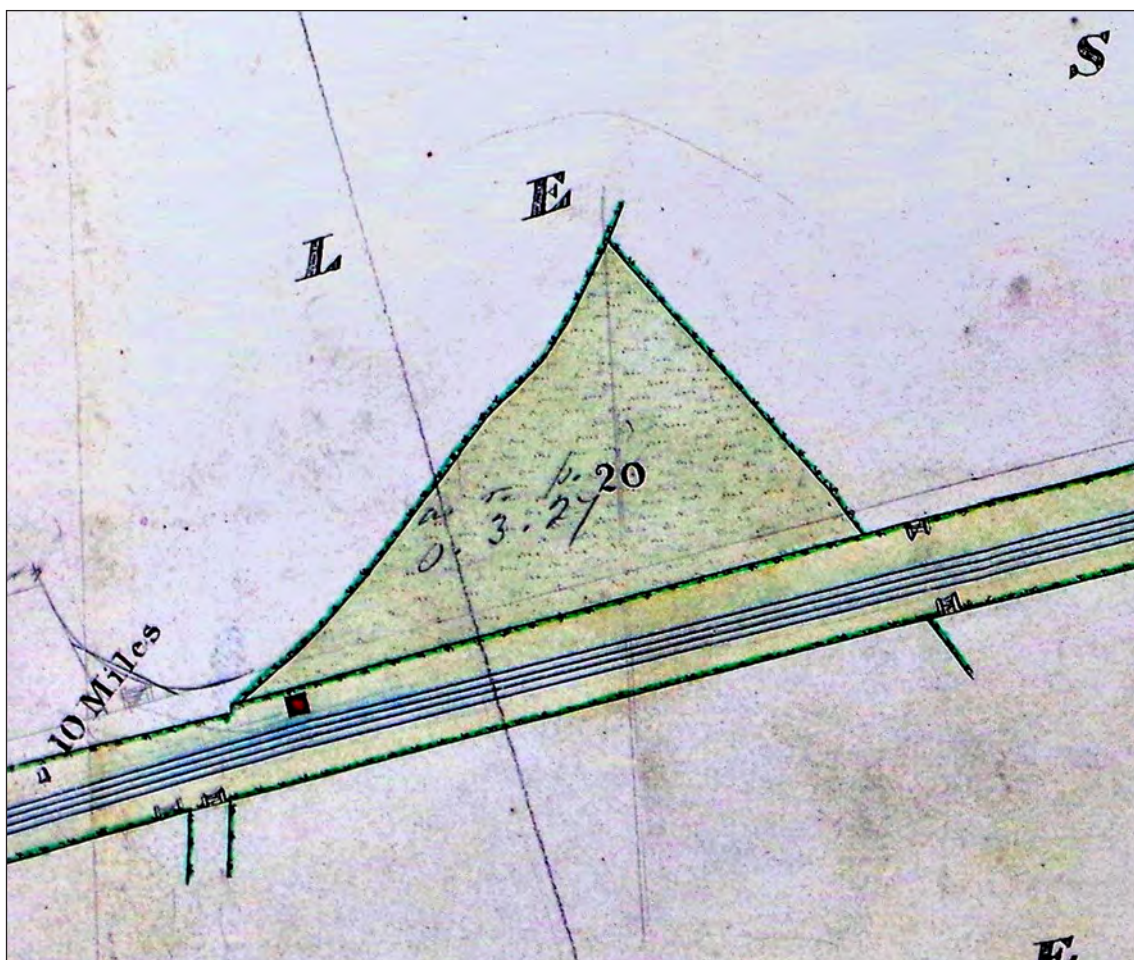
*Fig 31: A small building marked on Dixon's 1839 plan of the railway to the south of Red Hall was probably a platelayers' hut (AIM85; HEA362). The gated access to this and adjacent occupation crossing remained extant until the closure of the railway in the 1960s. Source: Archaeo-Environment Ltd. Reproduced with kind permission of The National Archives, ref. RAIL 1037/456.*

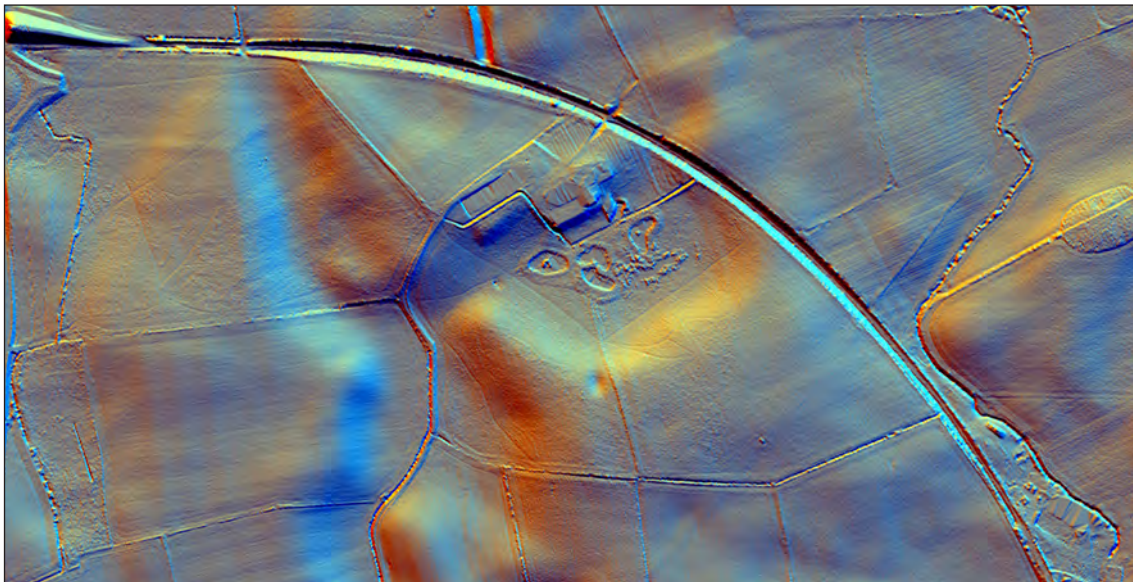
*Fig 32: Much of the original S&DR infrastructure between Darlington and Oak Tree Junction was removed following the closure of this section of line in the 1960s, although between the A66 and the A67 the line of the railway is preserved as a footpath and the original cutting is extant. LIDAR DTM 30-NOV-2008 © Historic England; source Environment Agency.*

East of the A66, despite closure, elements of the original railway are still visible on recent aerial photographs. The line entered a cutting, arcing to the south-east (Fig 32). An occupation crossing was located adjacent to South Burden Farm (AIM87; HEA368), but this went out of use with the railway. The railway cutting earthworks can still be traced for some length to the south-east of here, as can some of the boundaries, though several of these appear to have been removed. South of the A67, the line of the railway is still used as a footpath. To the north of Middleton St George, the north boundary remained intact into the late 20th century and is recorded on vertical aerial photographs. A short length of the railway cutting is preserved along this stretch, recorded on lidar beneath dense tree cover. An occupation crossing is illustrated on the Dixon survey, roughly to the north of the modern road, Yeadon Walk. The north gateway of this crossing is visible on 1940s vertical aerial photographs (AIM88; HEA408), but appears to have since been removed. The modern railway follows the line of the old Darlington and Saltburn Branch Railway and rejoins the old S&DR line at Oaktree Junction before continuing east along the route of the original line.

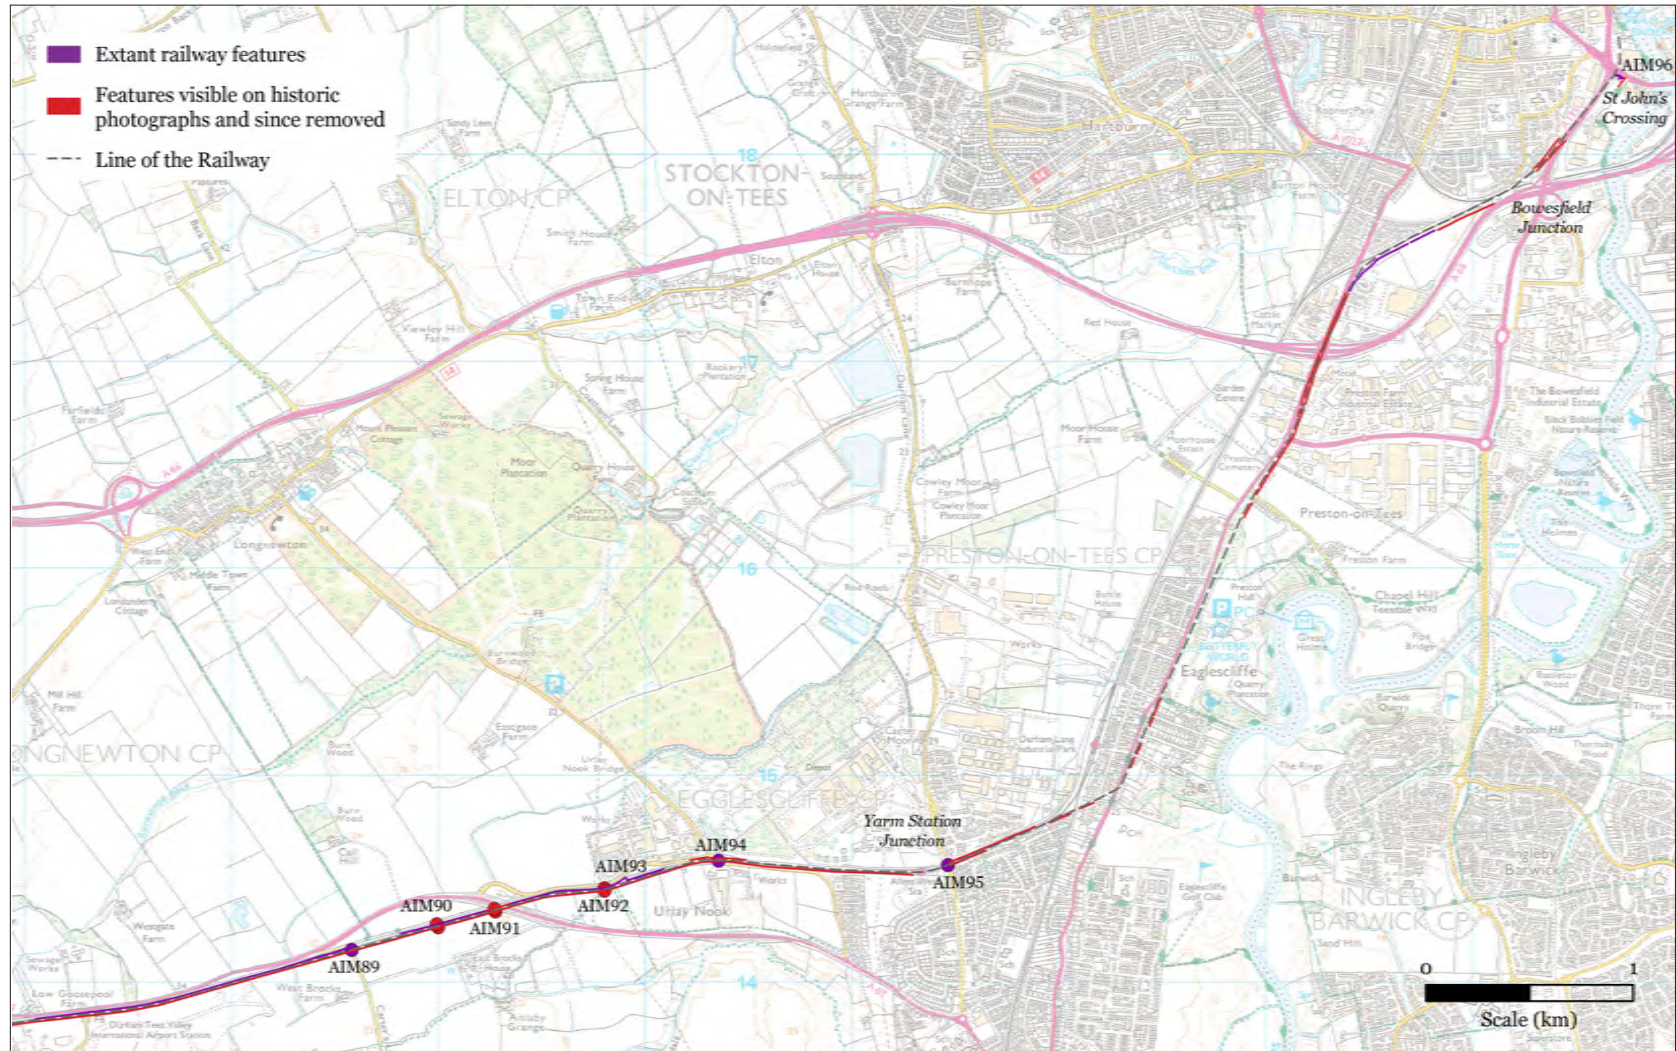
Fig 33: Original S&DR railway features visible on aerial photographs between Low Goosepool Farm and Stockton-on-Tees. Cuttings and embankments are not depicted. Archaeological mapping © Historic England; Base map © Crown Copyright and database right 2019.

### Low Goosepool Farm to Stockton (Fig 33)

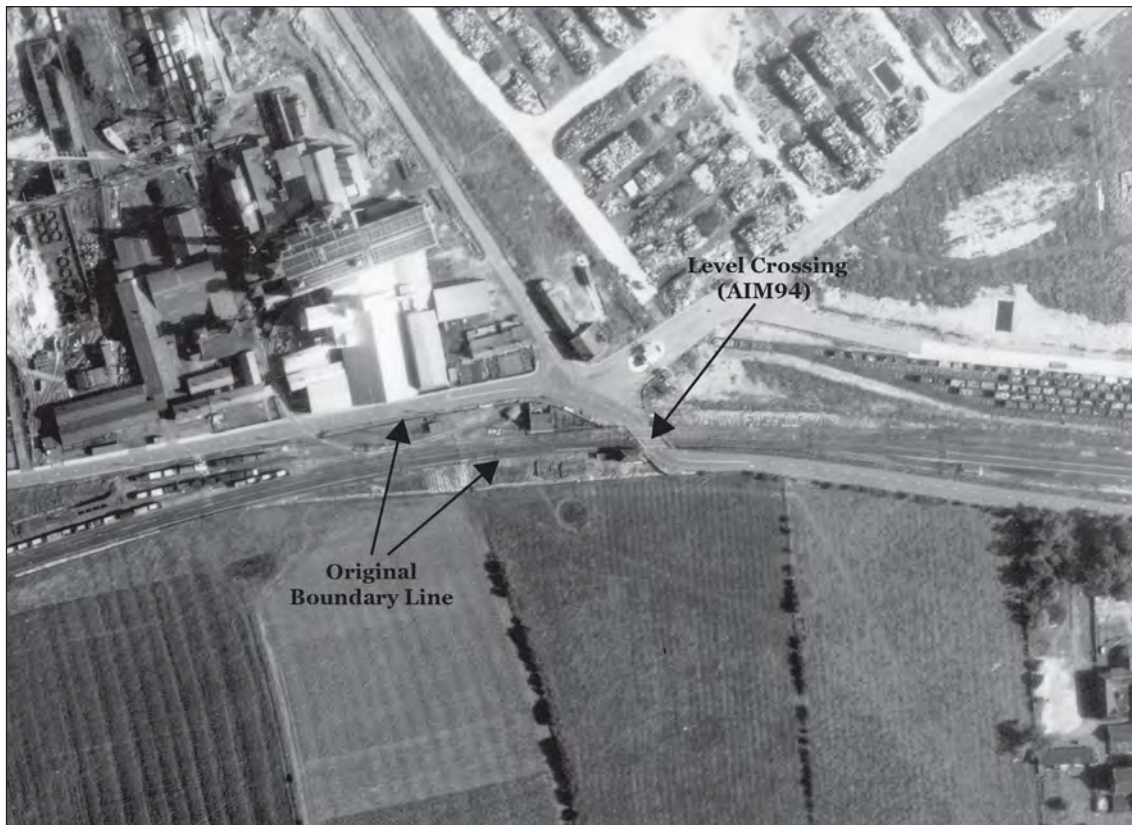
*Fig 34: The level crossing at Urlay Nook (AIM94), and some of the original boundaries remained intact into the late 20th century. The crossing remains in use, but most of the boundaries appear to have been removed. Detail of RAF/106G/UK/481 RP 3013 06-JUL-1945 Historic England Archive (RAF Photography).*

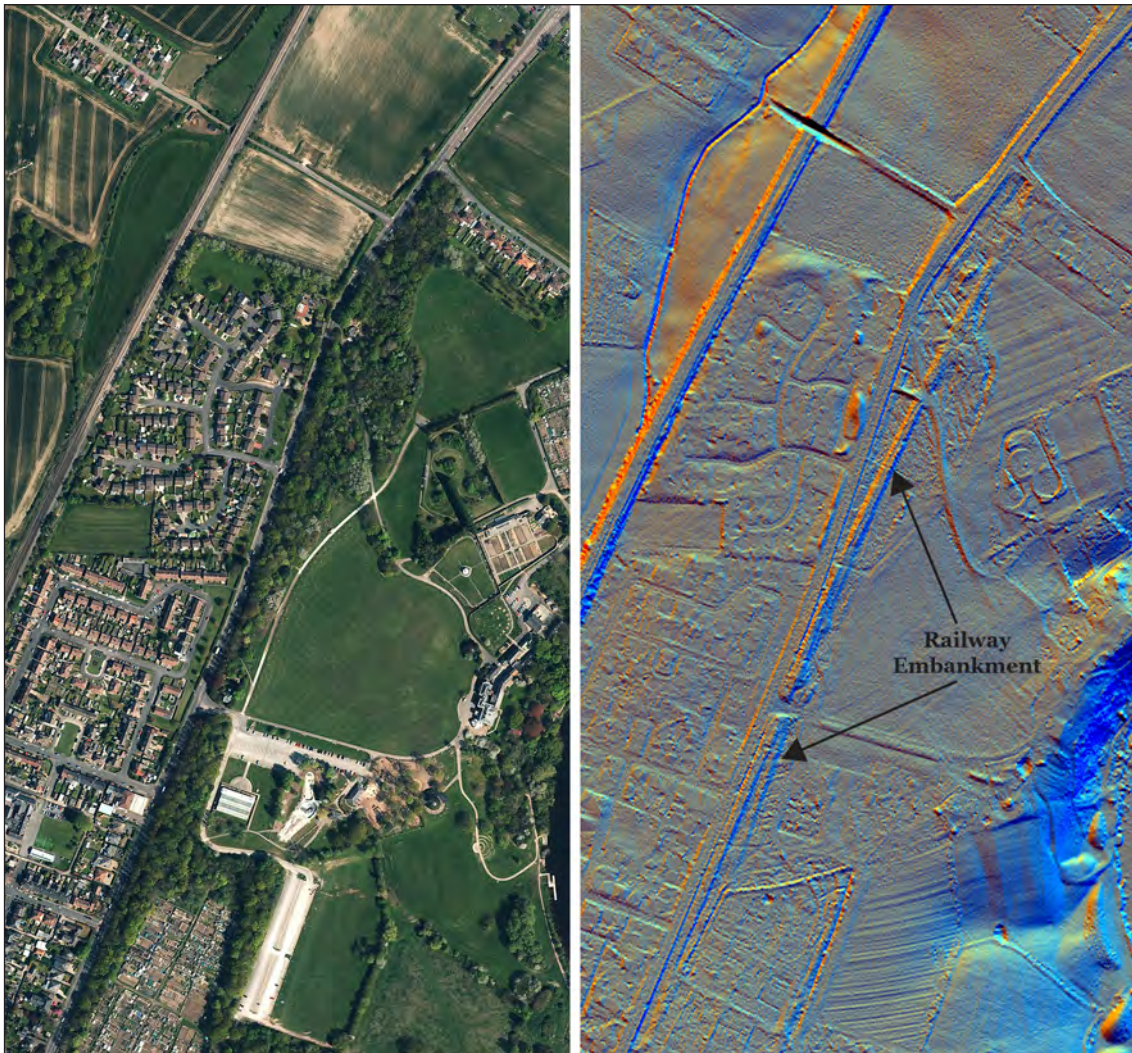
*Fig 35: The Yarm to Bowesfield stretch of the railway was abandoned in 1853, but the earthwork remains of the embankment can still be traced in woodland in Preston Park. Left image: NZ4215-4316 09-MAY-2016 © Bluesky International/Getmapping PLC; Right image: LIDAR DTM FEB-2011 © Historic England; source Environment Agency.*

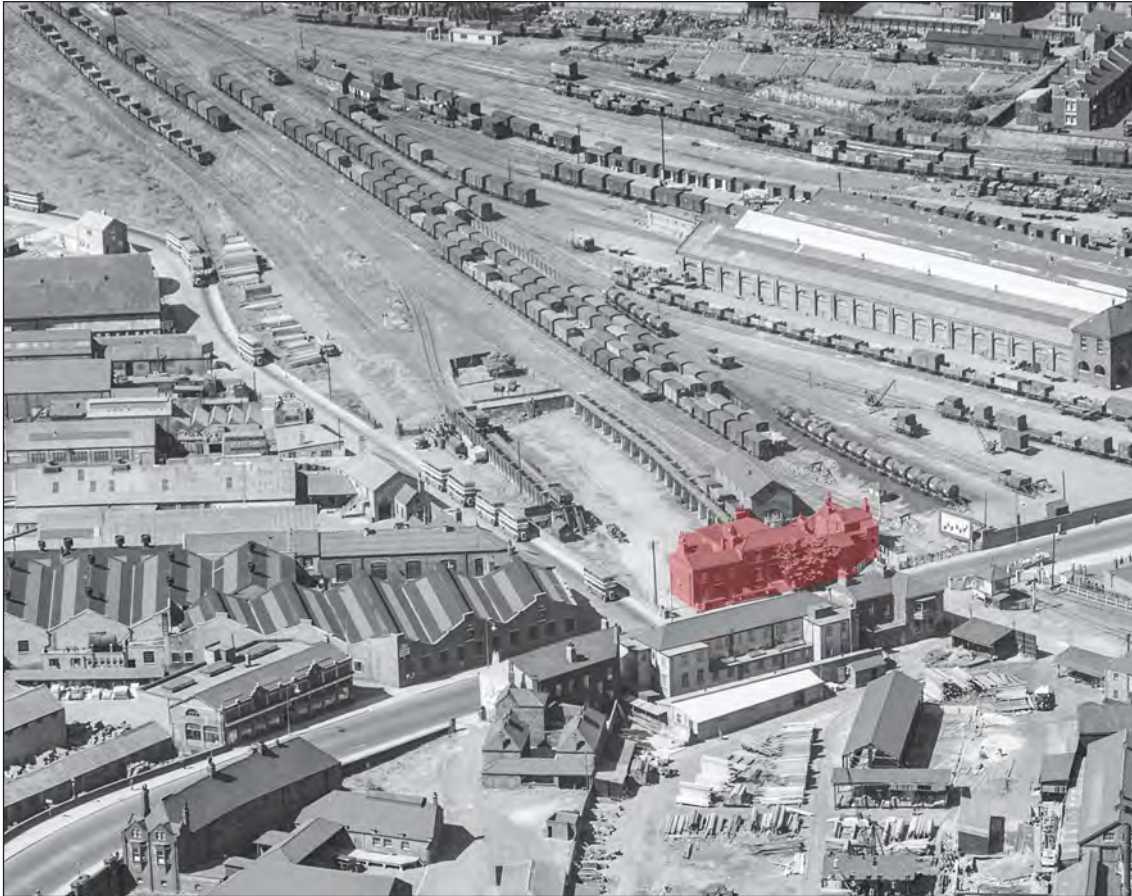
*Fig 36: The row of buildings at St John's Crossing (highlighted in red) formed the original terminus for passengers on the S&DR. It is shown here surrounded by the disused Coal and Lime Drops and later Goods Depot. EAW043770 05-JUN-1952 © Historic England Archive. Aerofilms Collection.*

Prior to entering the timber yards adjacent to the staithes in Stockton-on-Tees, the railway crossed the present A1130 at St John's Crossing (Fig 36). Here there are some of the most important buildings associated with the railway (AIM96). Although added to over the years and with elements rebuilt, the original features within a row of buildings include the Railway Tavern (now the Bay Horse) and the Weigh House (Archaeo-Environment Ltd 2016g, 14). The staithes were located on the site of the present-day Castlegate Quay. Although superseded by the staithes and dock at Middlesbrough, the Stockton staithes were still extant in 1857 when surveyed by the Ordnance Survey, but had been removed by the end of the century.
