# Stockton and Darlington Railway Heritage Action Zone Aerial Investigation & Mapping Report

**STOCKTON AND DARLINGTON RAILWAY  
HERITAGE ACTION ZONE**

**Aerial Investigation & Mapping Report**

NGR: NZ 290 156

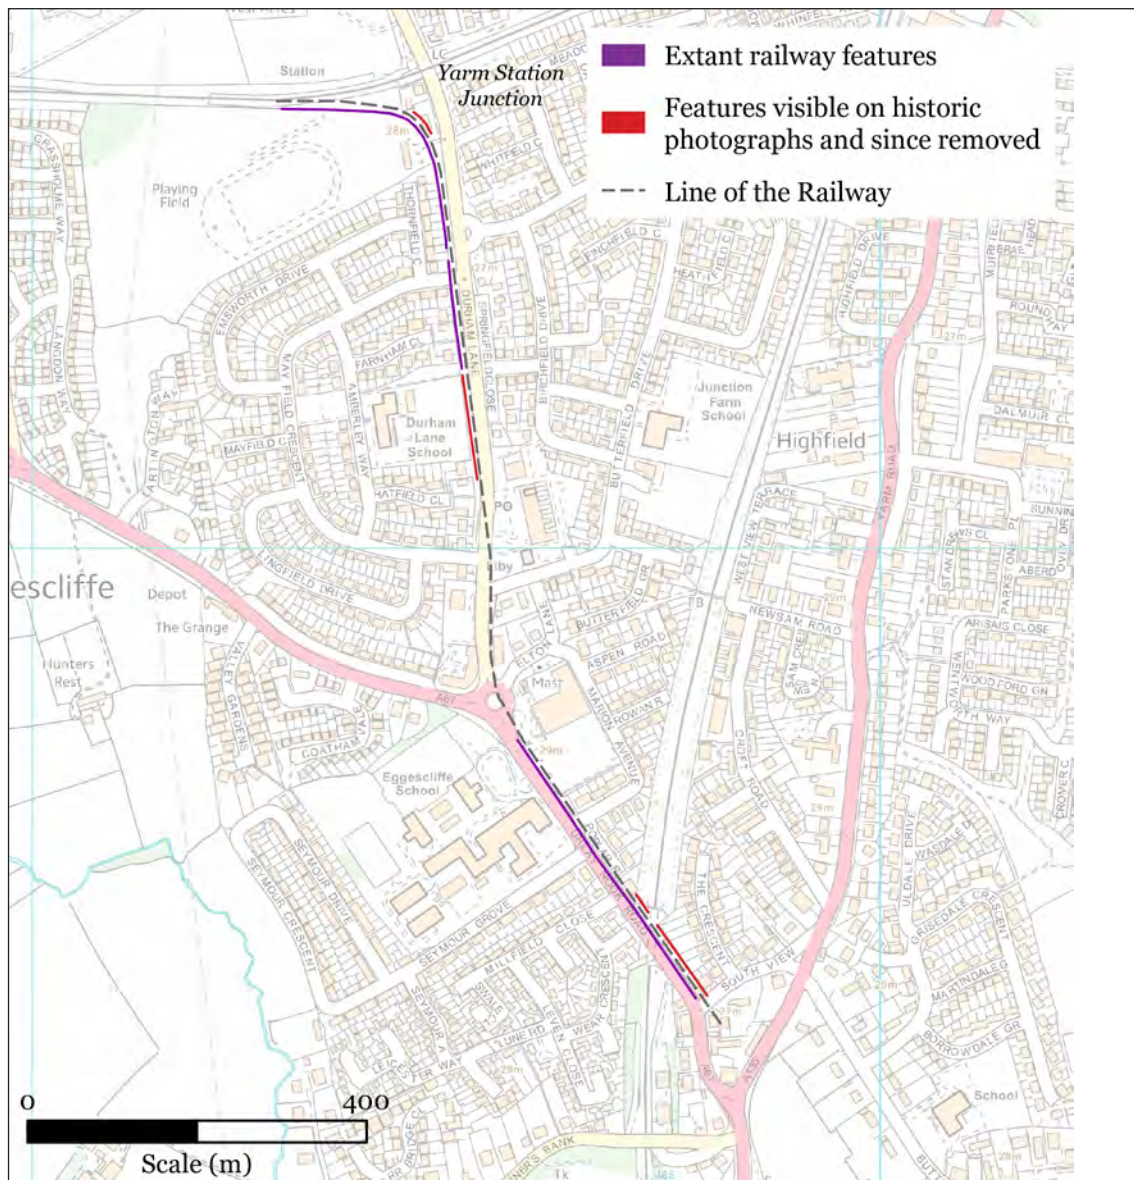
Fig 37: Features relating to the Yarm Branch Line visible on aerial photographs. Cuttings and embankments are not depicted. Archaeological mapping © Historic England; Base map © Crown Copyright and database right 2019.

### **Yarm Branch Line (Fig 37)**

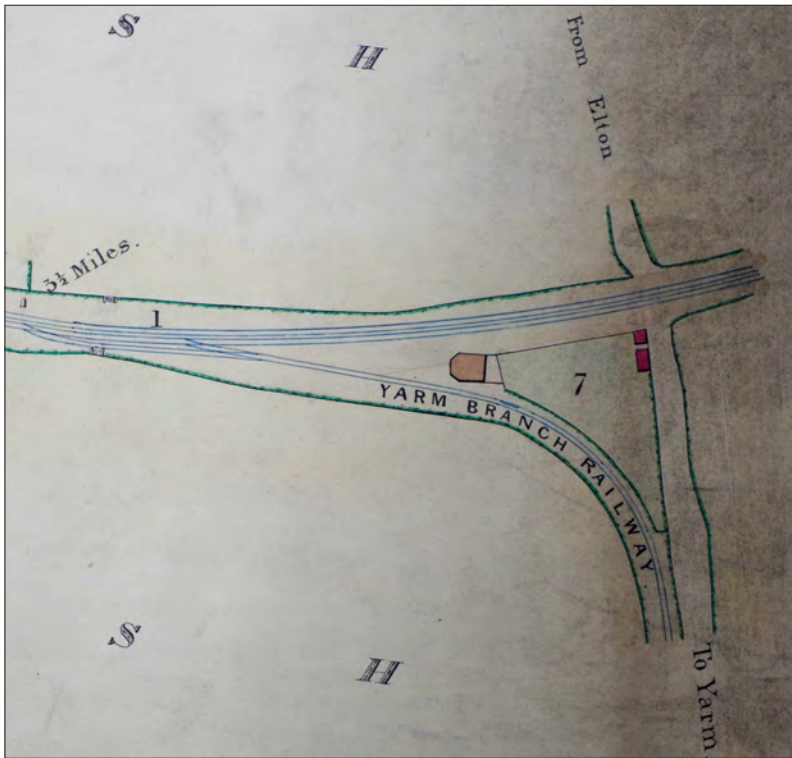
Fig 38: The Yarm Branch line left the main line roughly where Allens West Station now is. 1839 Thomas Dixon plan. Source: Archaeo-Environment Ltd. Reproduced with kind permission of The National Archives, ref. RAIL 1037/457.

When steam locomotives were introduced for passenger services on the main line in 1833, they did not use the Yarm branch. Instead, passengers had to alight at 'Yarm Station' (Fig 38) which was located on the main line at the head of the branch, and walk the remainder of the way (Semmens 1976, 109; Hoole 1975, 12). The opening of the Leeds Northern Railway in the 1840s offered an alternative route for passengers between Yarm and Stockton, and the old S&DR station closed in 1862 with the entire Branch closing in 1871 (Wall 2001, 110).

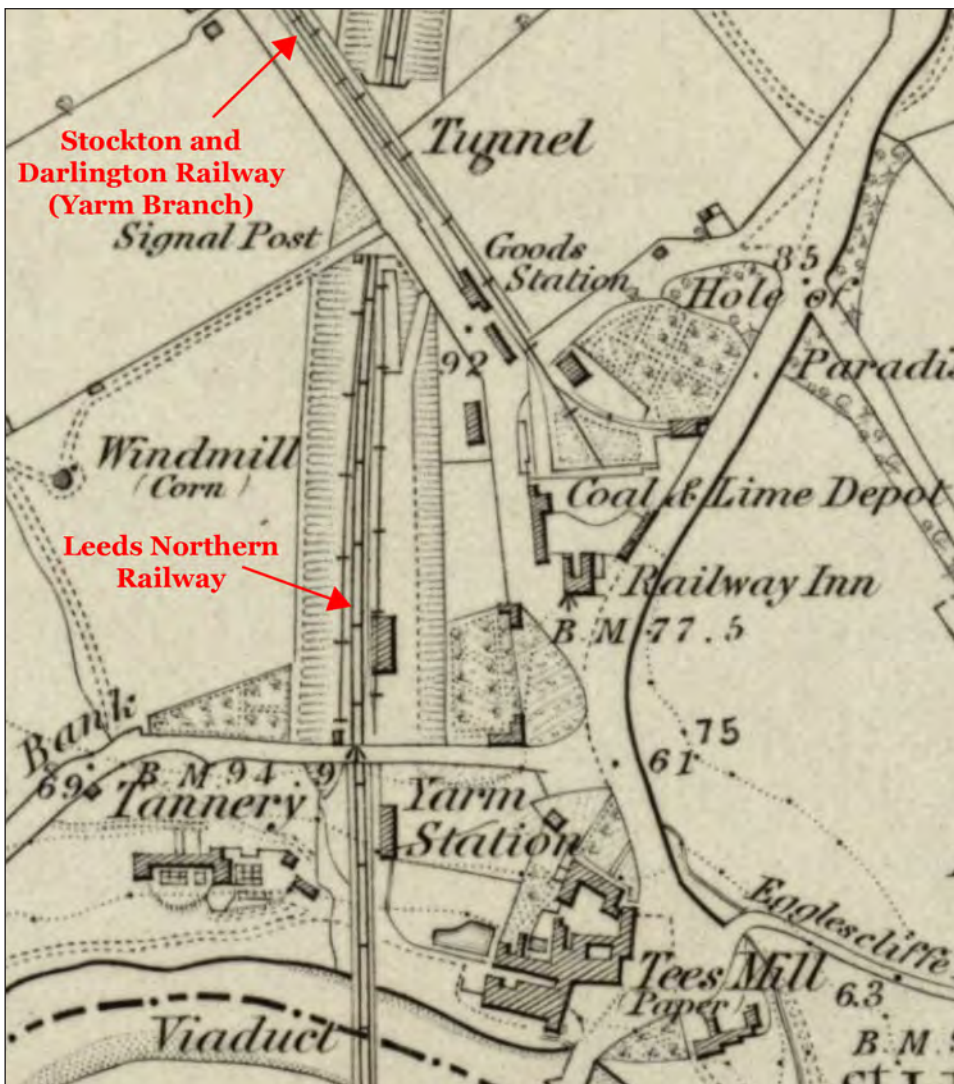
Fig 39: The S&DR Yarm Branch terminated at a coal and lime depot to the north of Yarm Bridge. Both branch and depot were closed following the opening of the Leeds Northern Railway, which opened its own station nearby and formed a more direct route between Yarm and Stockton. © and database right Crown Copyright and Landmark Information Group Ltd (All rights reserved 2019) Licence numbers 000394 and TP0024 reproduced by permission of the National Library of Scotland.

The Yarm Branch Line was the first branch of the S&DR to open, only a month after the main line. It left the main line near to the modern Allens West Station, and ran south for nearly 750m to a coal depot on the north side of the River Tees opposite the town of Yarm (see Fig 39). The railway did not proceed across the river to Yarm itself, but it did offer a short-lived horse-drawn passenger service from 1826, with passengers able to continue on foot across the bridge to the town (Wall 2001, 109).

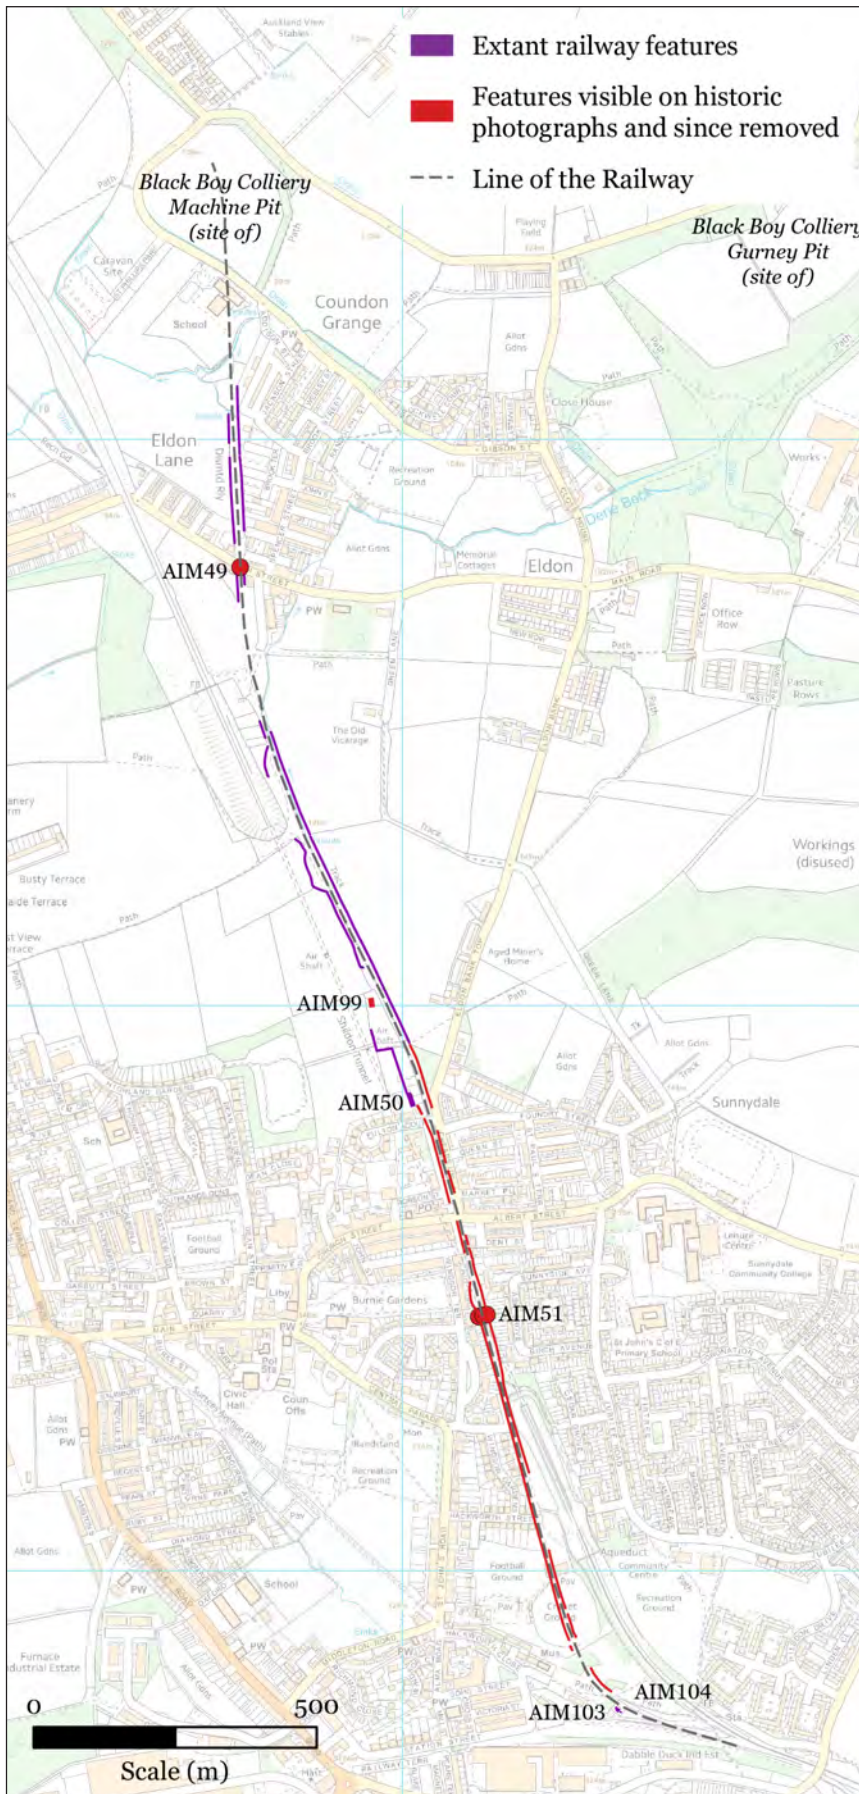
Fig 40: Features relating to the Black Boy Branch Line visible on aerial photographs. Cuttings and embankments are not depicted. Archaeological mapping © Historic England; Base map © Crown Copyright and database right 2019.

## Black Boy Branch Line (Fig 40)

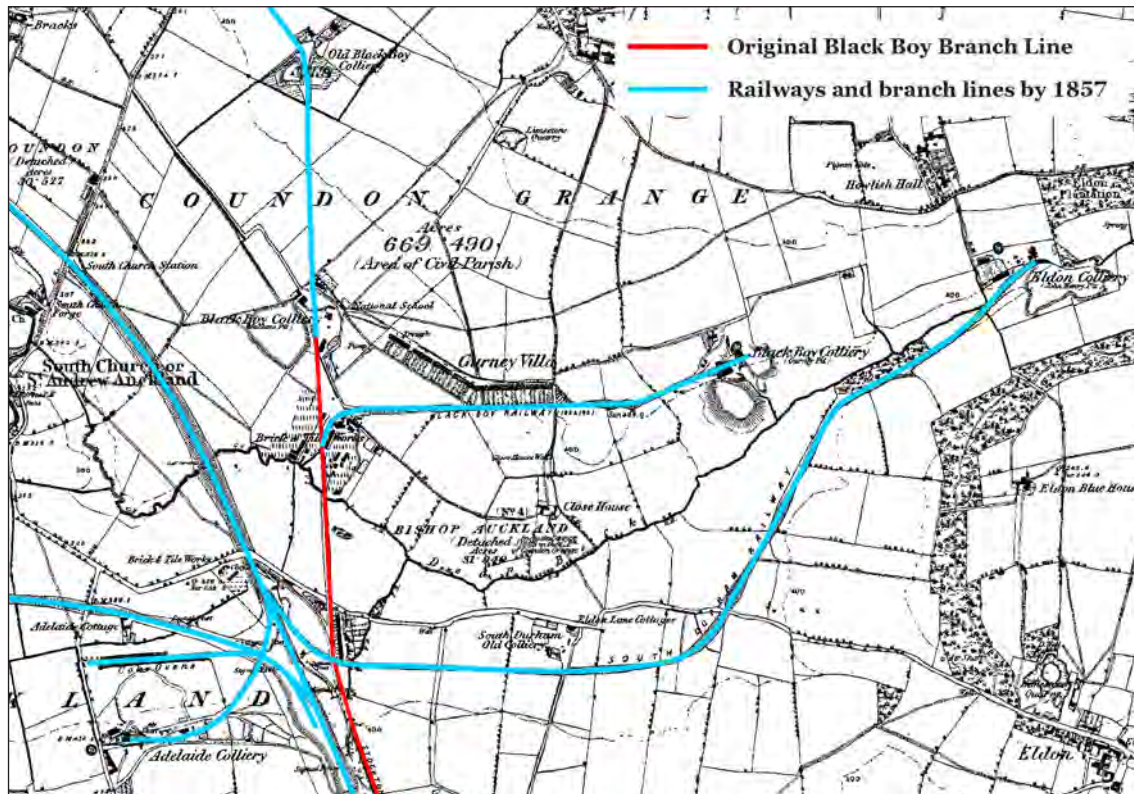
Fig 41: The Black Boy Branch originally terminated at ‘Machine Pit’ of Black Boy Colliery (centre-left), with a series of mineral railways serving the other nearby pit-heads. By 1857, the Bishop Auckland and Weardale Railway and numerous branch lines had also opened. © and database right Crown Copyright and Landmark Information Group Ltd (All rights reserved 2019) Licence numbers 000394 and TP0024.

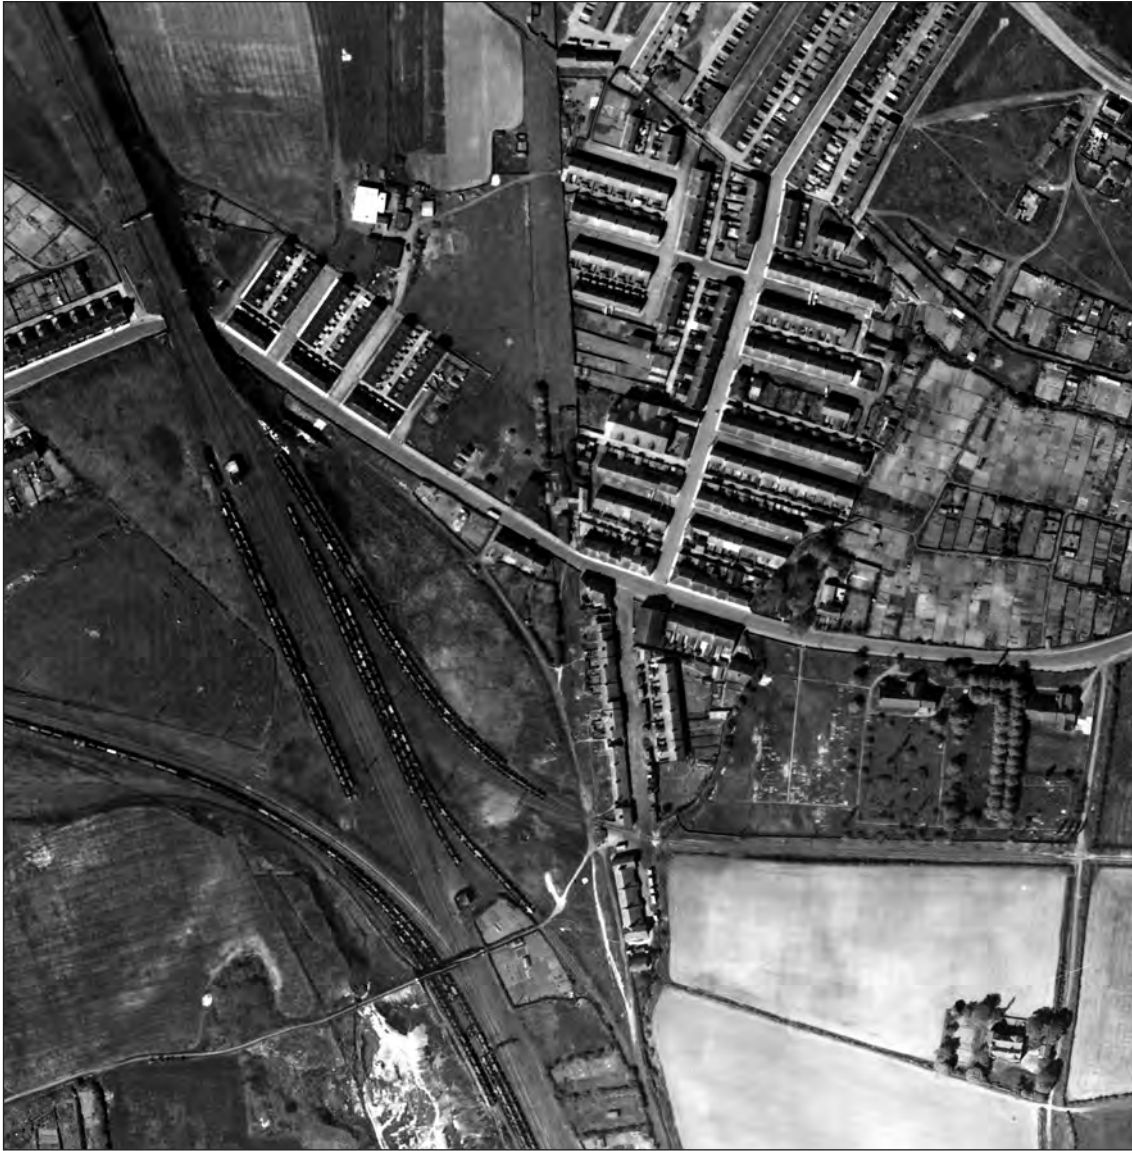
*Fig 42: The northern section of the Black Boy Branch line was already out of use by the end of the 19th century as the colliery railways now all fed into the Bishop Auckland and Weardale Railway. Detail of SfM RAF/58/B/37 V 5029-5379 17-MAY-1948 Historic England Archive (RAF Photography).*

The level crossing which carried High Street, Eldon, across the railway was already out of use by the 1940s (AIM49; Fig 42). Immediately north of the crossing, a 275m length of railway boundary can be traced. This alignment can still be seen on recent aerial photographs, though it looks as though any of the original wall or hedging has probably been replaced by modern fencing. All remains of the original line to the north of this were removed by late 19th- and early 20th-century colliery workings.

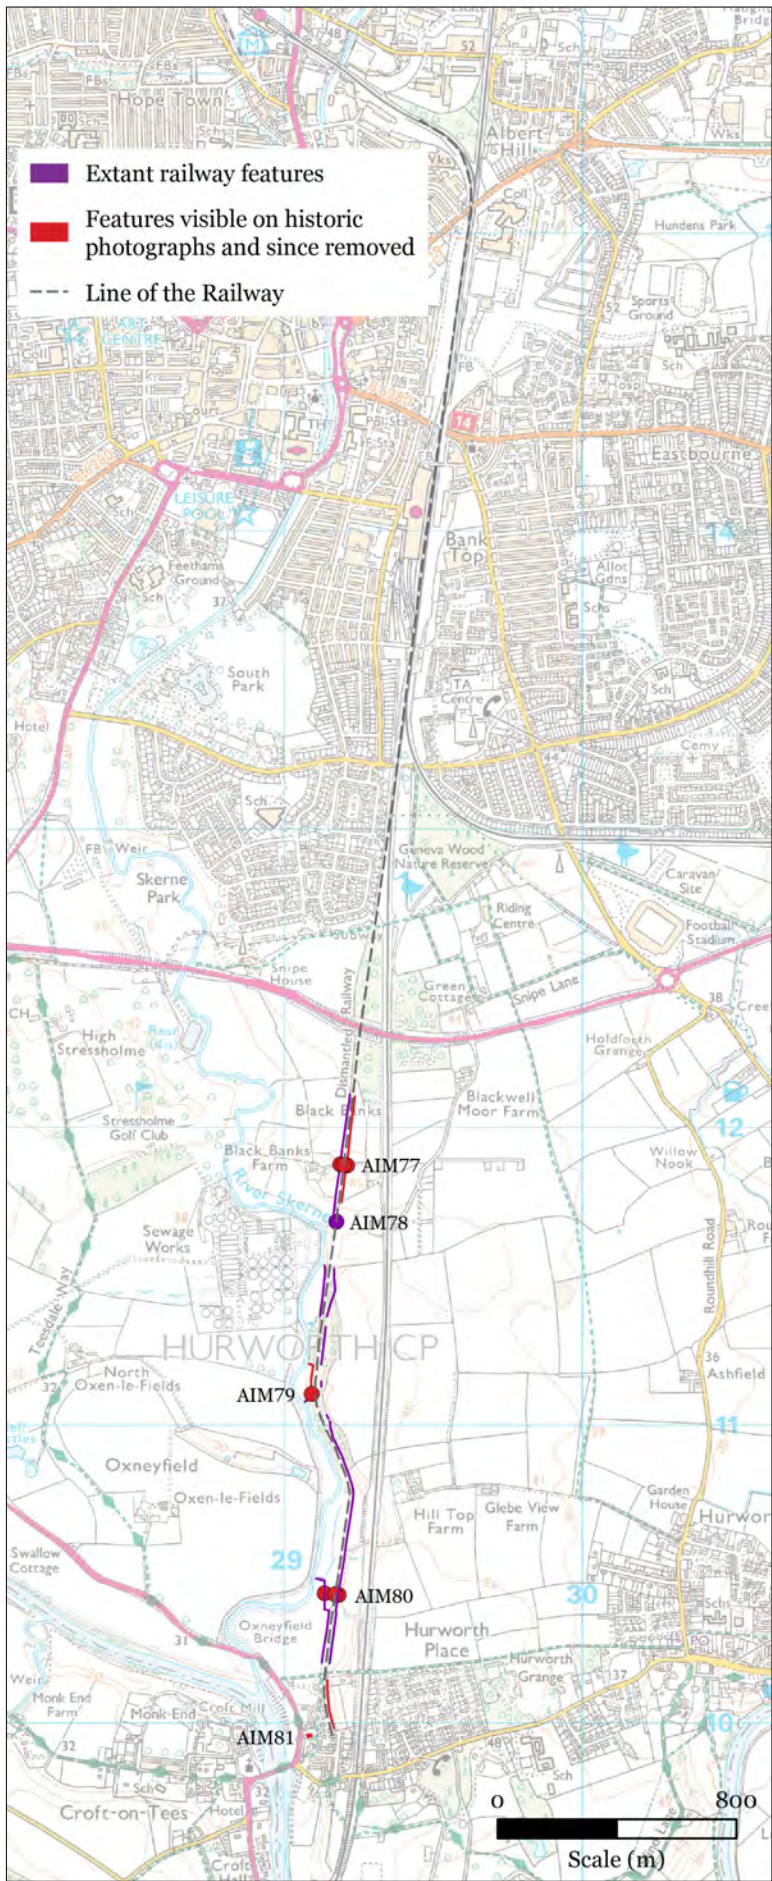
Fig 43: Features relating to the Croft Branch Line visible on aerial photographs. Cuttings and embankments are not depicted. Archaeological mapping © Historic England; Base map © Crown Copyright and database right 2019.

### **Croft Branch Line (Fig 43)**

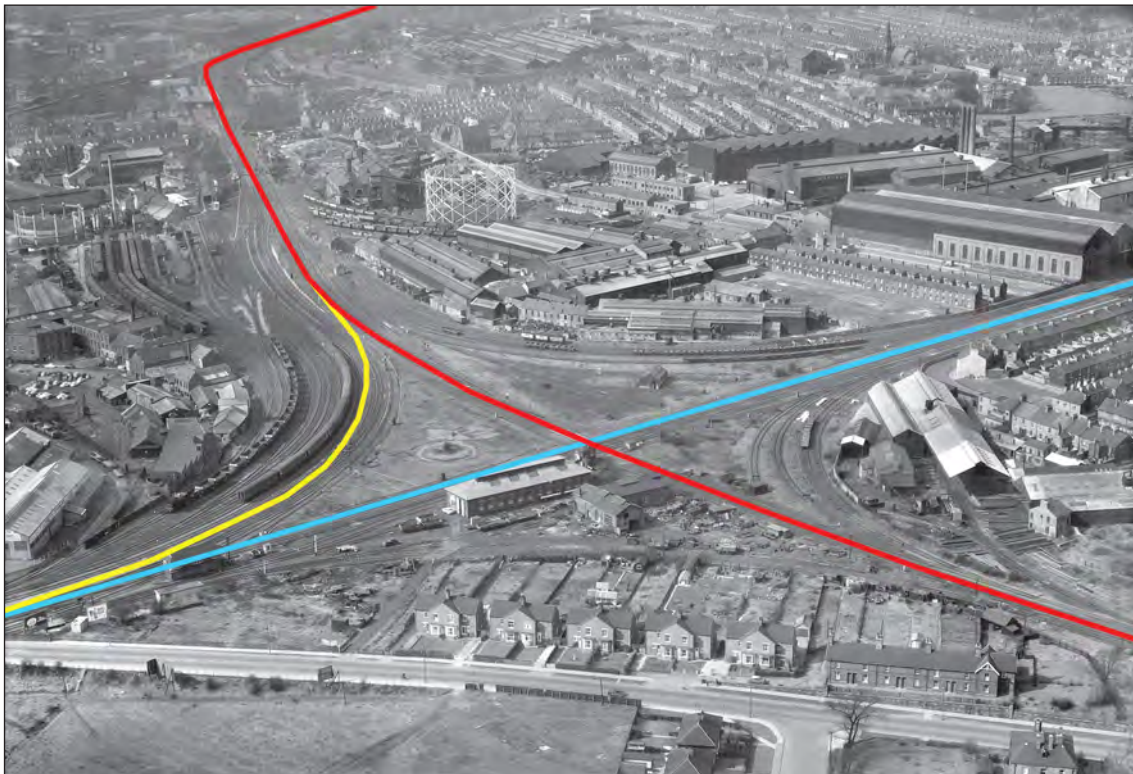
*Fig 44: Looking west over Parkgate Junction, where the Croft Branch (in yellow) left the S&DR main line (in red). The Great North of England Railway (cyan), which opened in 1841 used part of the Croft line. EAW124514 01-APR-1964 © Historic England Archive. Aerofilms Collection.*

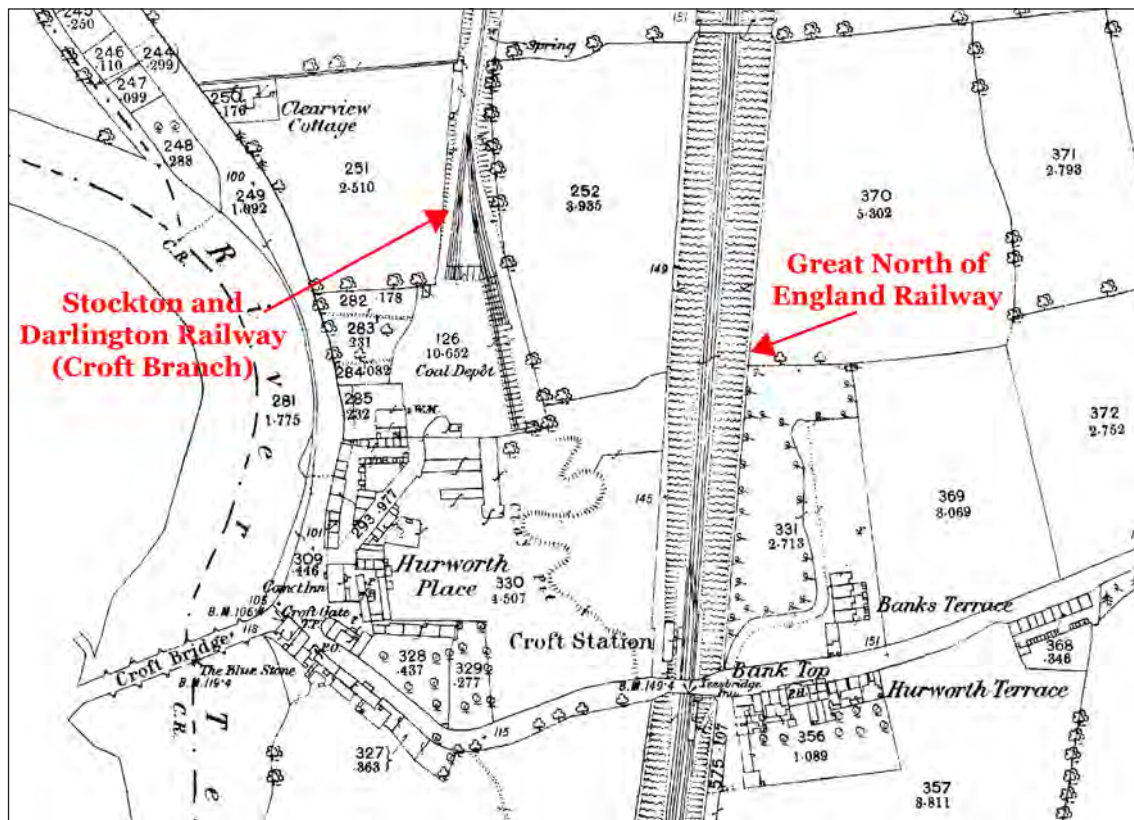
Fig 45: The southern end of the Croft Branch line ran alongside the Great North of England Railway (which re-used part of it further north), terminating at a coal depot north of Hurworth Place, as shown on the 1895 OS map. © and database right Crown Copyright and Landmark Information Group Ltd (All rights reserved 2019) Licence numbers 000394 and TP0024.

The line of the railway as it neared its terminus at Hurworth Place (Fig 45) has been heavily redeveloped, removing any obvious original railway features that might have been visible on aerial photographs. One building (AIM81), which appears to relate to one denoted on the 1838 survey, was recorded on aerial photographs taken in the latter half of the 20th century, but has since been demolished.

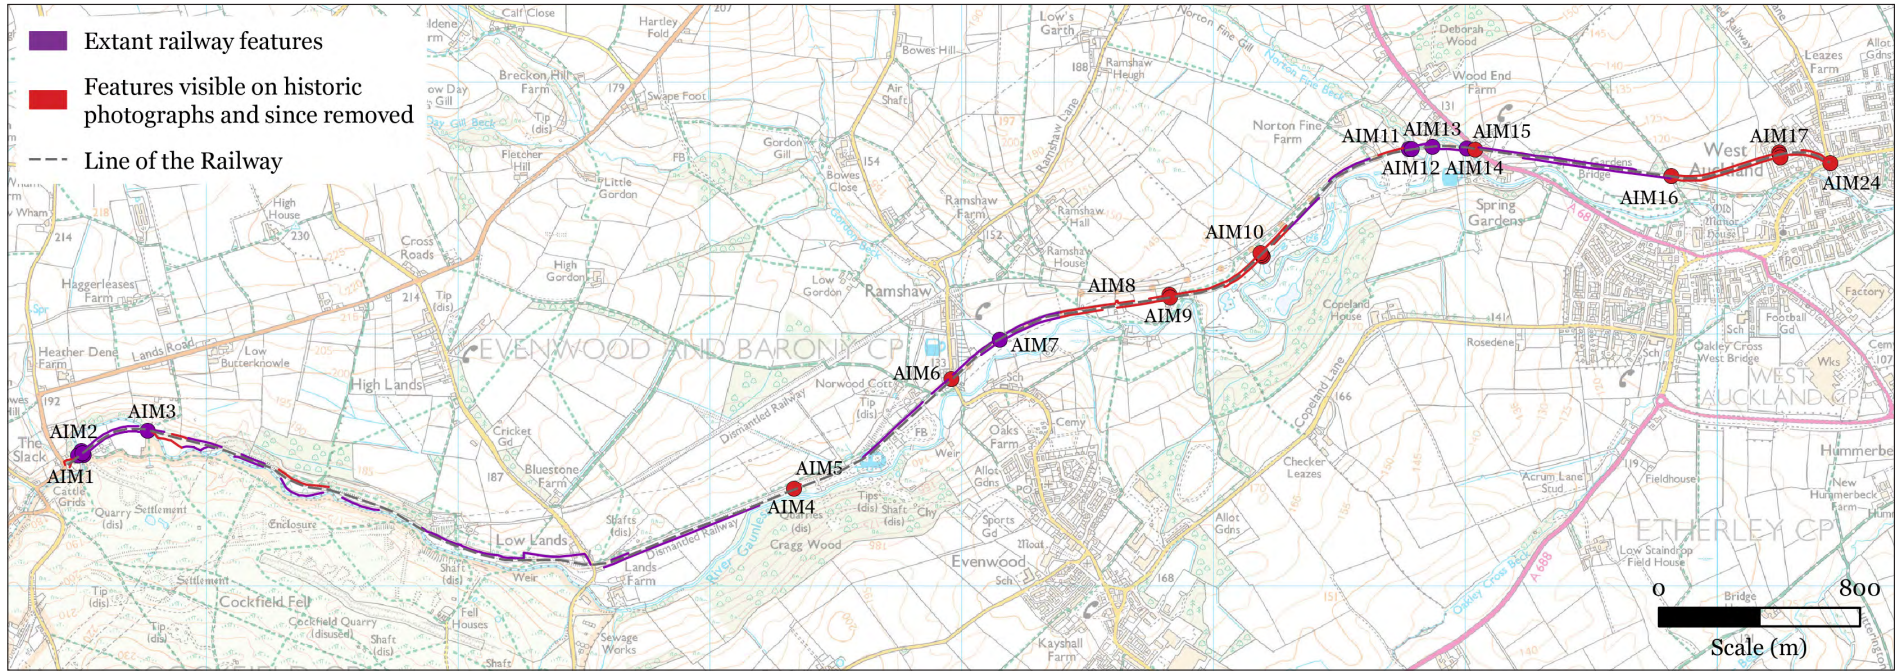
Fig 46: Features relating to the Haggerleas Branch Line visible on aerial photographs. Cuttings and embankments are not depicted. Archaeological mapping © Historic England; Base map © Crown Copyright and database right 2019.

### **Haggerleases Branch Line (Fig 46)**

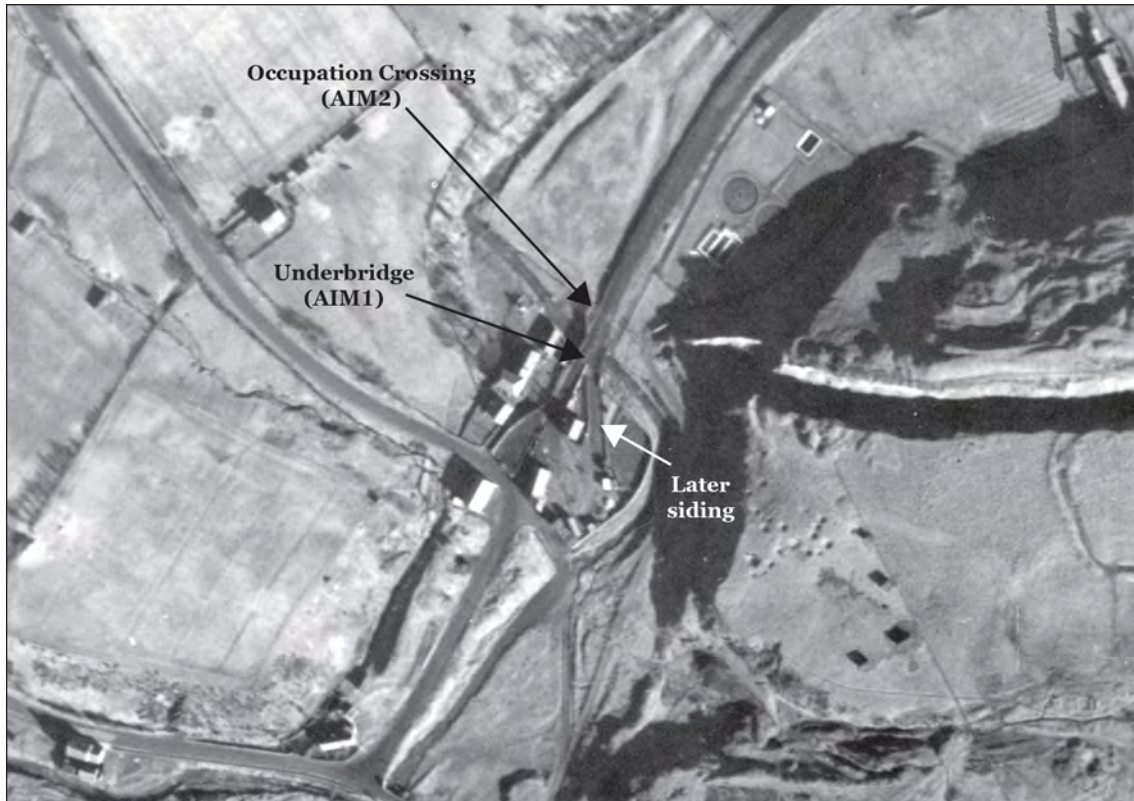
*Fig 47: Haggerleases Station (centre) was the westernmost terminus for passenger services. A mineral railway continued to the south-west to serve Copley Colliery. By the end of the 19th century, the Butterknowle Colliery Railway also joined the S&DR at Haggerleases. Detail of RAF/106G/LA/127 RS 4079 10-FEB-1945 Historic England Archive (RAF Photography).*

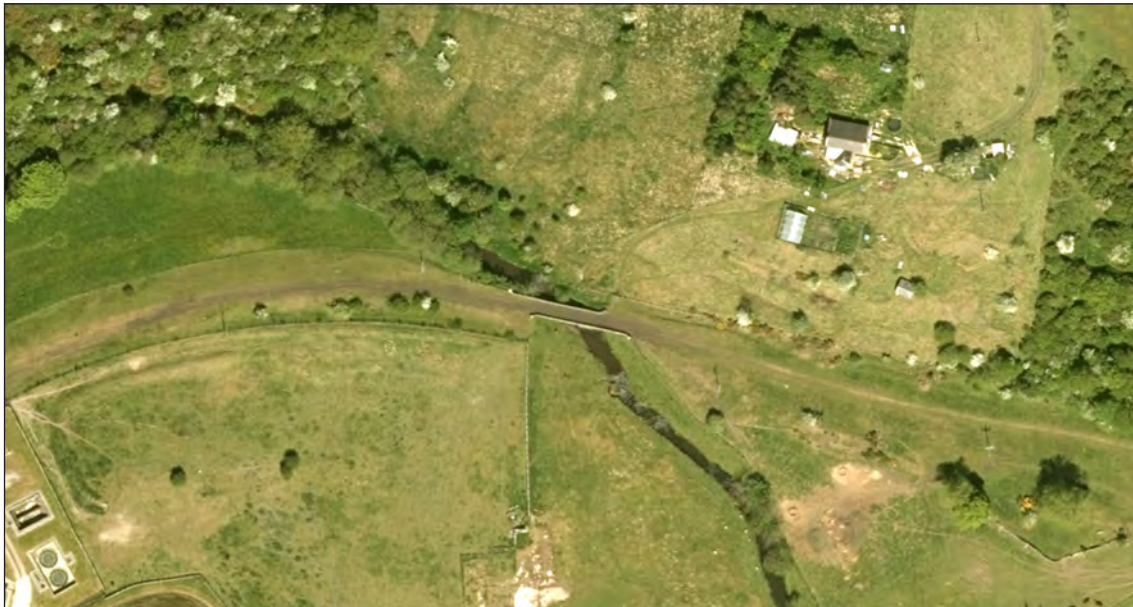
*Fig 48: Swin Bridge over the River Gaunless remains intact. Detail of NZ1125 11-JUN-2015 © Bluesky International/Getmapping PLC.*

The railway continued eastwards on a shallow and broad embankment recorded on lidar, to the next crossing point over the Gaunless, known as Swin Bridge (AIM3; Fig 48). This bridge is mistakenly described on the first edition OS map as 'Swing Bridge', but it is actually a skew-arch bridge – a local term for 'skew' being 'swin' (Wall 2001, 113). The bridge is a very early example of a skew railway bridge and is listed at Grade II (NHLE 1121831).

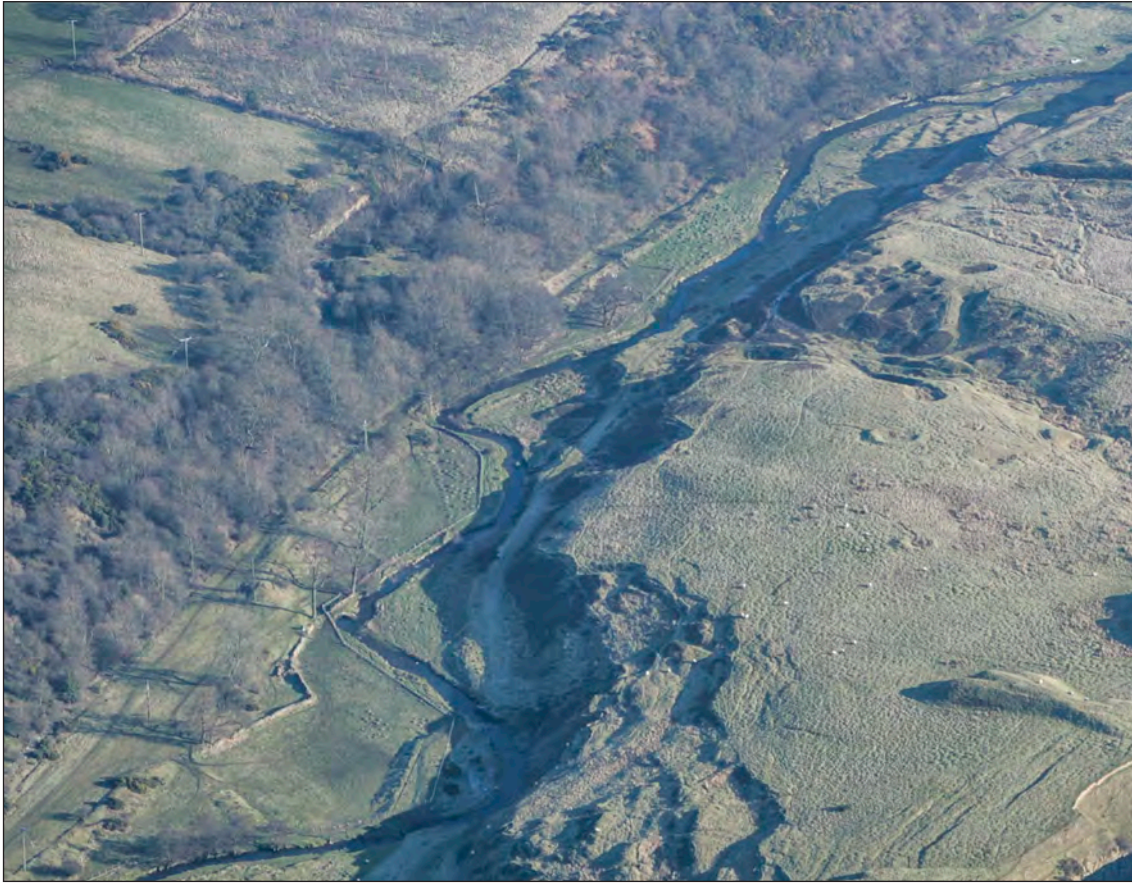
*Fig 49: The course of the Haggerleazes Branch line is visible as a path extending obliquely across the photograph. Part of the original boundary wall can be bordering the River Gaunless. NMR 20641\_44 07-FEB-2007 © Historic England Archive.*

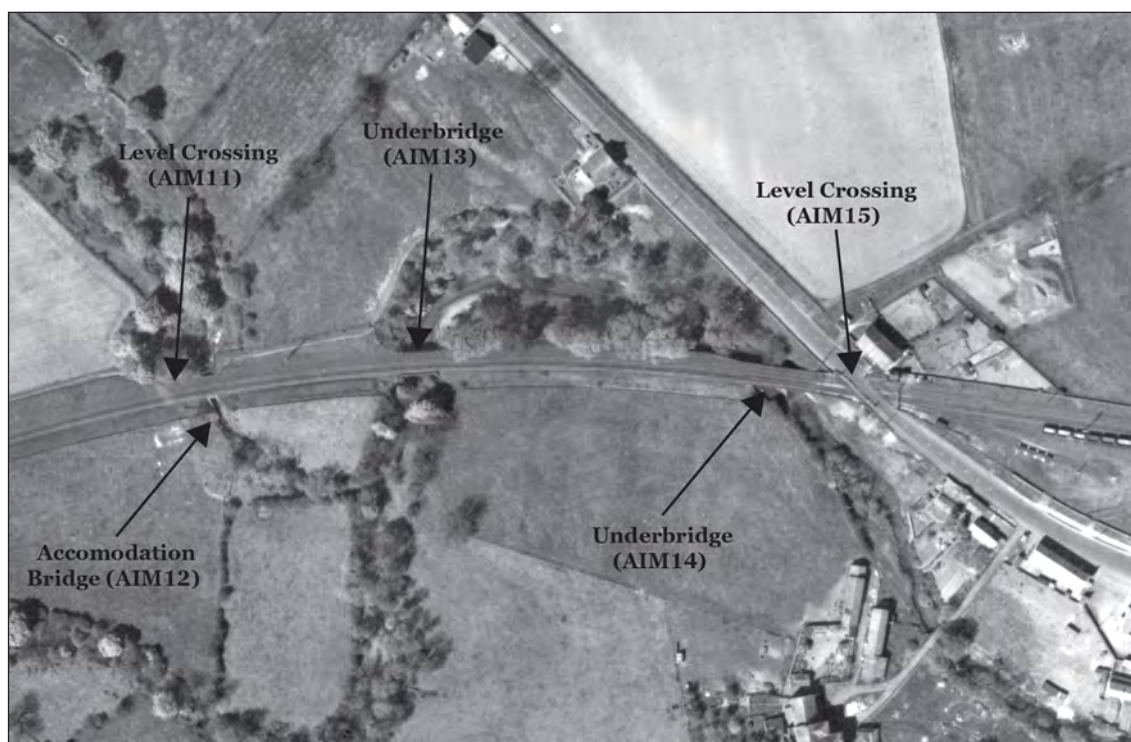
*Fig 50: East of Norton Fine Farm, there are several crossing points, either spanning the River Gaunless or allowing access across the railway. Detail of SfM RAF/58/B/37 V 5029-5379 17-MAY-1948 Historic England Archive (RAF Photography).*

South of Norton Fine Farm there was a further occupation crossing (AIM11) and although neither of the gates is visible on 1940s aerial photographs, the location of the crossing is nevertheless indicated by a path across the old railway line (Fig 50). Immediately adjacent to this, the railway passed over Norton Fine Beck by a narrow underbridge (AIM12; Fig 50). After passing through a short cutting, the railway then crossed the Gaunless twice more via small underbridges (AIM13 and AIM14) where the river makes a tight 'U'-bend to the south of Wood End Farm (Fig 50). The line was embanked for the 110m distance between the two crossing bridges. The modern footpath that follows the line of the Haggerleases Branch crosses the beck and river at the same points, so it is reasonable to assume that the original bridges are still intact, but this can only be confirmed by ground assessment.

There was a level crossing (AIM15) immediately east of the river bridges, which took the railway across Etherley Bank road (Fig 50). East of the road crossing, the line continued on an embankment which remains visible as earthworks. The boundary lines here also appear to remain intact as walls, but it is unclear if these are original. A level crossing carried a trackway between West Auckland and North Leazes across the railway (AIM16). The crossing is recorded as in use on 1940s aerial photographs but has since gone, although the track remains in use.

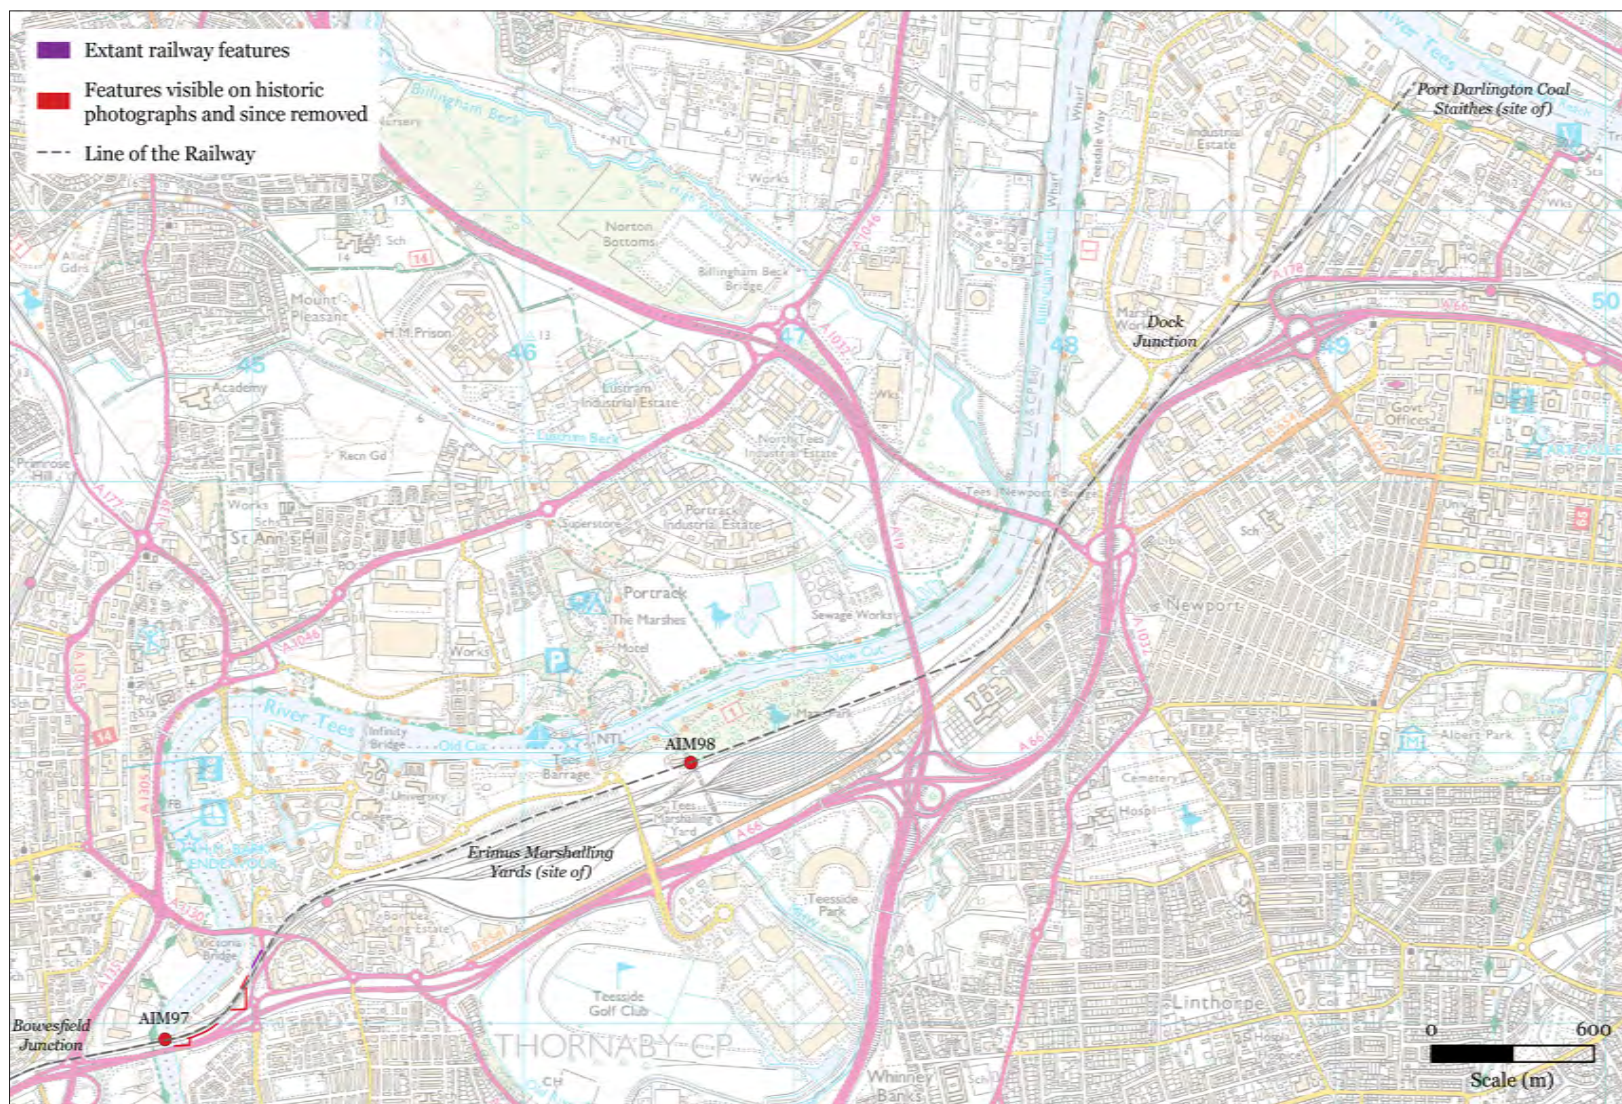
Fig 51: Features relating to the Middlesbrough Extension visible on aerial photographs. Cuttings and embankments are not depicted. Archaeological mapping © Historic England; Base map © Crown Copyright and database right 2019.

### **Middlesbrough Extension (Fig 51)**

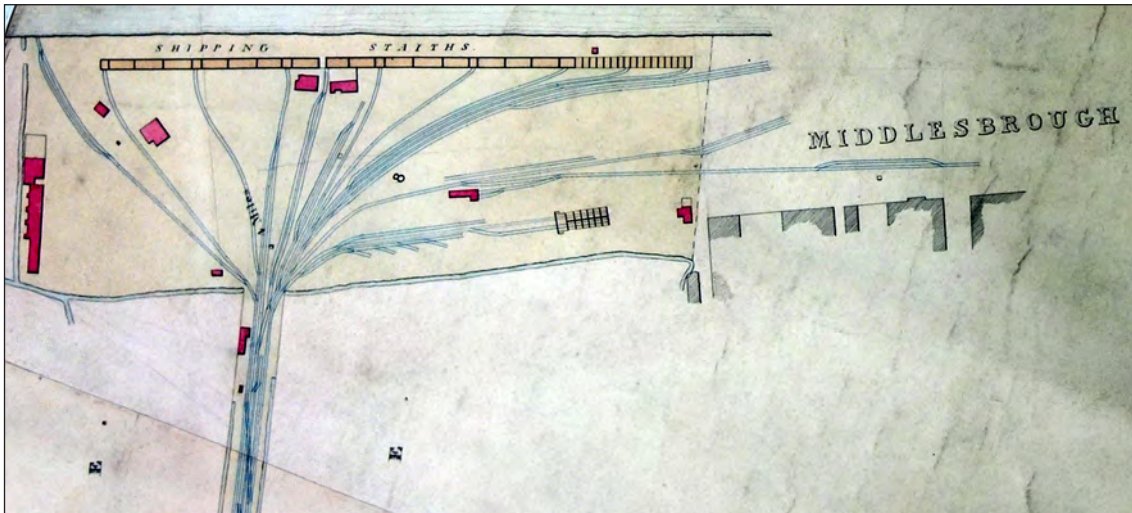
Fig 52: The original railway terminus at the coal staithes at Port Darlington, Middlesbrough. 1839 Thomas Dixon plan. Source: Archaeo-Environment Ltd. Reproduced with kind permission of The National Archives, ref. RAIL 1037/459.

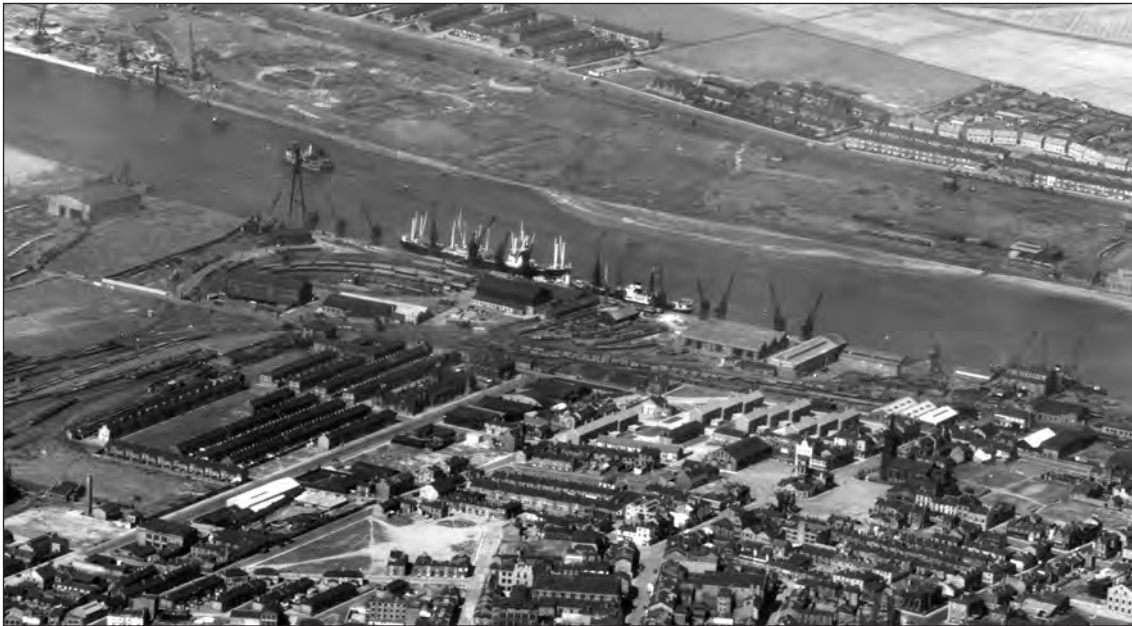
Fig 53: The coal staithes originally known as 'Port Darlington' remained in use as a series of wharfs following the opening of Middlesbrough Dock in 1842, though they were much remodelled over the following century. The site is now an industrial estate. Detail of RAF/58/2249/PSFO-0129 21-AUG-1957 Historic England Archive (RAF Photography).

The railway extension serving all these new facilities left the main line at Bowesfield Junction on the west bank of the Tees just south of the original Stockton terminus of the S&DR. The modern railway follows much of the S&DR route, though at Dock Junction, near the present-day Metz Bridge, the original line projected in a straight line north-east, terminating at the Port Darlington staithes, now the site of Dawson's Wharf Industrial Estate (Fig 53).

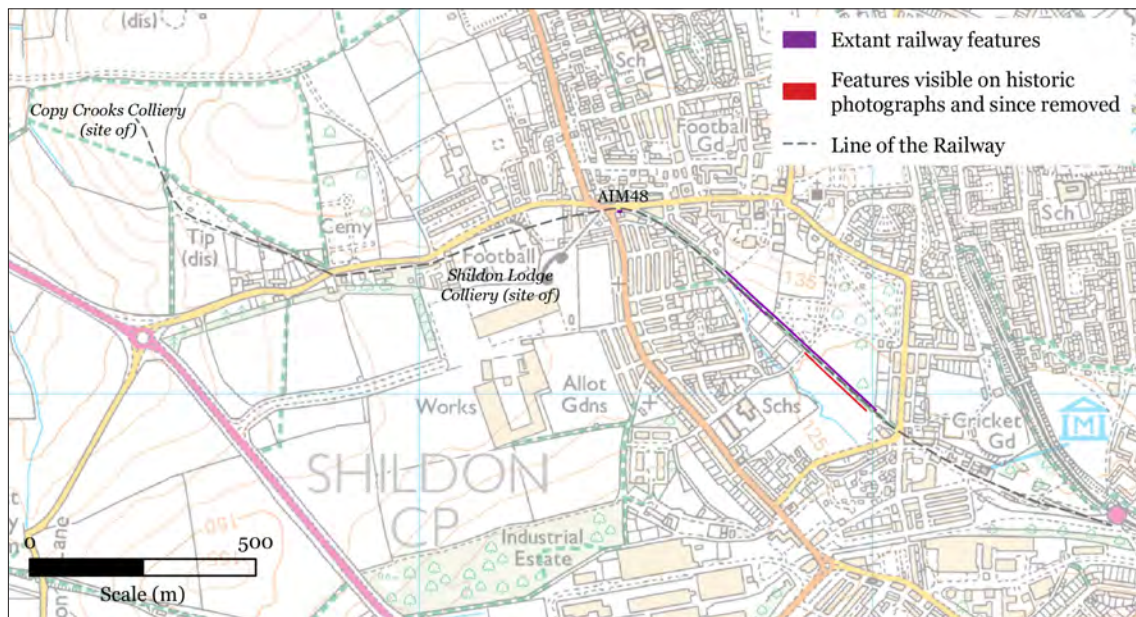
Fig 54: Features relating to the Copy Crooks Branch/Surtees Railway visible on aerial photographs. Cuttings and embankments are not depicted. Archaeological mapping © Historic England; Base map © Crown Copyright and database right 2019.

### Copy Crooks Branch or Surtees Railway (Fig 54)

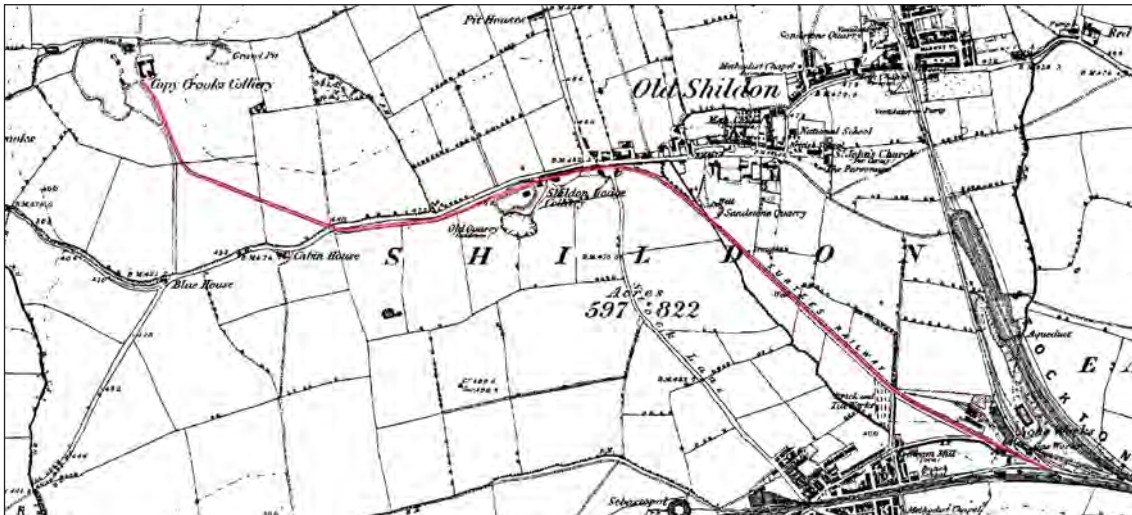
Fig 55: The Surtees Railway (in red) as shown on the 1876 OS 6-inch map. It was built to serve Copy Crooks Colliery, but by the 1850s only went as far as Shildon Lodge Colliery. © and database right Crown Copyright and Landmark Information Group Ltd (All rights reserved 2019) Licence numbers 000394 and TP0024.

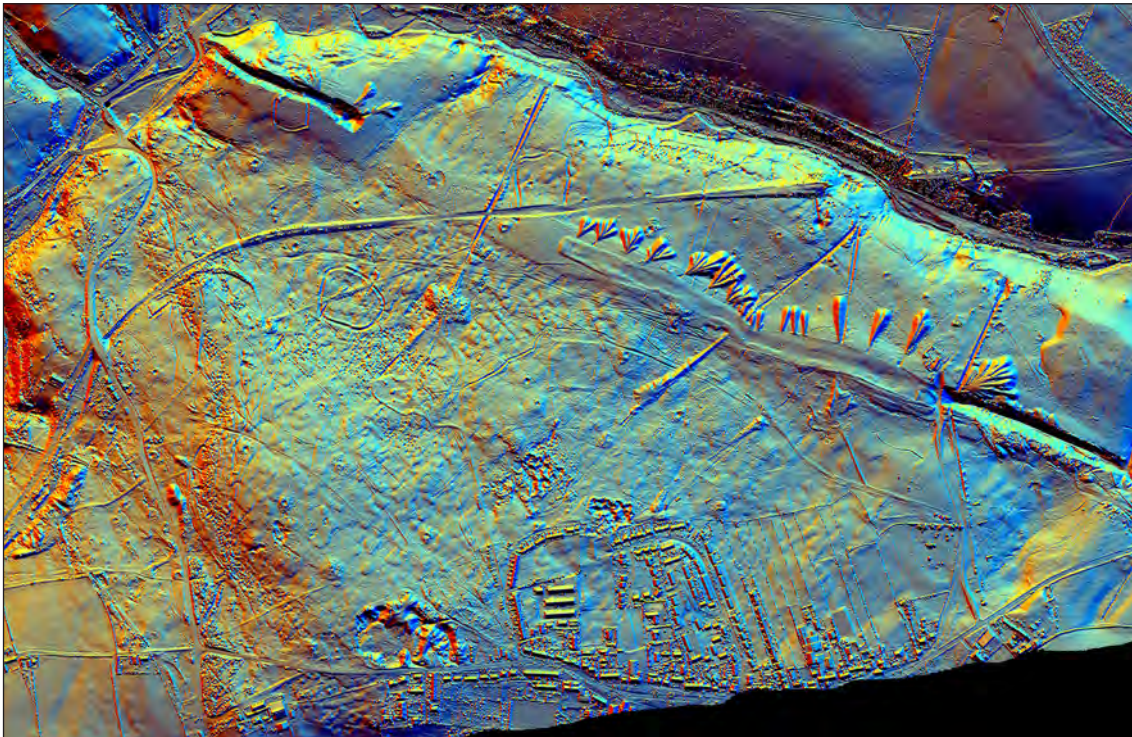
*Fig 56: Cockfield Fell is a lowland moor and multi-period archaeological landscape. Numerous archaeological monuments remain visible as earthworks. Some are thought to originate in the Iron Age, but many relate to medieval and later coal extraction and stone quarrying. LIDAR DSM 30-NOV-2008 © Historic England; source Environment Agency.*

The only extensive area within the project with known prehistoric and later archaeological remains is Cockfield Fell (Fig 56). Located at the extreme west of the project area, the fell is low-lying moorland nestled on the slope below Cockfield village, overlooking the River Gaunless. The fell has been common land for centuries and is remarkable in that it has never been enclosed or put under the plough (Roberts 1975, 48). Therefore archaeological features of many periods survive today as earthworks, although about one third of the scheduled area of the fell lies outside the S&DR project area and therefore not all features were mapped.
