# Stockton and Darlington Railway Heritage Action Zone Aerial Investigation & Mapping Report

**STOCKTON AND DARLINGTON RAILWAY  
HERITAGE ACTION ZONE**

**Aerial Investigation & Mapping Report**

NGR: NZ 290 156

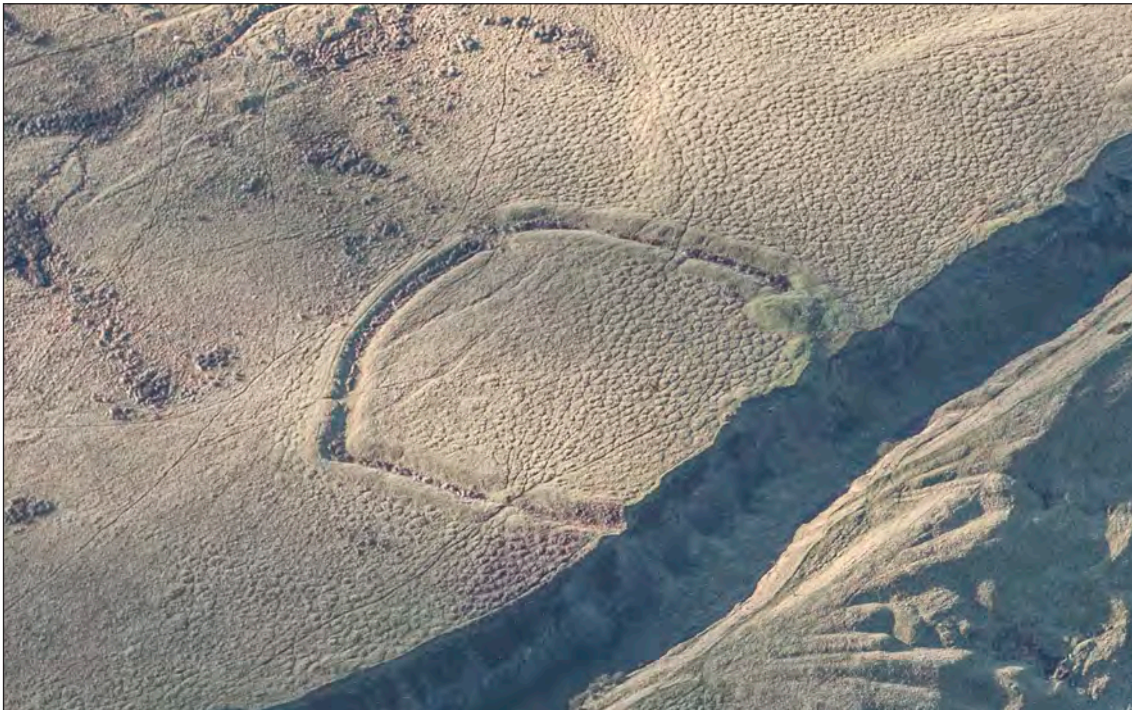
*Fig 57: A possible Iron Age enclosure on Cockfield Fell (NRHE 21981), which has been partly destroyed by whinstone quarrying. Detail of 28112\_039 18-JAN-2011 © Historic England Archive.*

There are a number of enclosures on the Fell that have probable prehistoric origins. Two fall within the project area and have been attributed an Iron Age or Roman date. The most intact is sub-rectangular in plan, comprising a ditch flanked by internal and external banks (NRHE 21981; Fig 57). The northern side of the enclosure was destroyed by late 19th-century quarrying, but it is depicted in full on the earlier 1874 OS map, which indicates that it originally measured approximately 88m by 85m. A larger, but much more mutilated enclosure is visible 400m to the east (NRHE 21988). This rectilinear enclosure is also defined by a ditch with intermittent evidence for internal and external banks. The south side of the enclosure was removed when a cutting was made for the South Durham and Lancashire Union Railway in the mid-19th century. The surviving earthworks enclose an area measuring 105m by 115m.

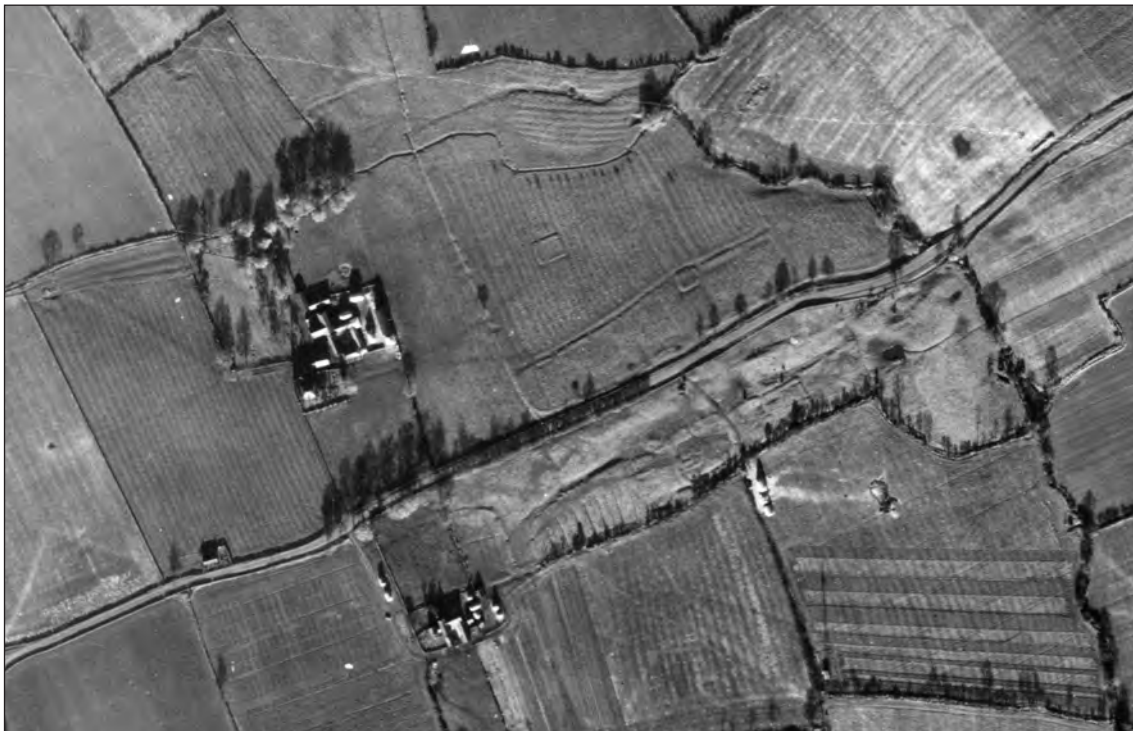
*Fig 58: Remnants of a medieval open-field system, visible as ridge and furrow (NRHE 25649), surround the deserted settlement of West Hartburn. Many of the earthworks were ploughed level during the latter part of the 20th century. Detail of RAF/CPE/UK/1835 RS 4237 13-NOV-1946 Historic England Archive (RAF Photography).*

Much more extensive evidence of medieval cultivation was recorded between Middleton St George and Stockton. Early aerial photographs record large areas of medieval ridge and furrow ploughing at Oak Tree (NRHE 1624195), West Hartburn (NRHE 25649; Fig 58), north of Durham Tees Valley Airport (NRHE 1624216), Egglecliffe (NRHE 1624228) and south of Stockton (NRHE 1624244 and 1624249). Aerial photographs taken between 2015 and 2016 indicate that less than 20% of medieval cultivation mapped from earthworks on historic aerial photographs from the 1940s remains extant, leaving isolated pockets.

A good example of medieval settlement visible as earthworks is at West Hartburn (NRHE 25649), located on the west bank of Goosepool Beck (Figs 58-9). The village comprised two rows of buildings and their associated plots arranged either side of a central green. The northern through-road forms the present-day Mill Lane. The village was formerly surrounded by medieval ridge and furrow, and hollow ways extended to the north-west and south. Many of the earthworks visible on 1940s photographs have since been levelled. A detailed survey and some excavation took place in 1962 (Still and Pallister 1964) recording earthworks to the north and south of the road. Aerial photographs show that by 1974 the north field was under the plough, and although the features were probably still extant as shallow earthworks, they show up mostly as recently formed soilmarks. By the time the site was surveyed again in 1991 by the RCHME, only the southern half of the settlement remained visible as earthworks. These remaining earthworks are scheduled as NHLE 1011257. This site illustrates the value of using historic aerial photographs to record lost elements and allow a more complete survey of the deserted settlement (Fig 59).

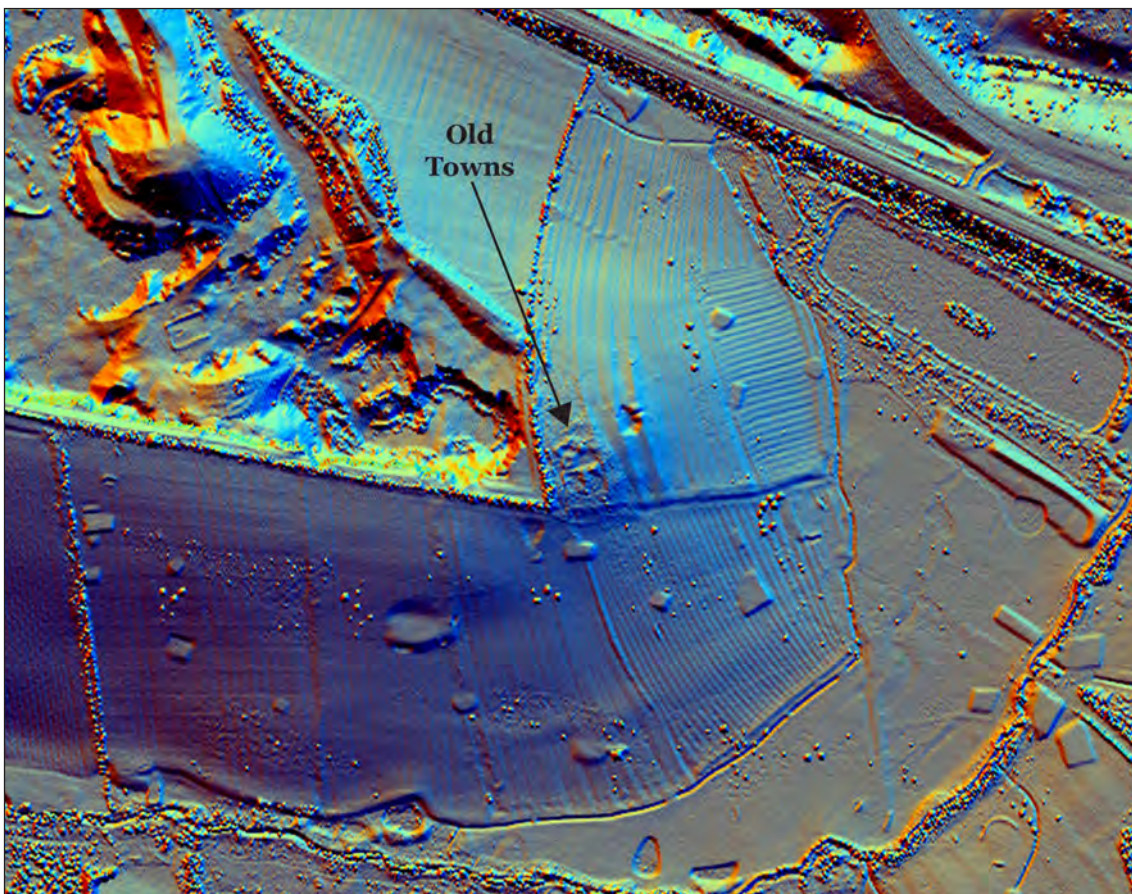
*Fig 60: The site of Old Towns (centre) is probably a late farmstead, but it may have had medieval origins. The platforms within the fields of ridge and furrow relate to a modern golf course. LIDAR DSM 8-DEC-2008 © Historic England; source Environment Agency.*

There was a farmstead at the site of Old Towns, north of School Aycliffe (NRHE 24024), which is depicted as ruins on the 1859 OS map, but may have been extant on the 1840s tithe map. The earthwork remains include the footings of at least two buildings, which only partly relate to the ruins visible on the early OS maps, and a hollow way extending to the east. It is sited within an area of medieval open field system, which if contemporary would support a medieval origin, although it is probable that the farmstead is later than the field system (Fig 60).

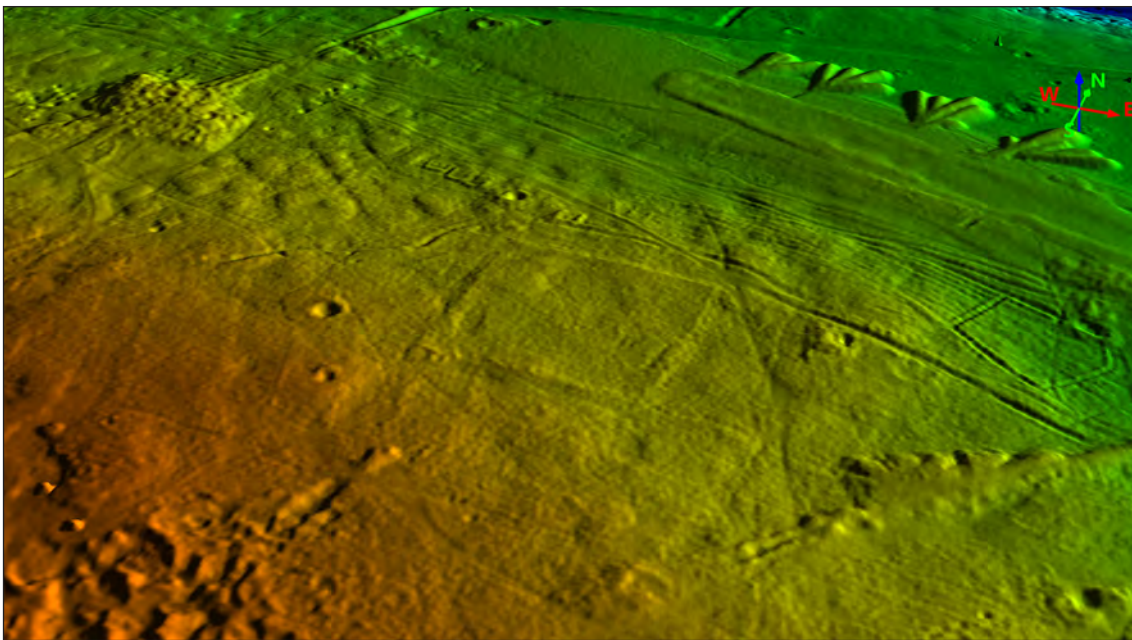
*Fig 61: A large rectangular enclosure on Cockfield Fell may be a medieval or post medieval garth (22089). LIDAR DSM 30-NOV-2008 © Historic England; source Environment Agency.*

A large rectangular enclosure (NRHE 22089; Fig 61) on Cockfield Fell was once suggested to be a Roman camp. However, this was reinterpreted by the RCHME as more likely to be a medieval or post-medieval garth (an enclosure) with adjoining house due to the lack of rounded corners and entrances (RCHME 1984, 6). The enclosure earthworks are very slight, but can be seen from the air on lidar images, and the foundations of a building are visible in the south-west corner of the monument. The northern boundary of the enclosure is skirted by a sinuous boundary ditch and bank (NRHE 873995) that appears to avoid the corner of the enclosure. The boundary adjoins another small rectilinear enclosure (NRHE 22074), which is probably post medieval in date. Numerous small 'U'-shaped embanked enclosures are located immediately to the north of the possible garth (NRHE 882410). With internal 'comb'-like banks, these features are unusual, but they do appear to overlie and post-date the sinuous boundary discussed above and are presumably post medieval in date. Some of these features may relate to industrial activity on the fell.

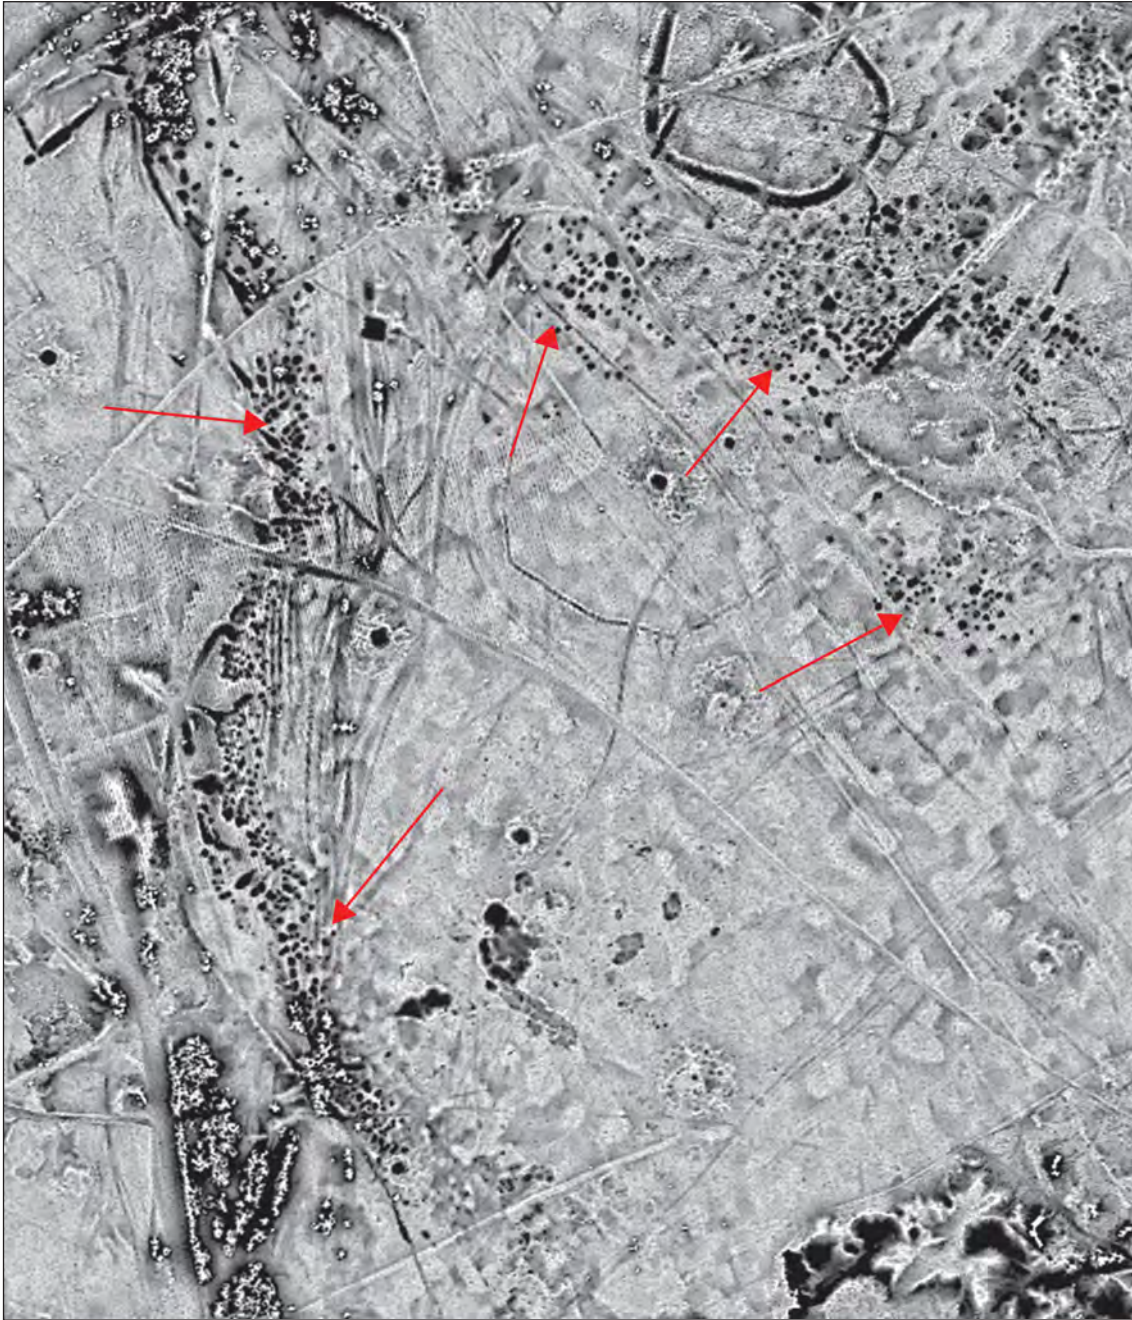
*Fig 62: Lidar visualised using positive openness reveals the dense concentration of coal mining pits on Cockfield Fell (NRHE 1622781), some of which may be medieval in origin. LIDAR DSM 30-NOV-2008 © Historic England; source Environment Agency.*

There are examples of shafts and shaft mounds at several locations throughout the west of the project area, and they are particularly extensive on Cockfield Fell. Approximately 50 were identified on the moor (NRHE 1622781). They vary in size, and are often arranged in clusters or in regularly spaced rows. Further examples were noted to the north and west of Witton Park Farm (NRHE 1622891), in and to the west of Brusselton Wood (NRHE 1622943), south of Copsy Crooks Farm (NRHE 1622954), east of Low Deanery Farm (NRHE 1622974), and north of Sunnydale (NRHE 1441888).

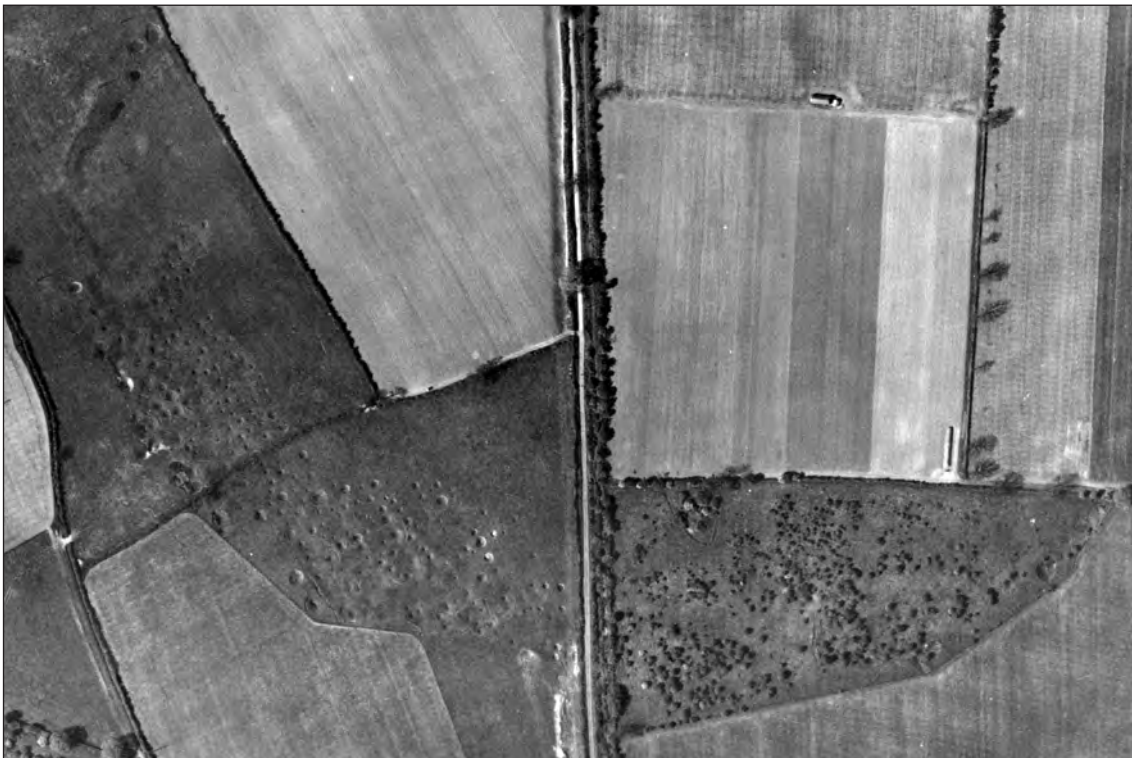
*Fig 63: Extractive pits for coal (NRHE 1441850) near the junction of Burnhouse Lane and Dere Street Roman roads could potentially have medieval origins. Detail of SfM RAF/58/B/37 V 5029-5379 17-MAY-1948 Historic England Archive (RAF Photography).*

- Between Burnhouse Lane and Dere Street, north of Brusselton Farm (NRHE 1441850; Fig 63). A large cluster of nearly 300 pits forms an arc; they are now levelled, but were mapped from earthworks visible on historical aerial photographs. There is no obvious association with other features, though soil marks on aerial photographs and undulating ground faintly visible on lidar suggests that extraction was originally much more extensive. If so, the pits pre-date the extant field system which appears to be post medieval in date.

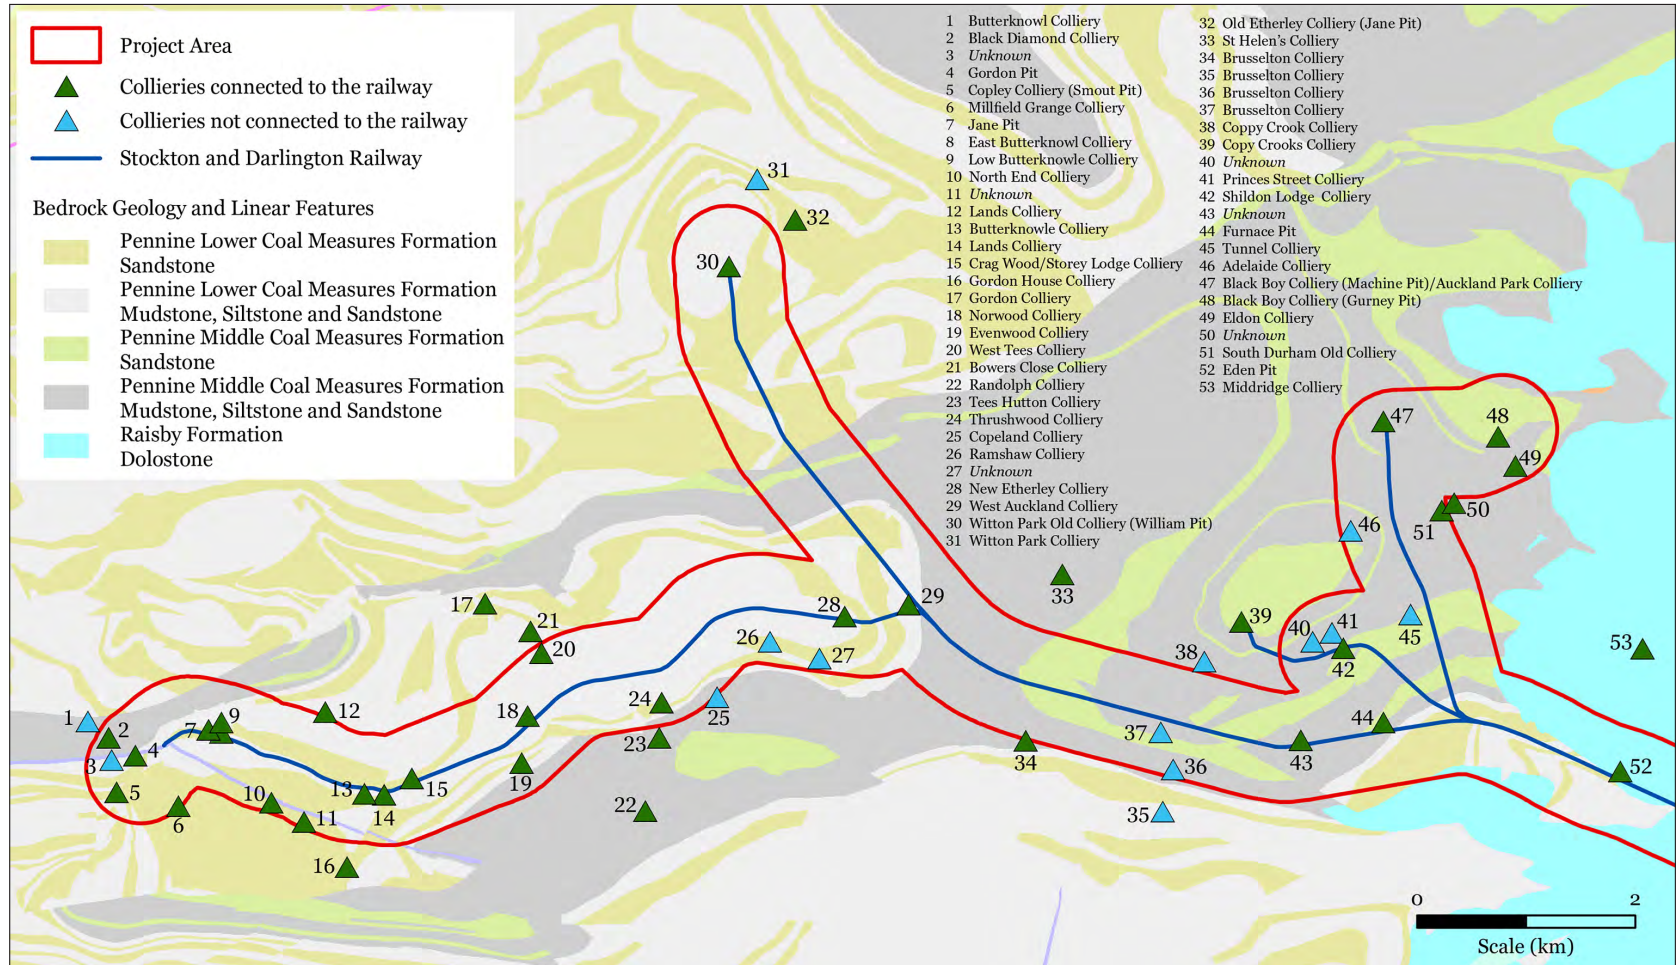
Fig 64: The western end of the S&DR main line and the Haggerleases, Black Boy and Copycrook Branches, showing the collieries served. Those not served directly were linked to the railway by wagonways, tramways or mineral railways. Contains British Geological Survey materials © UKRI 2019.

The collieries in the area are far too numerous to describe in detail, but it is important to note their impact on the landscape and their relationship with the railway (Fig 64). Between the 1830s and the closure of the last mines in the late 20th century, there were over 50 collieries either in or around the project area. Of these, nearly 40 were physically linked to the railway in some form. Those situated alongside the line had sidings leading directly on to the railway. Larger colliery complexes led to the construction of branch lines, including the Black Boy and Haggerleases Branches and the Surtees Railway. The remainder were connected to the S&DR by mineral railways or tramways.

Although the railway was put in place primarily to serve the pre-existing collieries, it afterwards became the focus for exploiting more seams, often at quite some distance from it (see Fig 64). Logistically, it made sense that these were linked into the S&DR to allow the transportation of the coal. This resulted in numerous mineral railways to the larger collieries, and a complex network of tramways serving others (Fig 79). Of the few collieries in the region that were not linked to the railway, they either had branch lines to other later railways or were short-lived small late-19th/early-20th

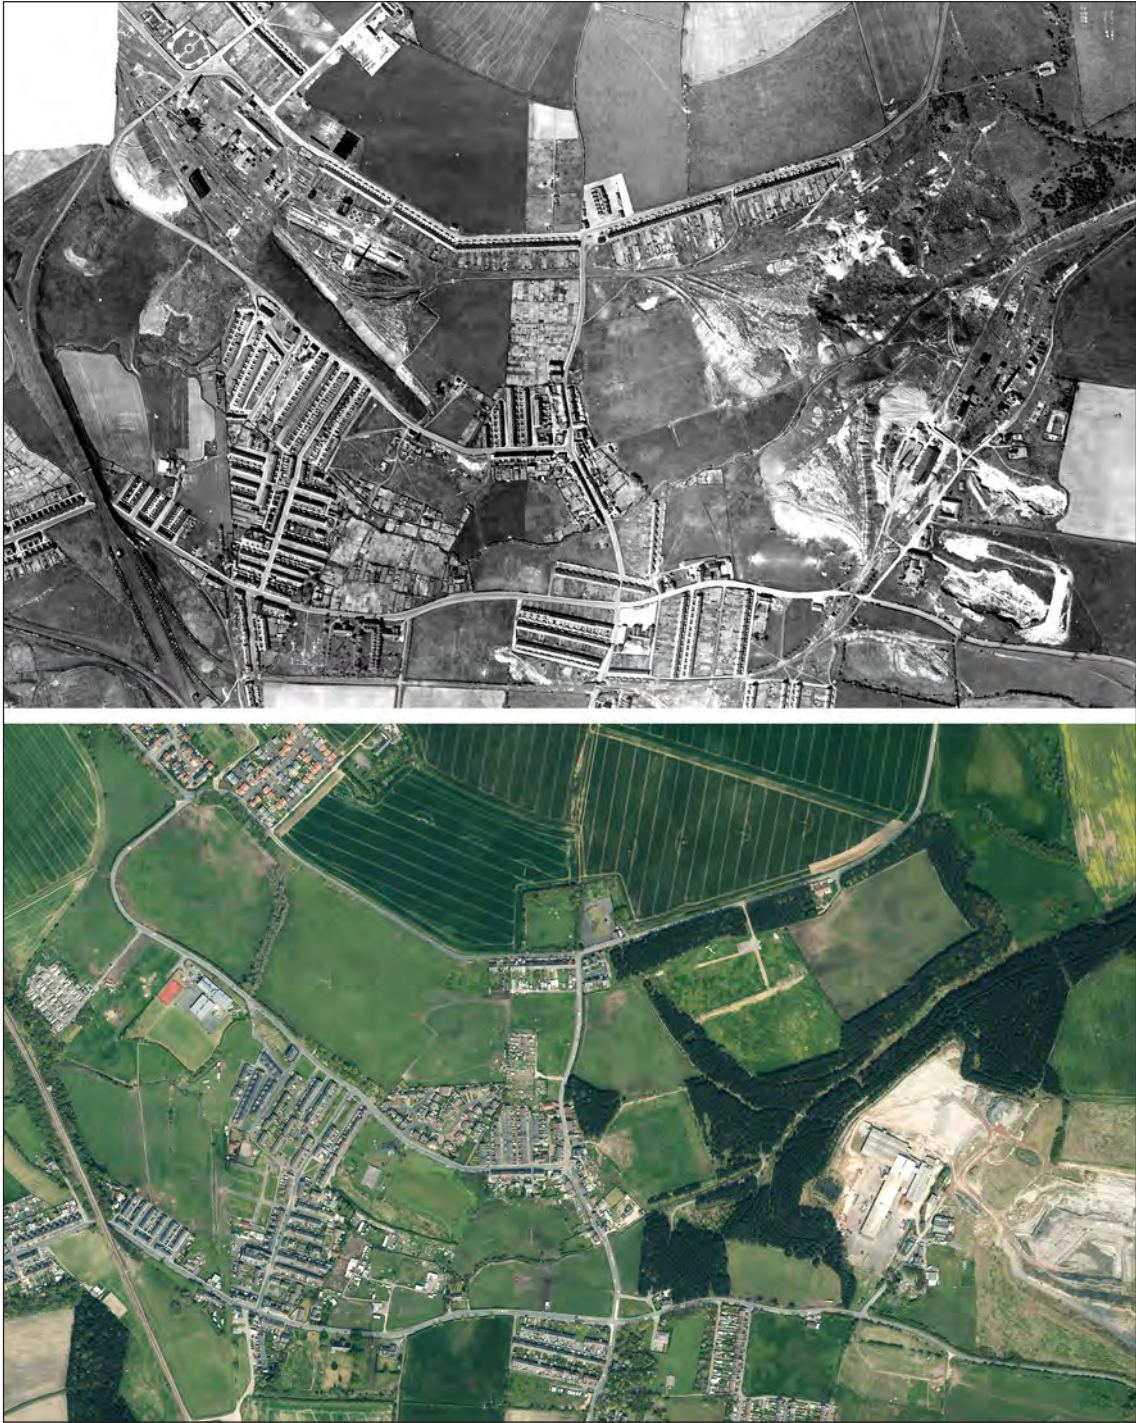
*Fig 65: The landscape around the Black Boy collieries has changed a great deal since the closure of the final colliery in 1946, but the pattern of roads can still be seen. Top: SfM derived orthophotograph RAF/58/B/37 V 5029-5379 17-MAY-1948 Historic England Archive (RAF Photography); Bottom: NZ2227-2428 mosaic 06-MAY-2016 ©Bluesky International/Getmapping PLC.*

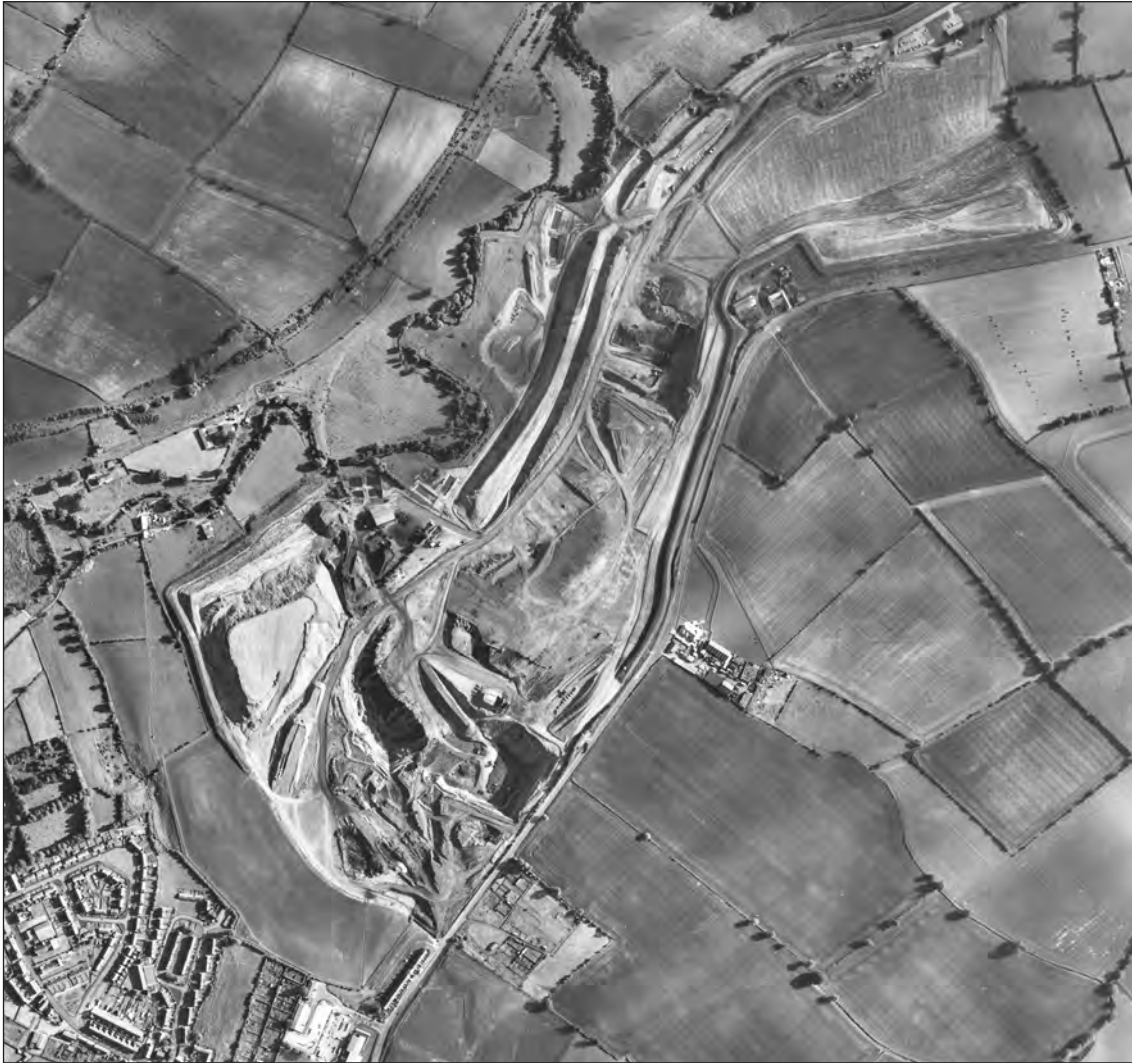
*Fig 66: Opencast coal extraction was taking place as late as the 1990s between Evenwood and West Auckland. OS/91128 V 9 03-AUG-1991 © Crown copyright. Ordnance Survey.*

After the closure of the deep mines, coal mining switched to opencast methods through the later 20th century. Opencast workings were excavated and backfilled over a very short period, and therefore appear only fortuitously on aerial photographs often taken infrequently and at intervals from the 1940s onwards (Fig 66). The largest identified area of open casting was to the south-west of Shildon (NRHE 1441869). Here, 75ha of opencast workings were recorded on late 1940s aerial photographs, although the workings may have covered a much greater area at their maximum extent and it has been argued that they removed a significant length of the S&DR Brusselton Incline (*see* page 31). There was another extensive area of opencast mining in the 1990s between Evenwood and West Auckland (NRHE 1455011), but even in the short period of time since its closure, the area has been landscaped and returned to agriculture. Smaller areas of late 20th-century opencast coal workings were mapped north of Etherley (NRHE 1455015), west of Witton Park Farm (NRHE 1622931) and possibly even on Cockfield Fell (NRHE 1622781).

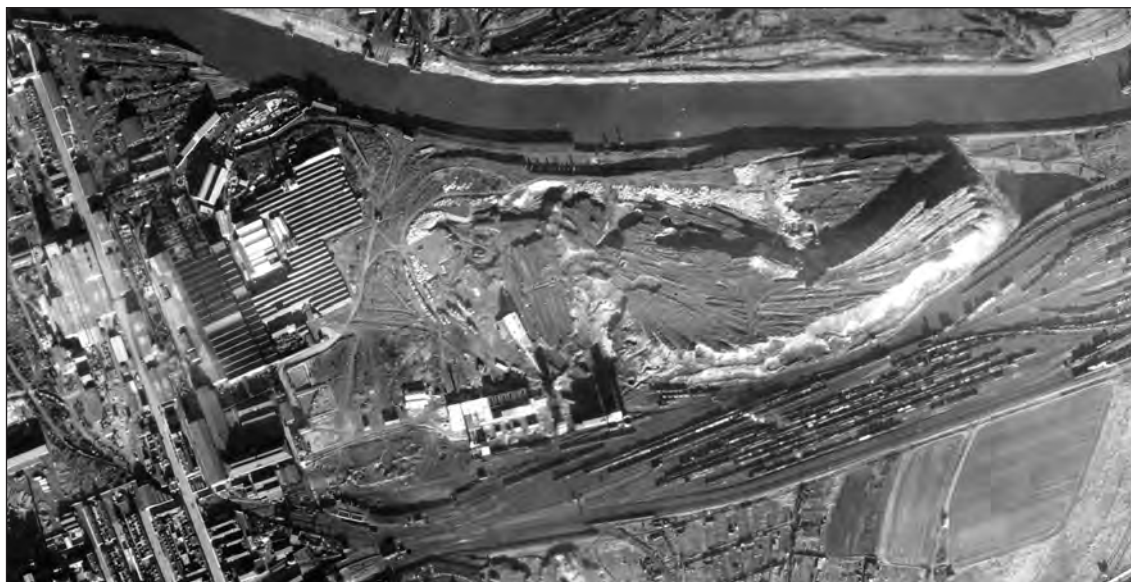
*Fig 67: The Thornaby Iron Works (NRHE 1623941) was just one of many situated along the River Tees. In common with many other industries along the S&DR (and later extensions/incorporations), it linked directly into the railway. Detail of RAF/CPE/UK/1835 RS 4213 13-NOV-1946 Historic England Archive (RAF Photography).*

There were ironworks as far west as Drinkfield (NRHE 1623559). The remains of additional works were recorded from aerial photographs at Palm Bridge (NRHE 1623889) and north of Middleton St George (NRHE 1623883), which is now under a housing estate. The major iron and steel works were concentrated along the Tees. These include the North Yorkshire Iron Works (NRHE 1624177) south of the Surtees Bridge, the Thornaby Iron Works (NRHE 1623941; Fig 67) which was linked to the S&DR by multiple branch lines feeding in to the Erimus Marshalling

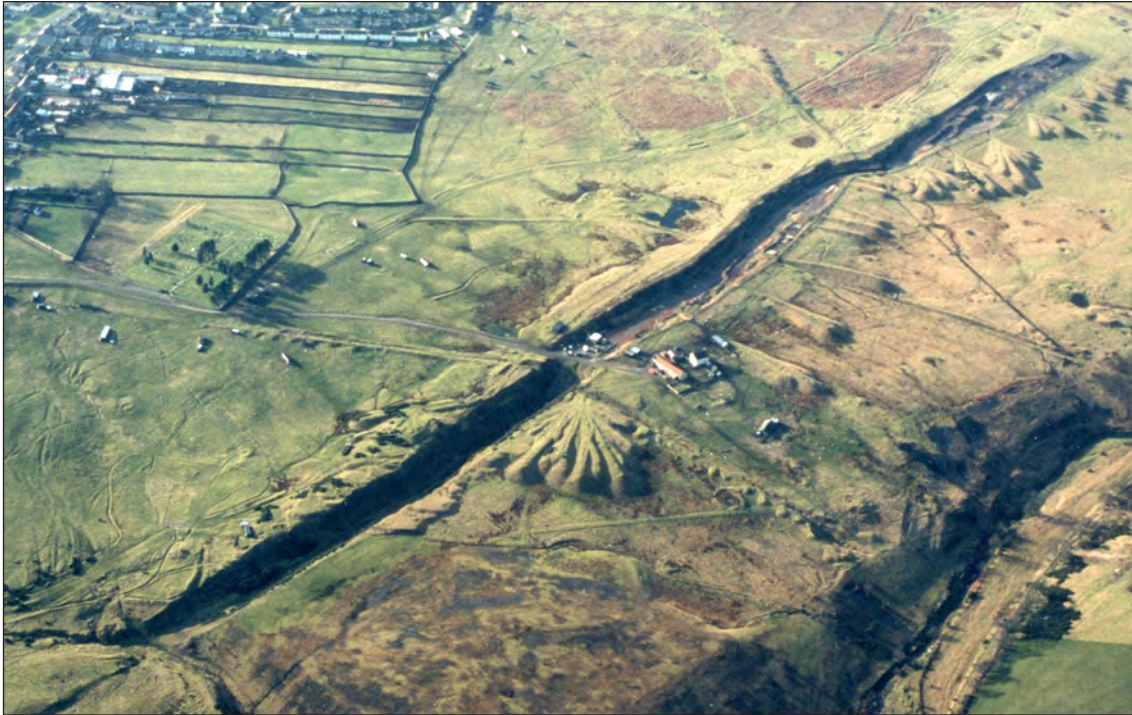
*Fig 68: 19th and 20th century whinstone quarrying extended across Cockfield Fell, cutting through many earlier archaeological features. NMR 17072/24 02-FEB-1998 © Crown copyright. Historic England Archive.*

Although coal mining dominates the western half of the project area, other minerals were also extracted. On Cockfield Fell for example, there are a series of long linear whinstone quarries (NRHE 1466221 and 1466218; Fig 68). Established in the late 19th century to supply rock for road construction, these quarries were expansive, being over 2.6km in length, and were linked to the Haggerleases Branch Railway by a tramway. They remained in use into the 20th century. Unlike most of the other industrial activity on the fell, large stretches of the quarries were back-filled but elements survive to the north of Blackburn Bridge and east of The Slack. Many of the associated earthworks, such as a series of finger-dump spoil heaps, also remain extant. Whinstone was also quarried north of Urray Nook and in the grounds of Preston Park (NRHE 1623913 and 1623918). The latter quarrying was already active by 1822 and linked to the railway when it opened in 1825 (Daniels 1996). Limestone was also quarried in the centre of the project area. Both Middridge (NRHE 1623425) and Old Town (NRHE 1443698) Quarries were in operation by the 19th century, and remained in use either continually or intermittently until the latter half of the 20th century. Thickley Quarry (NRHE 1622986) was operating lime kilns into the latter half of the 19th century.

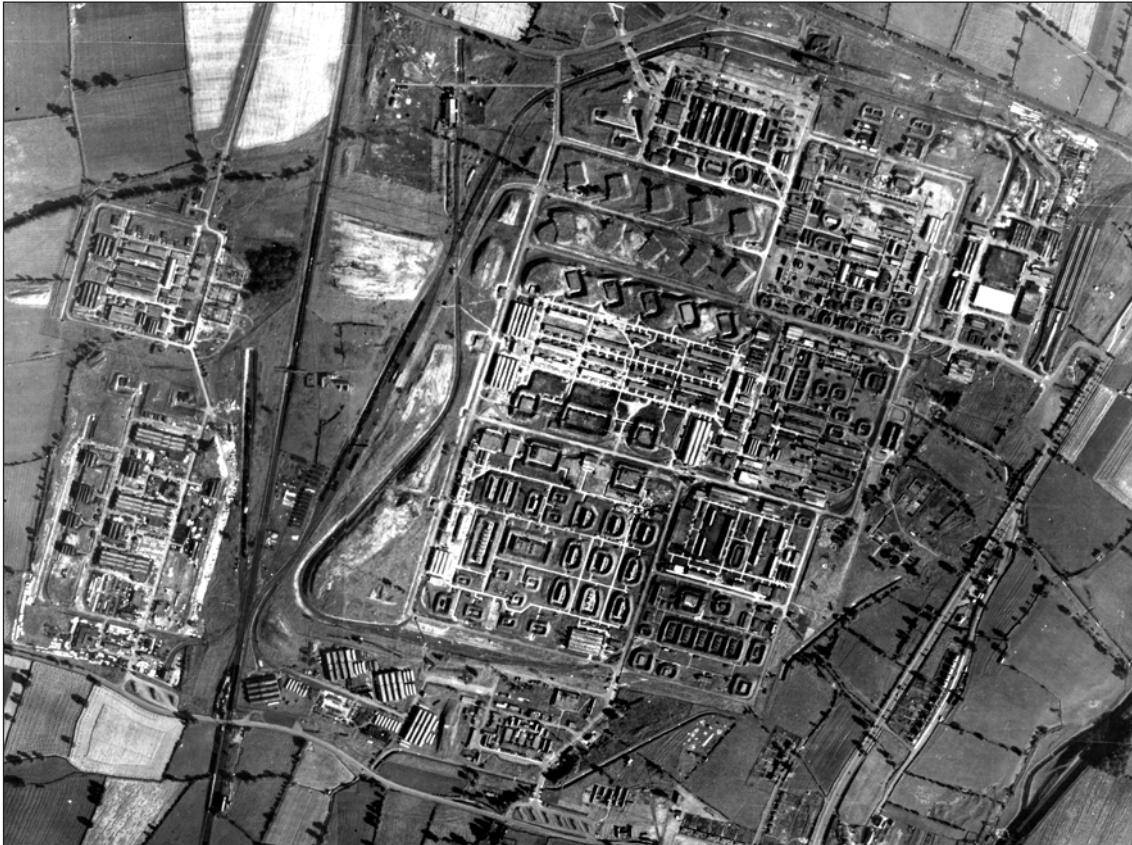
*Fig 69: The Royal Ordnance Filling Factory No. 9, south of Newton Aycliffe was deliberately positioned adjacent to the S&DR to allow munitions to be transported around the country. RAF/106G/UK/1700 RS 4091-2 27-AUG-1946 Historic England Archive (RAF Photography).*

There is extensive evidence of wartime activity along the S&DR. The railway acted as an important line of communication, and was one of the reasons why military sites such as the Royal Ordnance Filling Factory No. 9 Aycliffe (NRHE 1075763) were sited alongside it. The factory was established in 1941 and occupied land on both sides of the S&DR, south of Newton Aycliffe (Fig 69). The layout of the site is partly preserved in the Aycliffe Business Park, but little remains of the original factory bar a handful of buildings.

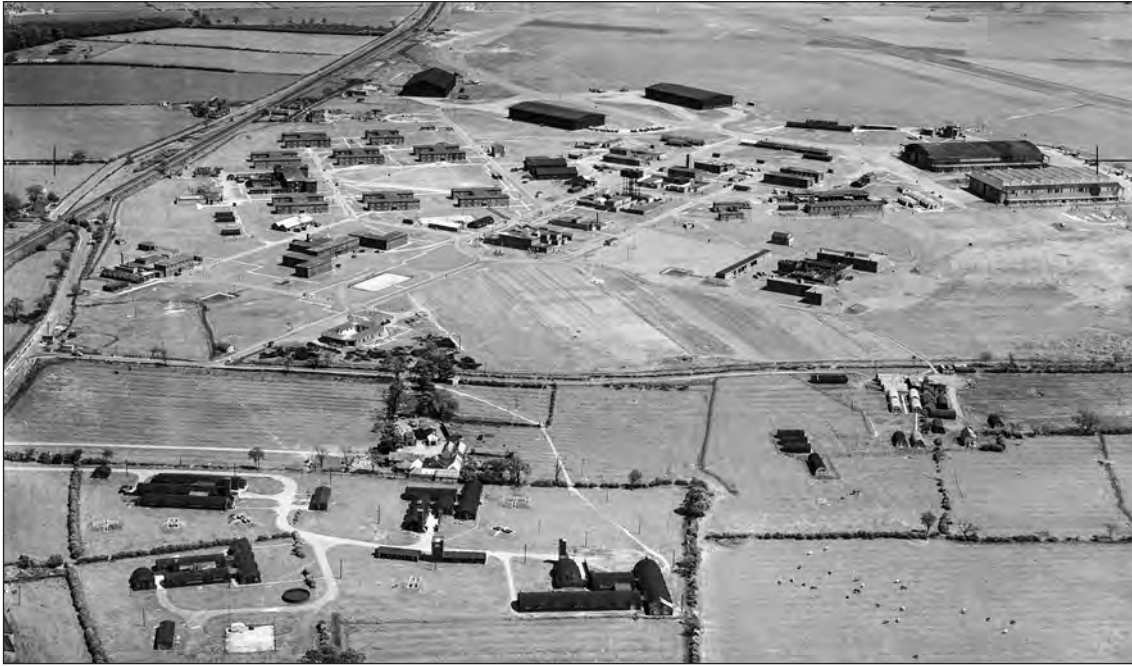
*Fig 70: RAF Middleton St. George shortly after the end of the Second World War. The runways are top right of frame. The S&DR extends along the northern boundary of the airfield to the top-left of the image. EAW001005 06-JUN-1946 © Historic England Archive. Aerofilms Collection.*

Other military installations were also sited along the railway to take advantage of communication links. The largest was Royal Air Force Middleton St George (NRHE 1406315), which covered 29ha to the south of Oak Tree (Fig 70). Although much remodelled for use as a civilian airport in 1966 (it is now Durham Tees Valley Airport), the original military airfield is recorded on historical aerial photographs. It comprised runways, support buildings for the airfield and numerous ancillary camps to the west (NRHE 1623861, 1623862 and 1623863). Five masts (NRHE 1623876), arranged in a quincunx pattern, south of Oaktree Junction, may be associated with the airfield, though probably part of a wartime telegraph station.

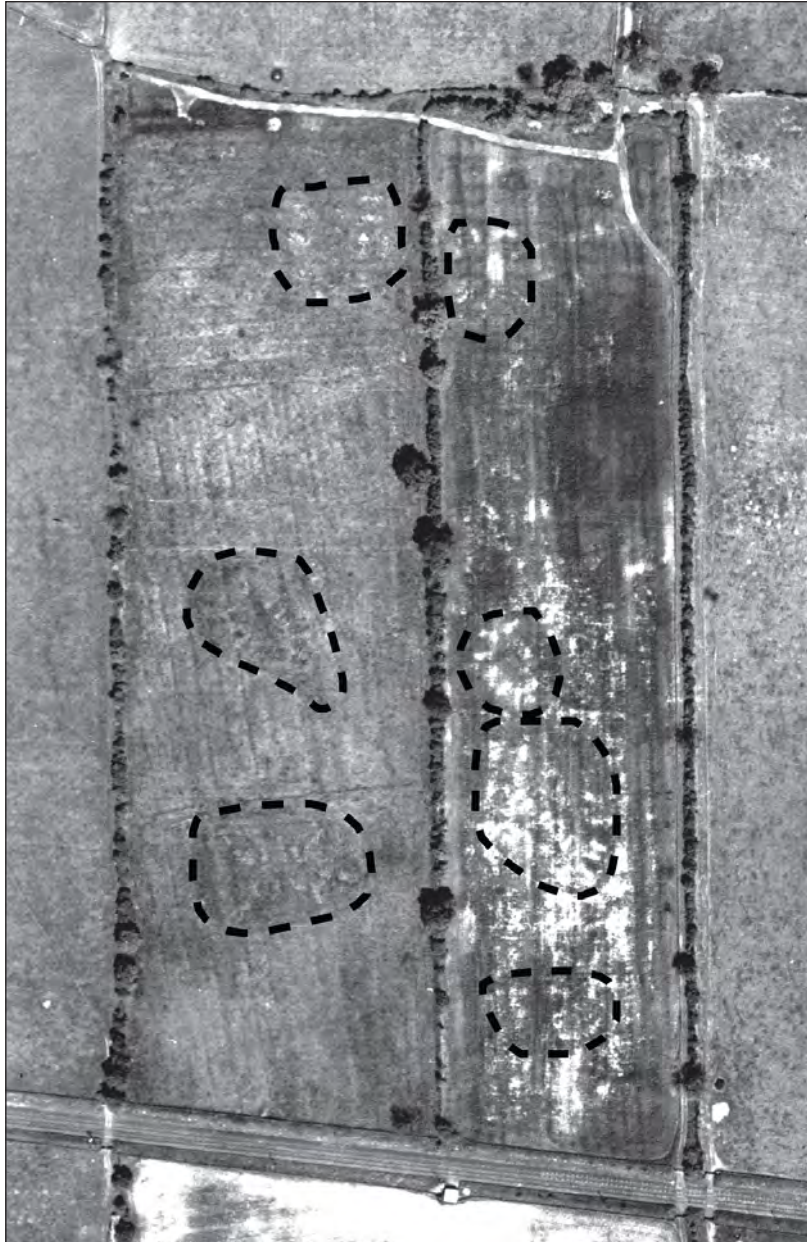
*Fig 71: The scorch marks of the bombing decoy (dashed outline) east of Red Hall were still visible in 1948 despite being out of use for several years. Detail of RAF/58/B/49 V 5022 12-JUN-1948 Historic England Archive (RAF Photography).*

The concentration of industrial sites around the mouth of the Tees and along the railway made it an obvious target for enemy aircraft, resulting in various forms of civil and military defence systems being constructed. This included a Starfish Bombing Decoy east of Red Hall (NRHE 1413365). The decoy, which opened in 1941 and remained in use until at least 1943, was used to simulate burning buildings and divert enemy bombers away from Darlington. It comprised a series of 'fire baskets' in an enclosure, which would be set on fire to represent burning targets on the ground. Although already out of use when photographed in 1948, the site of the decoy can still be seen as a series of scorch-marks on the ground (Fig 71). The command centre is located 500m to the north. It originally consisted of a concrete bunker covered in earth with a small side building, perhaps a generator or guard building (NRHE 1377270). The bunker remains intact, though now devoid of its earth covering.

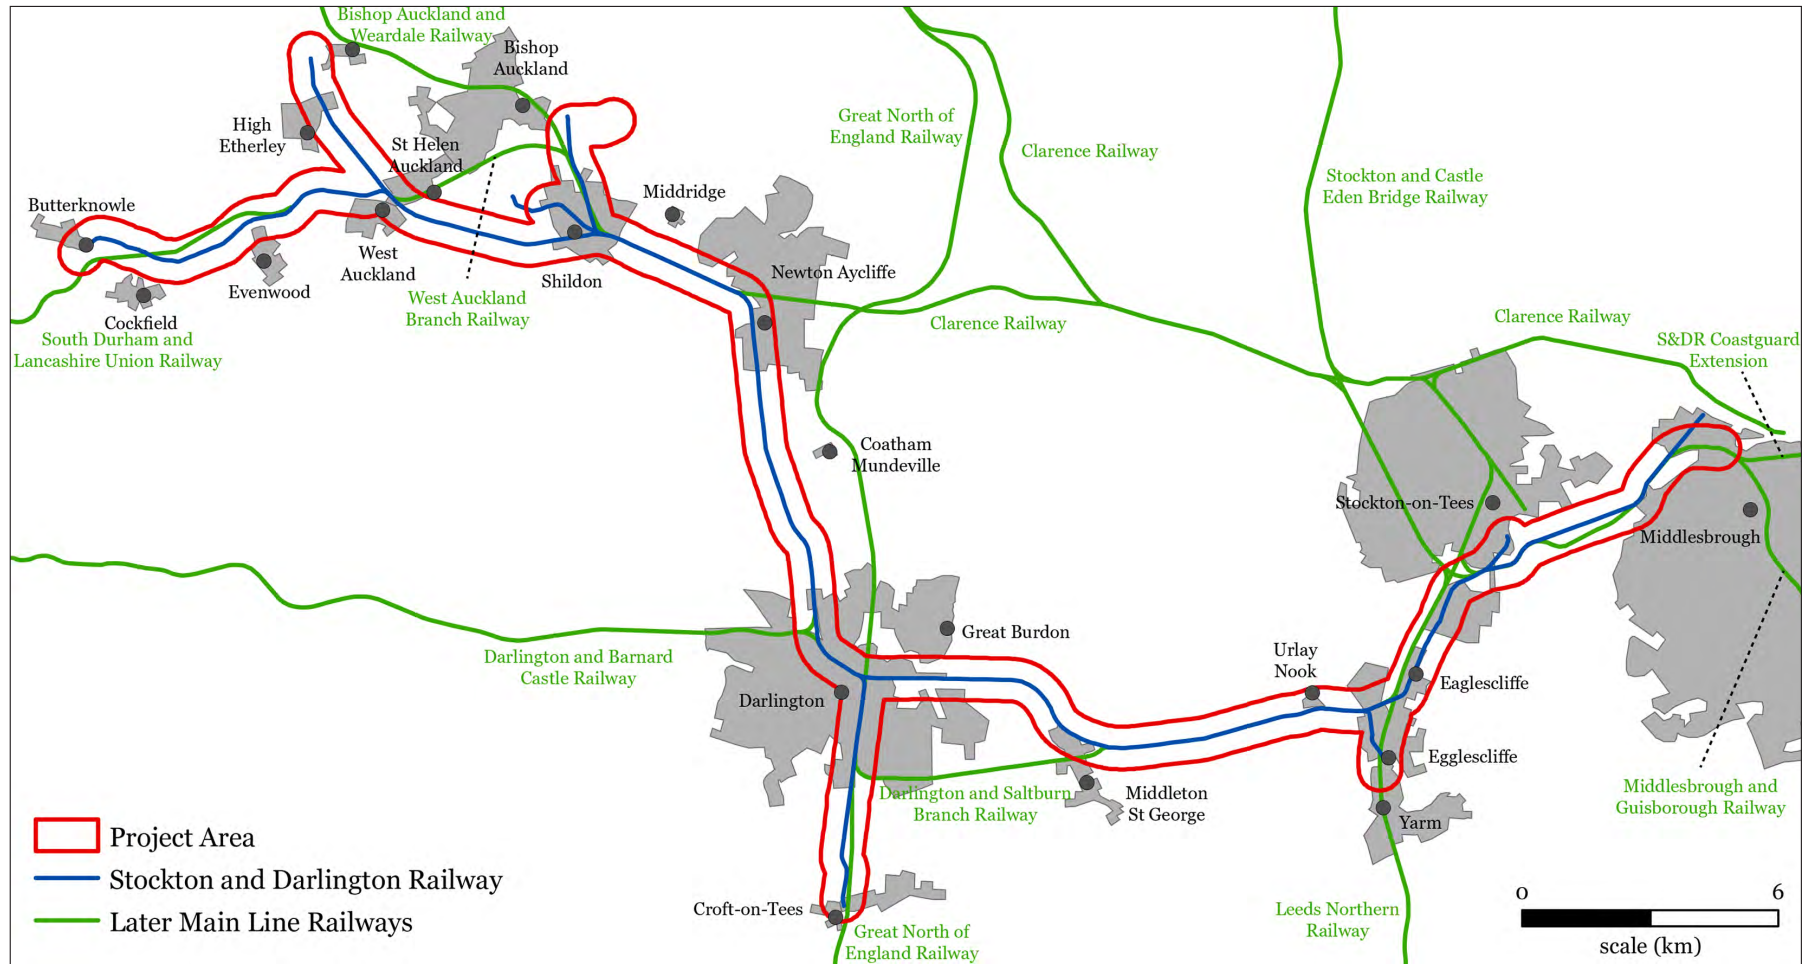
Fig 72: Within only a few decades of the opening of the S&DR, new railways had been constructed.

The S&DR was an immediate success, and within three decades, numerous new lines had been constructed (Fig 72), several of which were independently owned but had running rights over sections of the S&DR. One such example was the Great North of England Railway in 1841, which utilised a section of the Croft Branch Line as it passed through Darlington. This company was absorbed into the York and Newcastle Railway in 1845, then into the York, Newcastle and Berwick Railway in 1847, which then merged to form the North Eastern Railway (NER) in 1854. Most of the other local railways were either set up as sub-companies to, or later absorbed into the S&DR, until 1863 when the S&DR was itself taken into the NER (Holmes 1975, 44).

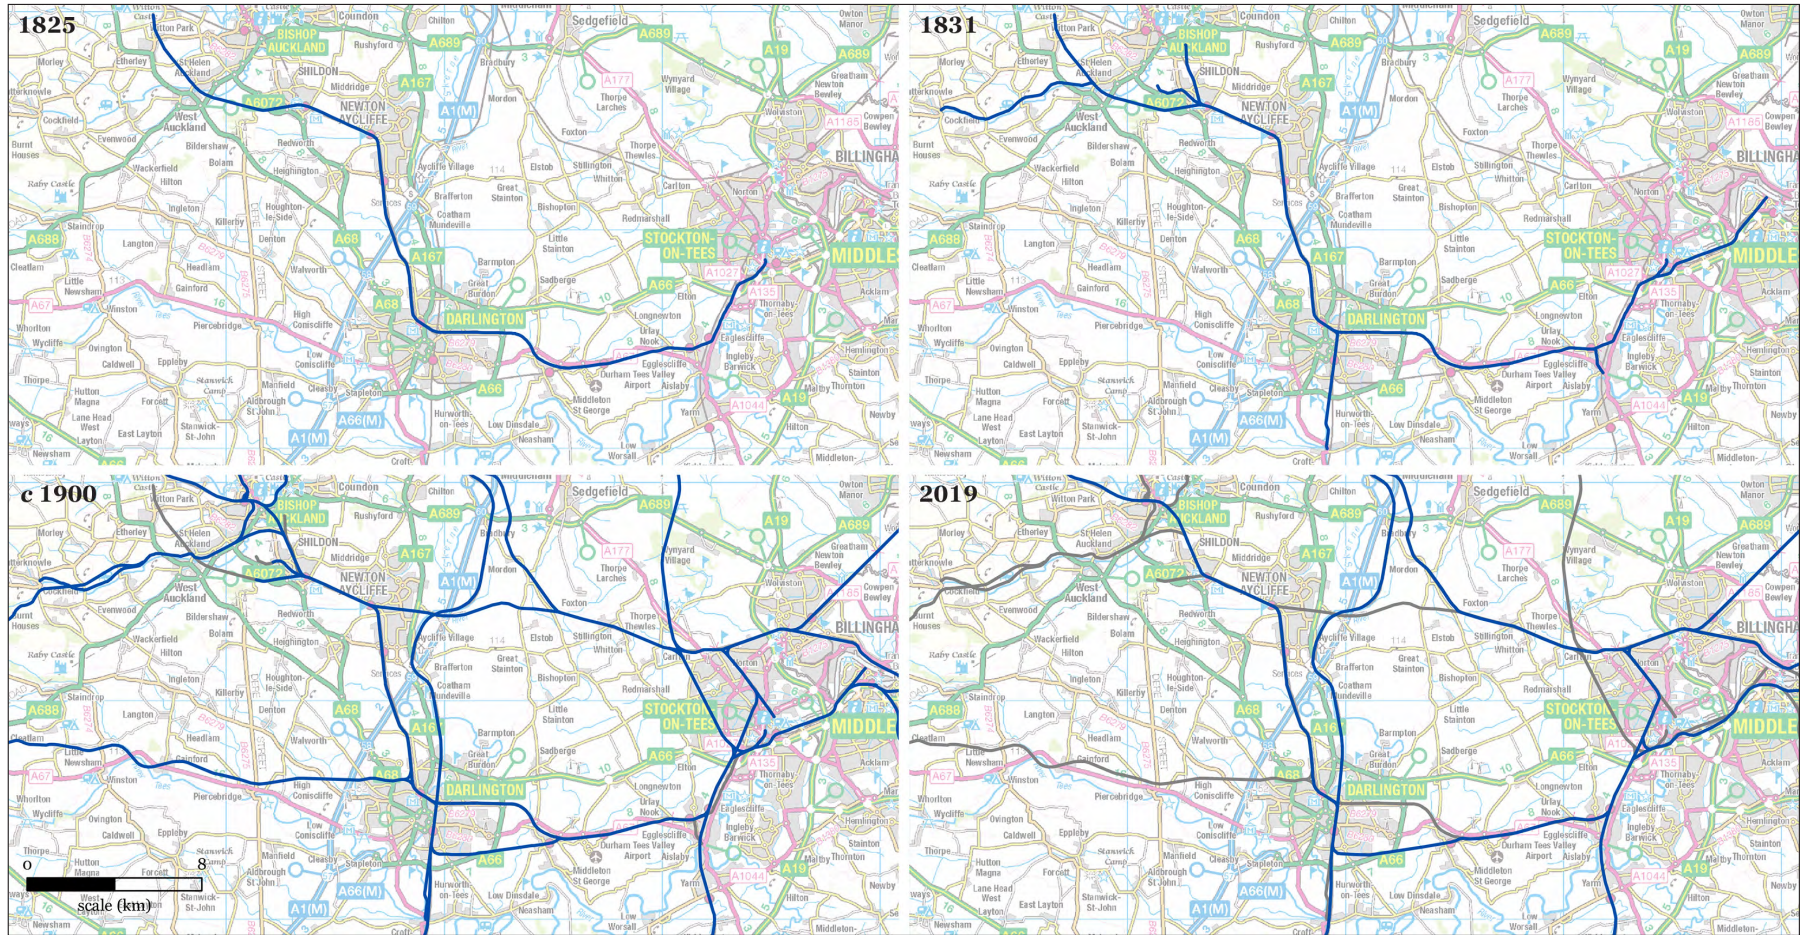
Fig 73: The main phases of railway growth and retraction in and around the Stockton and Darlington area. Active lines are in blue, the sections of line that became disused are in grey. Base map © Crown Copyright and database right 2019. All rights reserved. Ordnance Survey Licence number 100019088.
