# Stockton and Darlington Railway Heritage Action Zone Aerial Investigation & Mapping Report

**STOCKTON AND DARLINGTON RAILWAY  
HERITAGE ACTION ZONE**

**Aerial Investigation & Mapping Report**

NGR: NZ 290 156

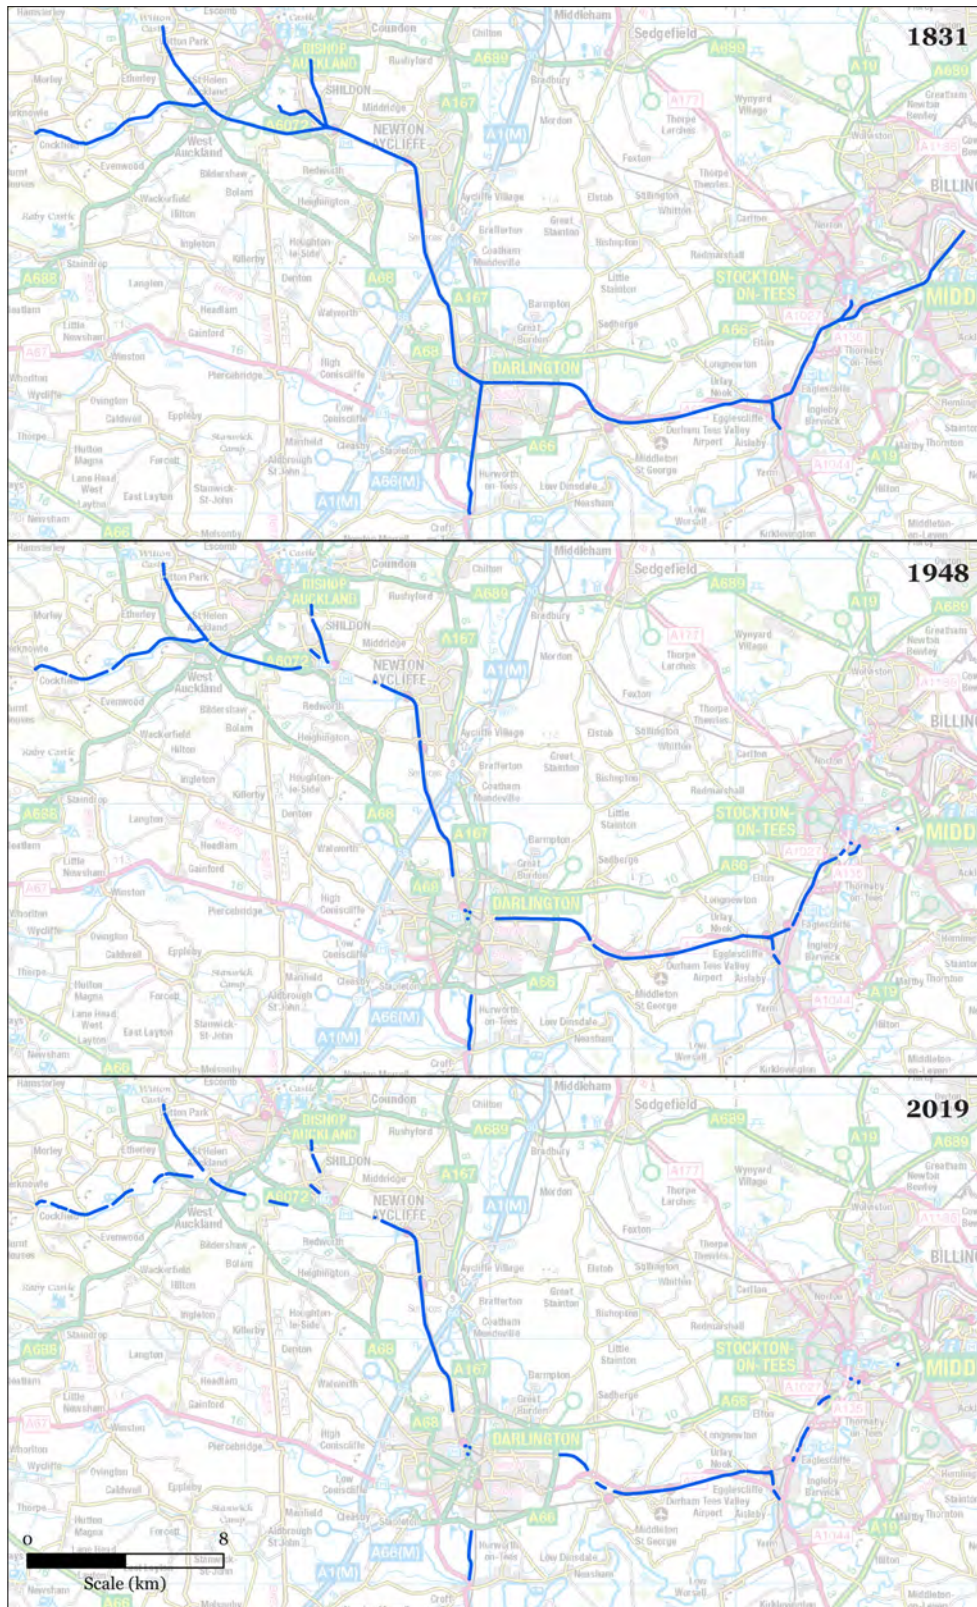
Fig 74: Of the original S&DR core network, much of the structural and earthwork remains were intact in some form on the 1948 aerial photographs. Since the 1940s, the physical remains of this core network have continued to gradually disappear. Archaeological mapping © Historic England; Base map © Crown Copyright and database right 2019. All rights reserved. Ordnance Survey Licence number 100019088.

Despite the alteration and closures that happened to the S&DR over nearly two centuries, a remarkable amount of the original infrastructure survives as earthwork embankments and cuttings, buildings in the form of goods sheds or taverns, or as other structural features including bridges and culverts (Fig 74).

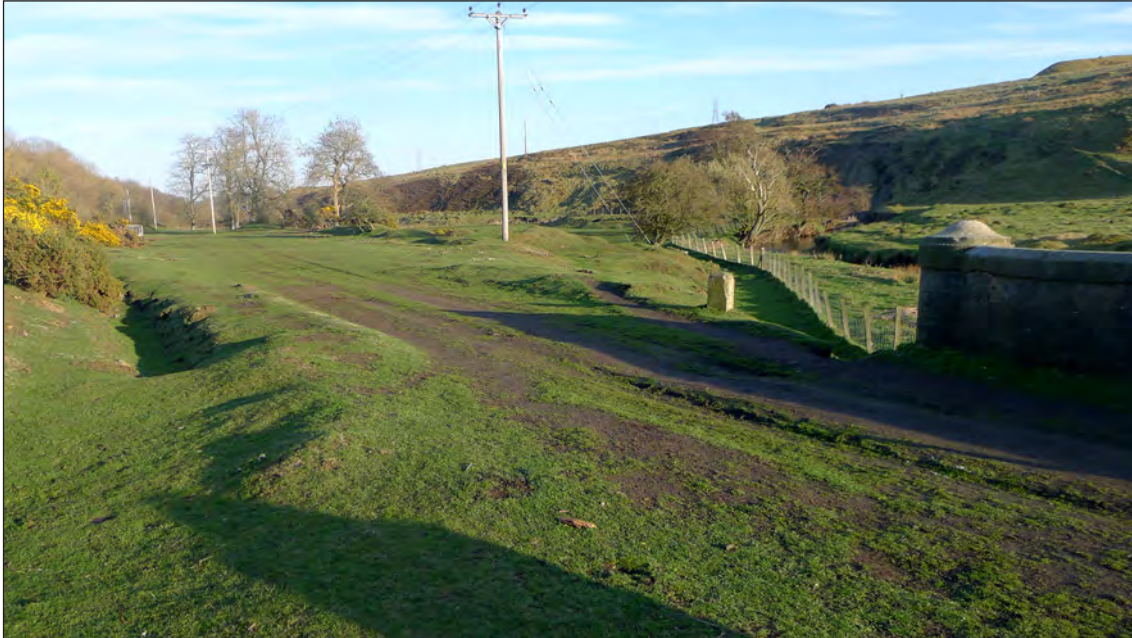
*Fig 75: The Haggerleases Branch railway follows the River Gaunless in the valley bottom. March 2019 © Historic England.*

The interaction between the railway and the landscape was complex – the topography dictated where the railway would be built, and the railway brought land-use change as it aided the development of local industries. Along the Haggerleases Branch, the railway hugged the north bank of the River Gaunless in the valley bottom as far as West Auckland (Fig 75), with numerous collieries feeding into the railway by tramways and road. Between Witton Park and Shildon, the topography was too steep to traverse by early steam-locomotives, so the inclines

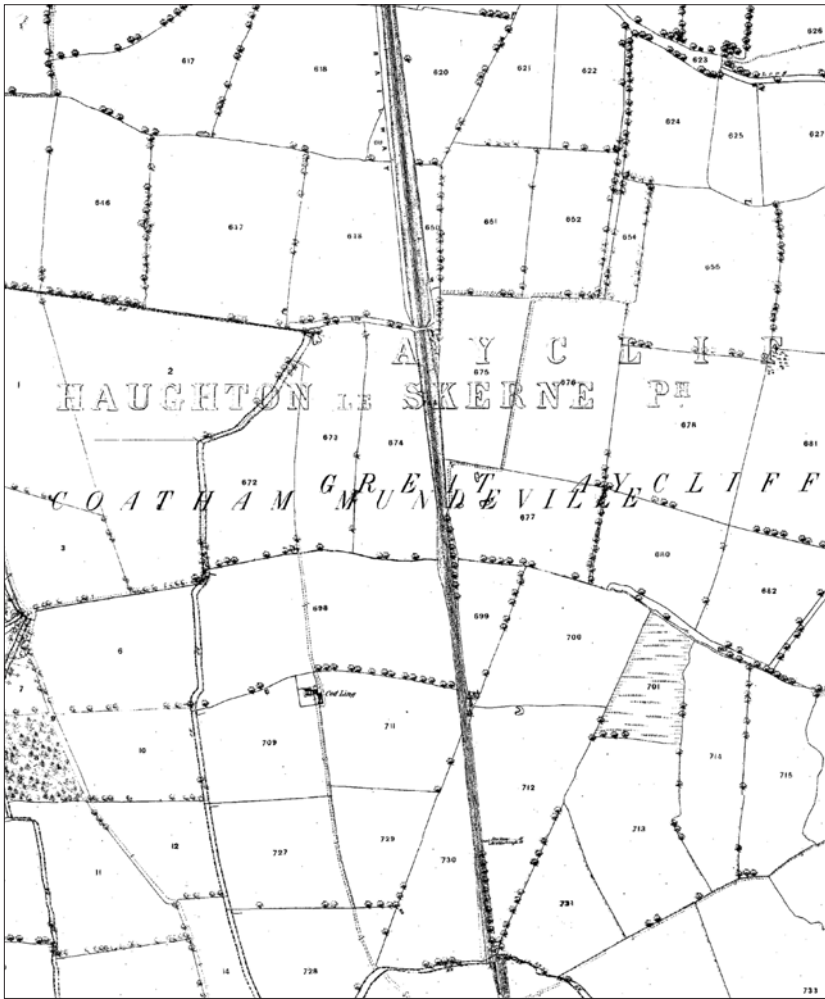
*Fig 76: Most of the 1825 railway simply sliced through the pre-existing agricultural landscape of post medieval enclosure. © and database right Crown Copyright and Landmark Information Group Ltd (All rights reserved 2019) Licence numbers 000394 and TP0024.*

The impact on the agricultural landscape is particularly evident from Witton Park to Middlesbrough. The early edition OS maps show where fields have clearly been cut in half by the railway (Fig 76). This was one reason why the railway needed an Act of Parliament for its construction. In some sections, the course of the railway was slightly less invasive. Between Low Goosepool and the Yarm Branch, the line extended parallel to a pre-existing road, therefore impacting the field systems less. Similarly, much of the line between the Yarm and Bowesfield junctions also ran alongside pre-existing roads, though this section of the railway was short-lived, closing in 1853. Where the railway did bisect pre-existing fields, numerous accommodation bridges or crossings had to be constructed to allow farm traffic access to land on either side.

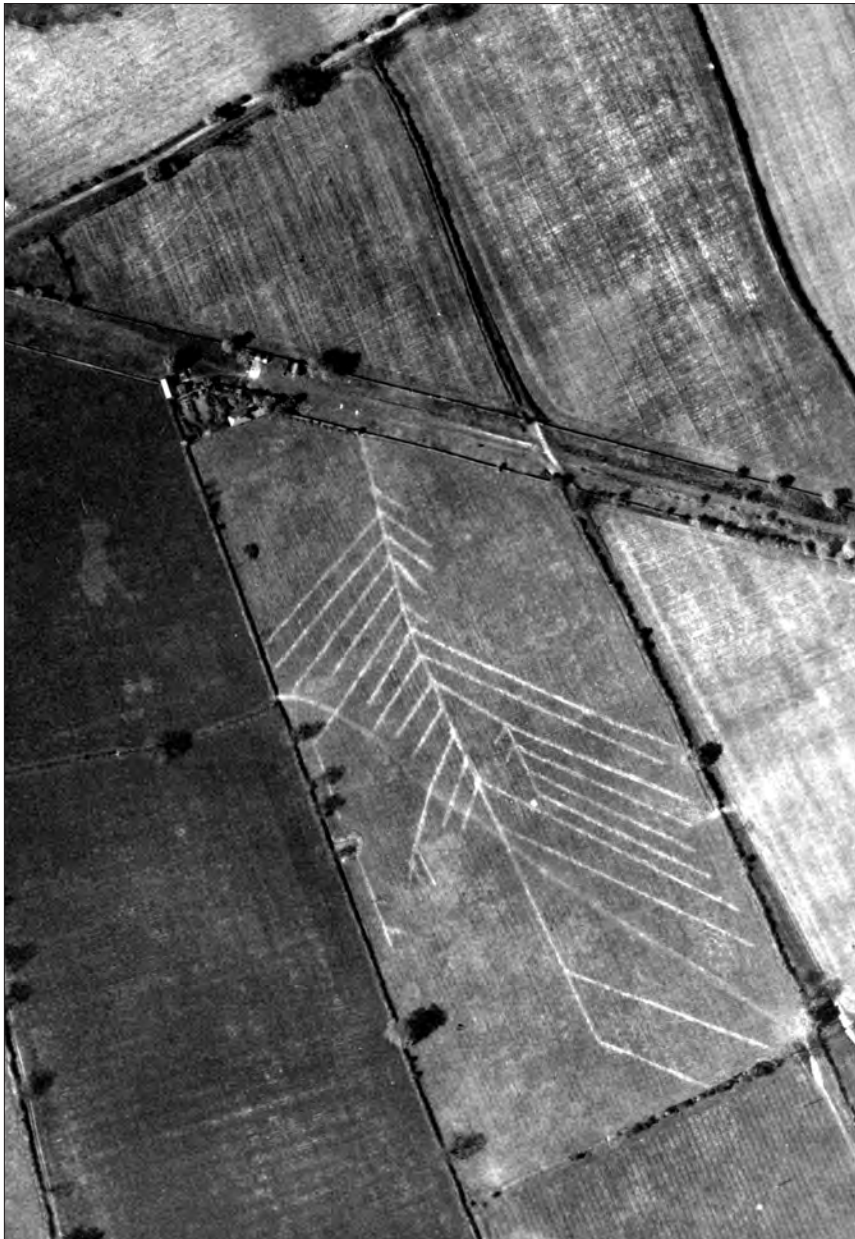
*Fig 77: Narrow ridge and furrow can be seen in fields to the north and south of the railway at Bankfoot Farm. Despite the common orientation of the rig, this cultivation post-dates the railway. The lighter pattern of marks, centre of image, relate to recent field drains. Detail of SfM RAF/58/B/37 V 5029-5379 17-MAY-1948 Historic England Archive (RAF Photography).*

In most instances, the earthwork evidence more often shows different directions of ploughing on either side of the railway, such as north of Whiley Hill (Fig 78). Most of the post-medieval ridge and furrow mapped by the project was narrow in form. The regularity and spacing (generally between 2.5m and 4m in width) of this

narrow ridge and furrow is suggestive of ploughs being pulled by steam traction engines, a technology which did not become the norm until the mid-19th century. Therefore, this would suggest that most of this form of cultivation post-dates the railway. There are however instances, although not physically associated with the railway, where the ridges and furrows are less regular and more widely spaced. Dating these is more difficult.

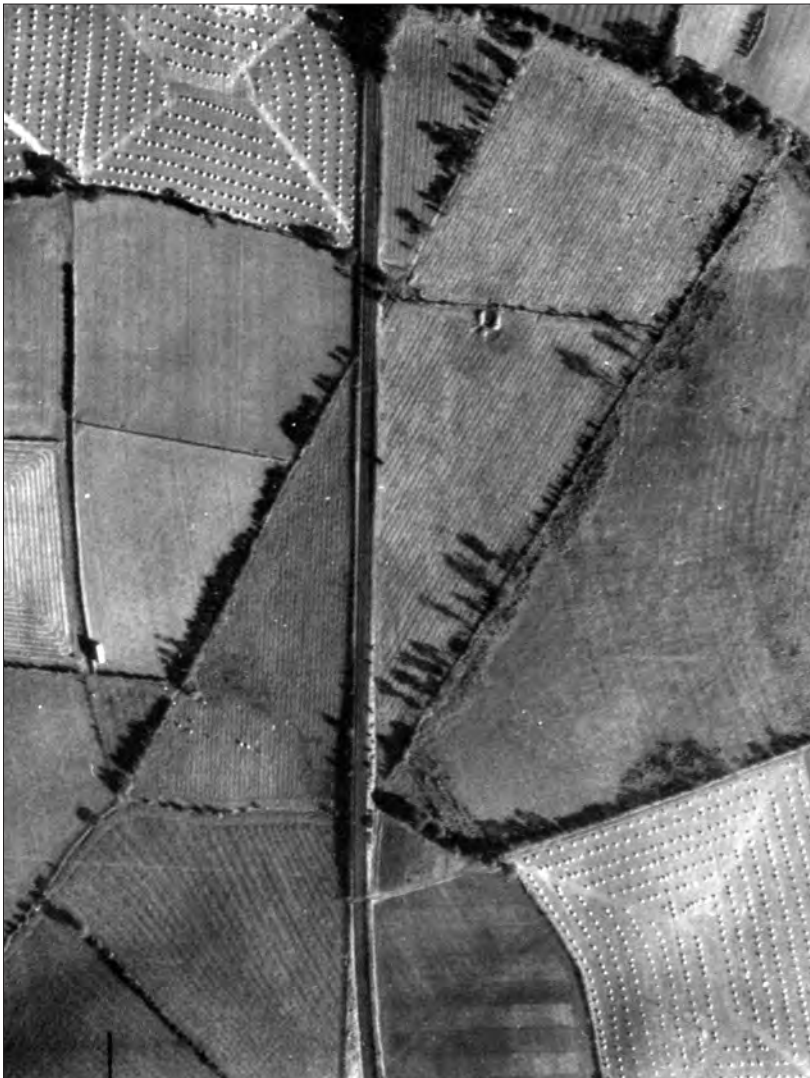
*Fig 78: North of Whiley Hill, post medieval narrow and straight ridge and furrow can be seen extending in different directions on either side of the railway, suggesting this cultivation post-dates the railway. The fields to the bottom of the image however show curving medieval ridge and furrow bisected by the railway. Detail of RAF/543/396 F22 132 SEP-1958 Historic England Archive (RAF Photography).*

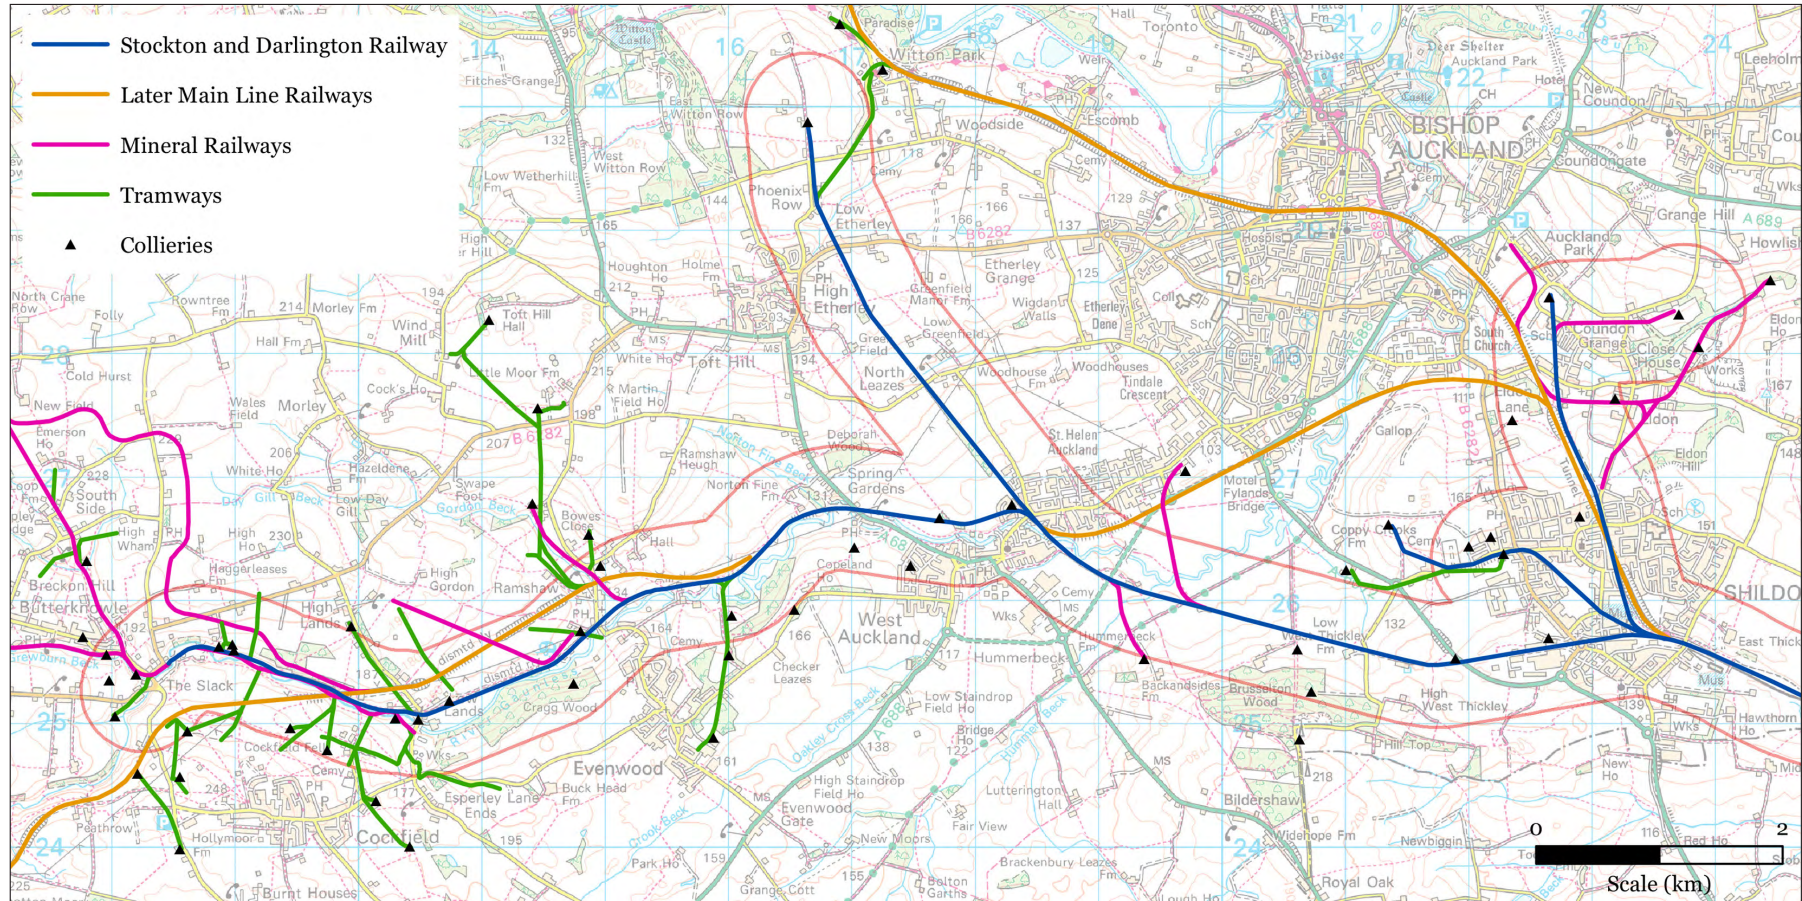
Fig 79: Most of the collieries in the region were linked to the S&DR by a network of tramways and mineral railways. Base map © Crown Copyright and database right 2019. All rights reserved. Ordnance Survey Licence number 100019088.

Although the railway was put in place primarily to serve the pre-existing collieries, it afterwards became the focus for exploiting more seams, often at quite some distance from it (see Fig 64). Logistically, it made sense that these were linked into the S&DR to allow the transportation of the coal. This resulted in numerous mineral railways to the larger collieries, and a complex network of tramways serving others (Fig 79). Of the few collieries in the region that were not linked to the railway, they either had branch lines to other later railways or were short-lived small late-19th/early-20th

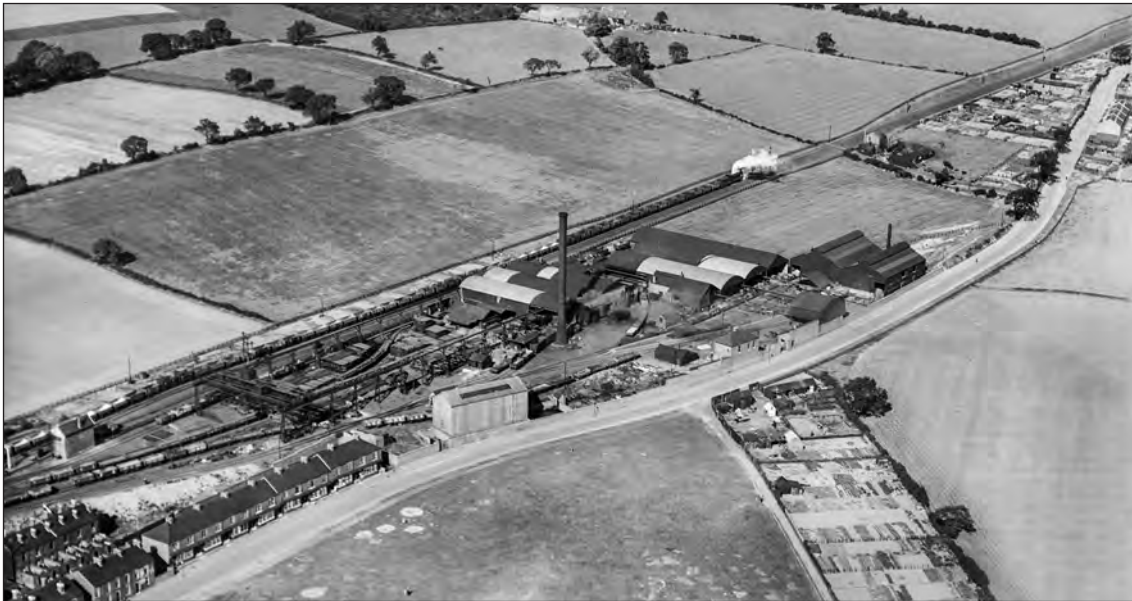
*Fig 80: This 1929 oblique photograph of the S&DR south of Drinkfield provides a rare and detailed record of part of the railway line and associated structures. EPW029511 SEP-1929 © Historic England Archive. Aerofilms Collection.*

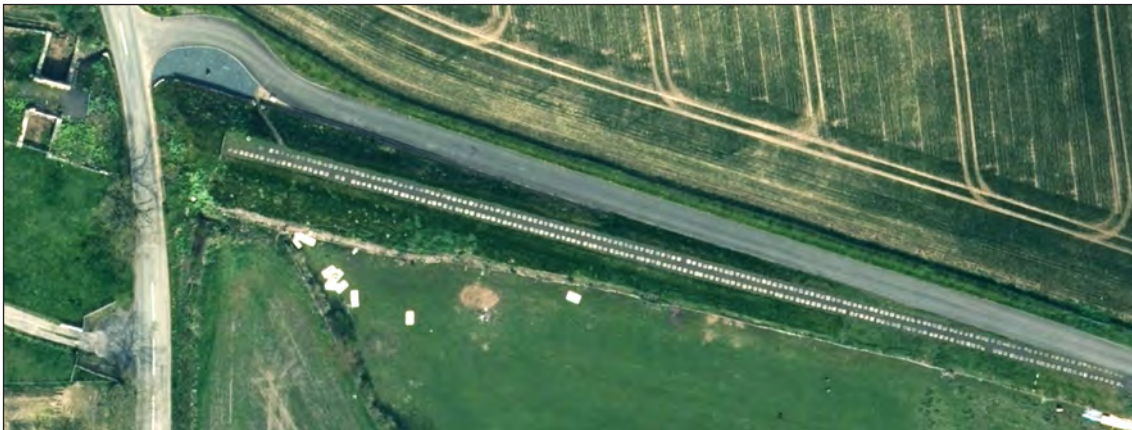
*Fig 81: Where the S&DR spanned Brusselton Lane is the only place in the project where the original stone sleepers were visible on aerial photographs. They were exposed recently by a local volunteer group and are not visible on historic aerial photography. Detail of NZ2125 06-MAY-2016 © Bluesky International/Getmapping PLC.*

This is also the only location on the S&DR line where any of the original stone railway sleepers are visible on aerial photographs (AIM41; Fig 18). The Brusselton Incline Group exposed the stone blocks in 2014 by clearing the surrounding vegetation (*ibid*, 12); they are clearly visible on recent aerial photographs (*see* Fig 81). The stretch is included within the scheduling NHLE 1002315.

With the exception of earthwork features drawn from lidar (this data typically dates to the mid-2000s), the latest source used for a condition statement was the orthophotography supplied through the Aerial Photography for Great Britain (APGB) agreement by Next Perspectives, which date to 2015-2016. The usefulness of this photography varied due to the nature of the features that were being assessed. For example, in many instances it was impossible to state whether the original boundaries remained extant due to the growth of vegetation. Similarly, the location of occupation crossing gates were often beneath tree and shrub growth on this most recent photography. However, the clarity of the photography, for some of the area up to 12.5cm resolution, made the detail of features that were visible exceptional. This is demonstrated with the visibility of stone sleepers on the Brusselton Incline (Fig 81).

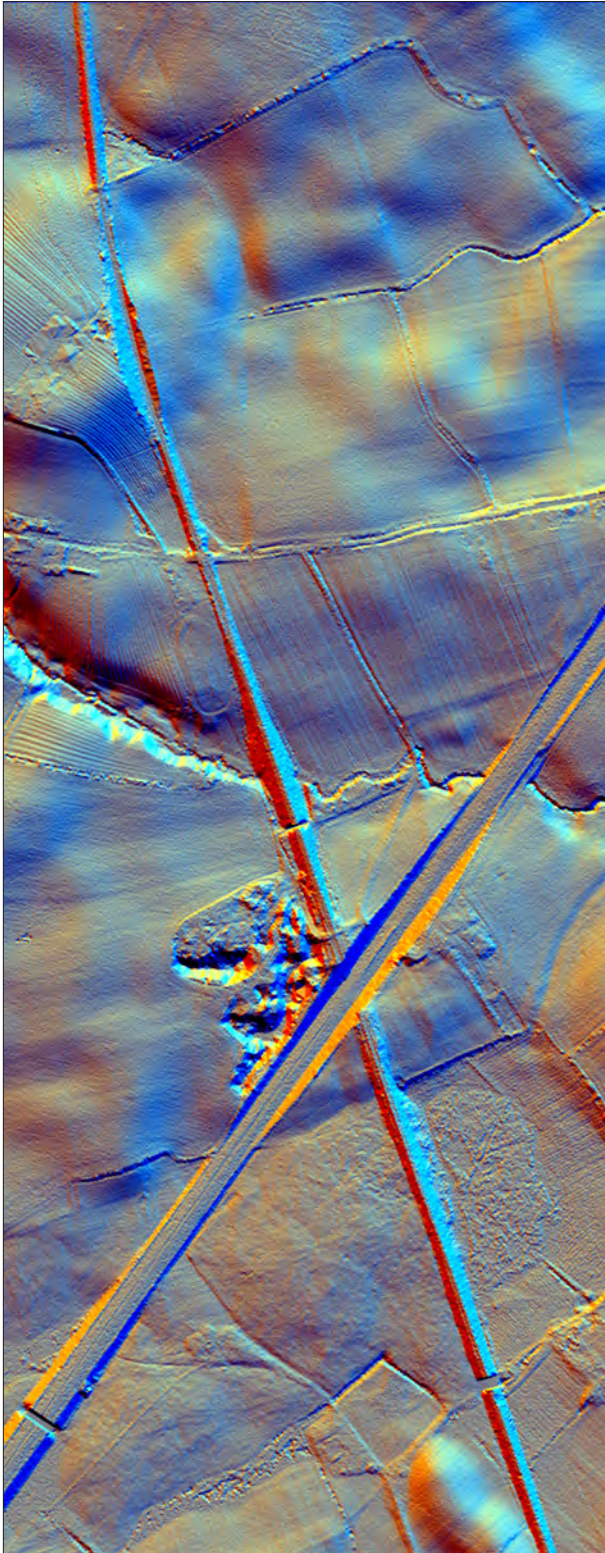
*Fig 82: Many of the original railway embankments and cuttings remain intact and in use, as with this section, west of Coatham Mundeville (top left to bottom right). LIDAR DTM 08-DEC-2008 © Historic England; source Environment Agency.*

Where cuttings and embankments remain as earthworks, lidar was particularly useful for mapping. Most of the project area was covered by 1m resolution lidar, and although this is not particularly useful for small earthworks, it was sufficient to map larger features. Crucially, since the demise of many sections of the railway, these cuttings and embankments have become largely overgrown with vegetation. As a result, the earthworks are only visible on the DTM lidar data, which has removed surface features to reveal the terrain.

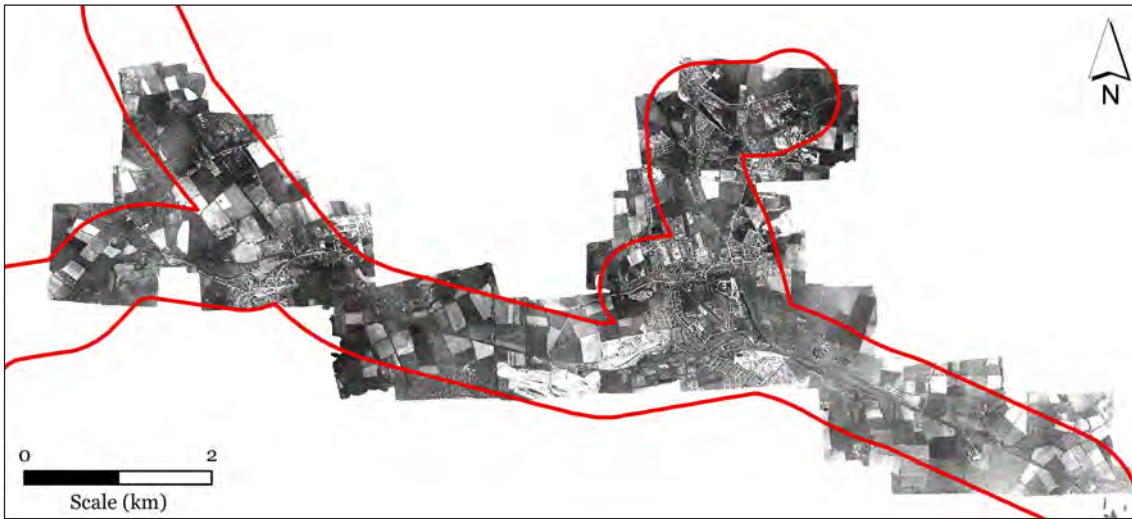
*Fig 83: A large portion of the western half of the railway was mapped from one single sortie of RAF photography, mosaicked and georeferenced using Structure from Motion. SfM RAF/58/B/37 V 5029-5379 17-MAY-1948 Historic England Archive (RAF Photography).*

To attempt to streamline this process, the project experimented with using Structure from Motion (SfM) to mosaic and rectify multiple vertical images at once. This is a digital photogrammetric method of rendering a single mosaicked orthophotograph from a series of images using Agisoft PhotoScan Professional 1.4.3. Control was taken from a combination of APGB orthophotography, lidar, and 5m height data. This process was undertaken on three sorties of photography, two of which were successful. The resulting orthophotographs had a locational accuracy ranging from 22cm to 70cm and were output at 25cm-30cm resolution. These accuracies are nominal figures, as it was discovered when overlaid with OS MasterMap data, that some areas of the orthophotographs were less accurate, simply because they required more control.

The result was that a nearly a quarter of the railway was mapped from a single sortie of photography, mosaicked into one raster image (Fig 83). The photogrammetry process worked best using good quality large-scale vertical aerial photographs with good clarity and no cloud cover. It was unsuccessful on grainy small-scale photographs where the detail was not enough to align the photos correctly. The scale of the photographs was such that it was not possible to create an accurate terrain model.

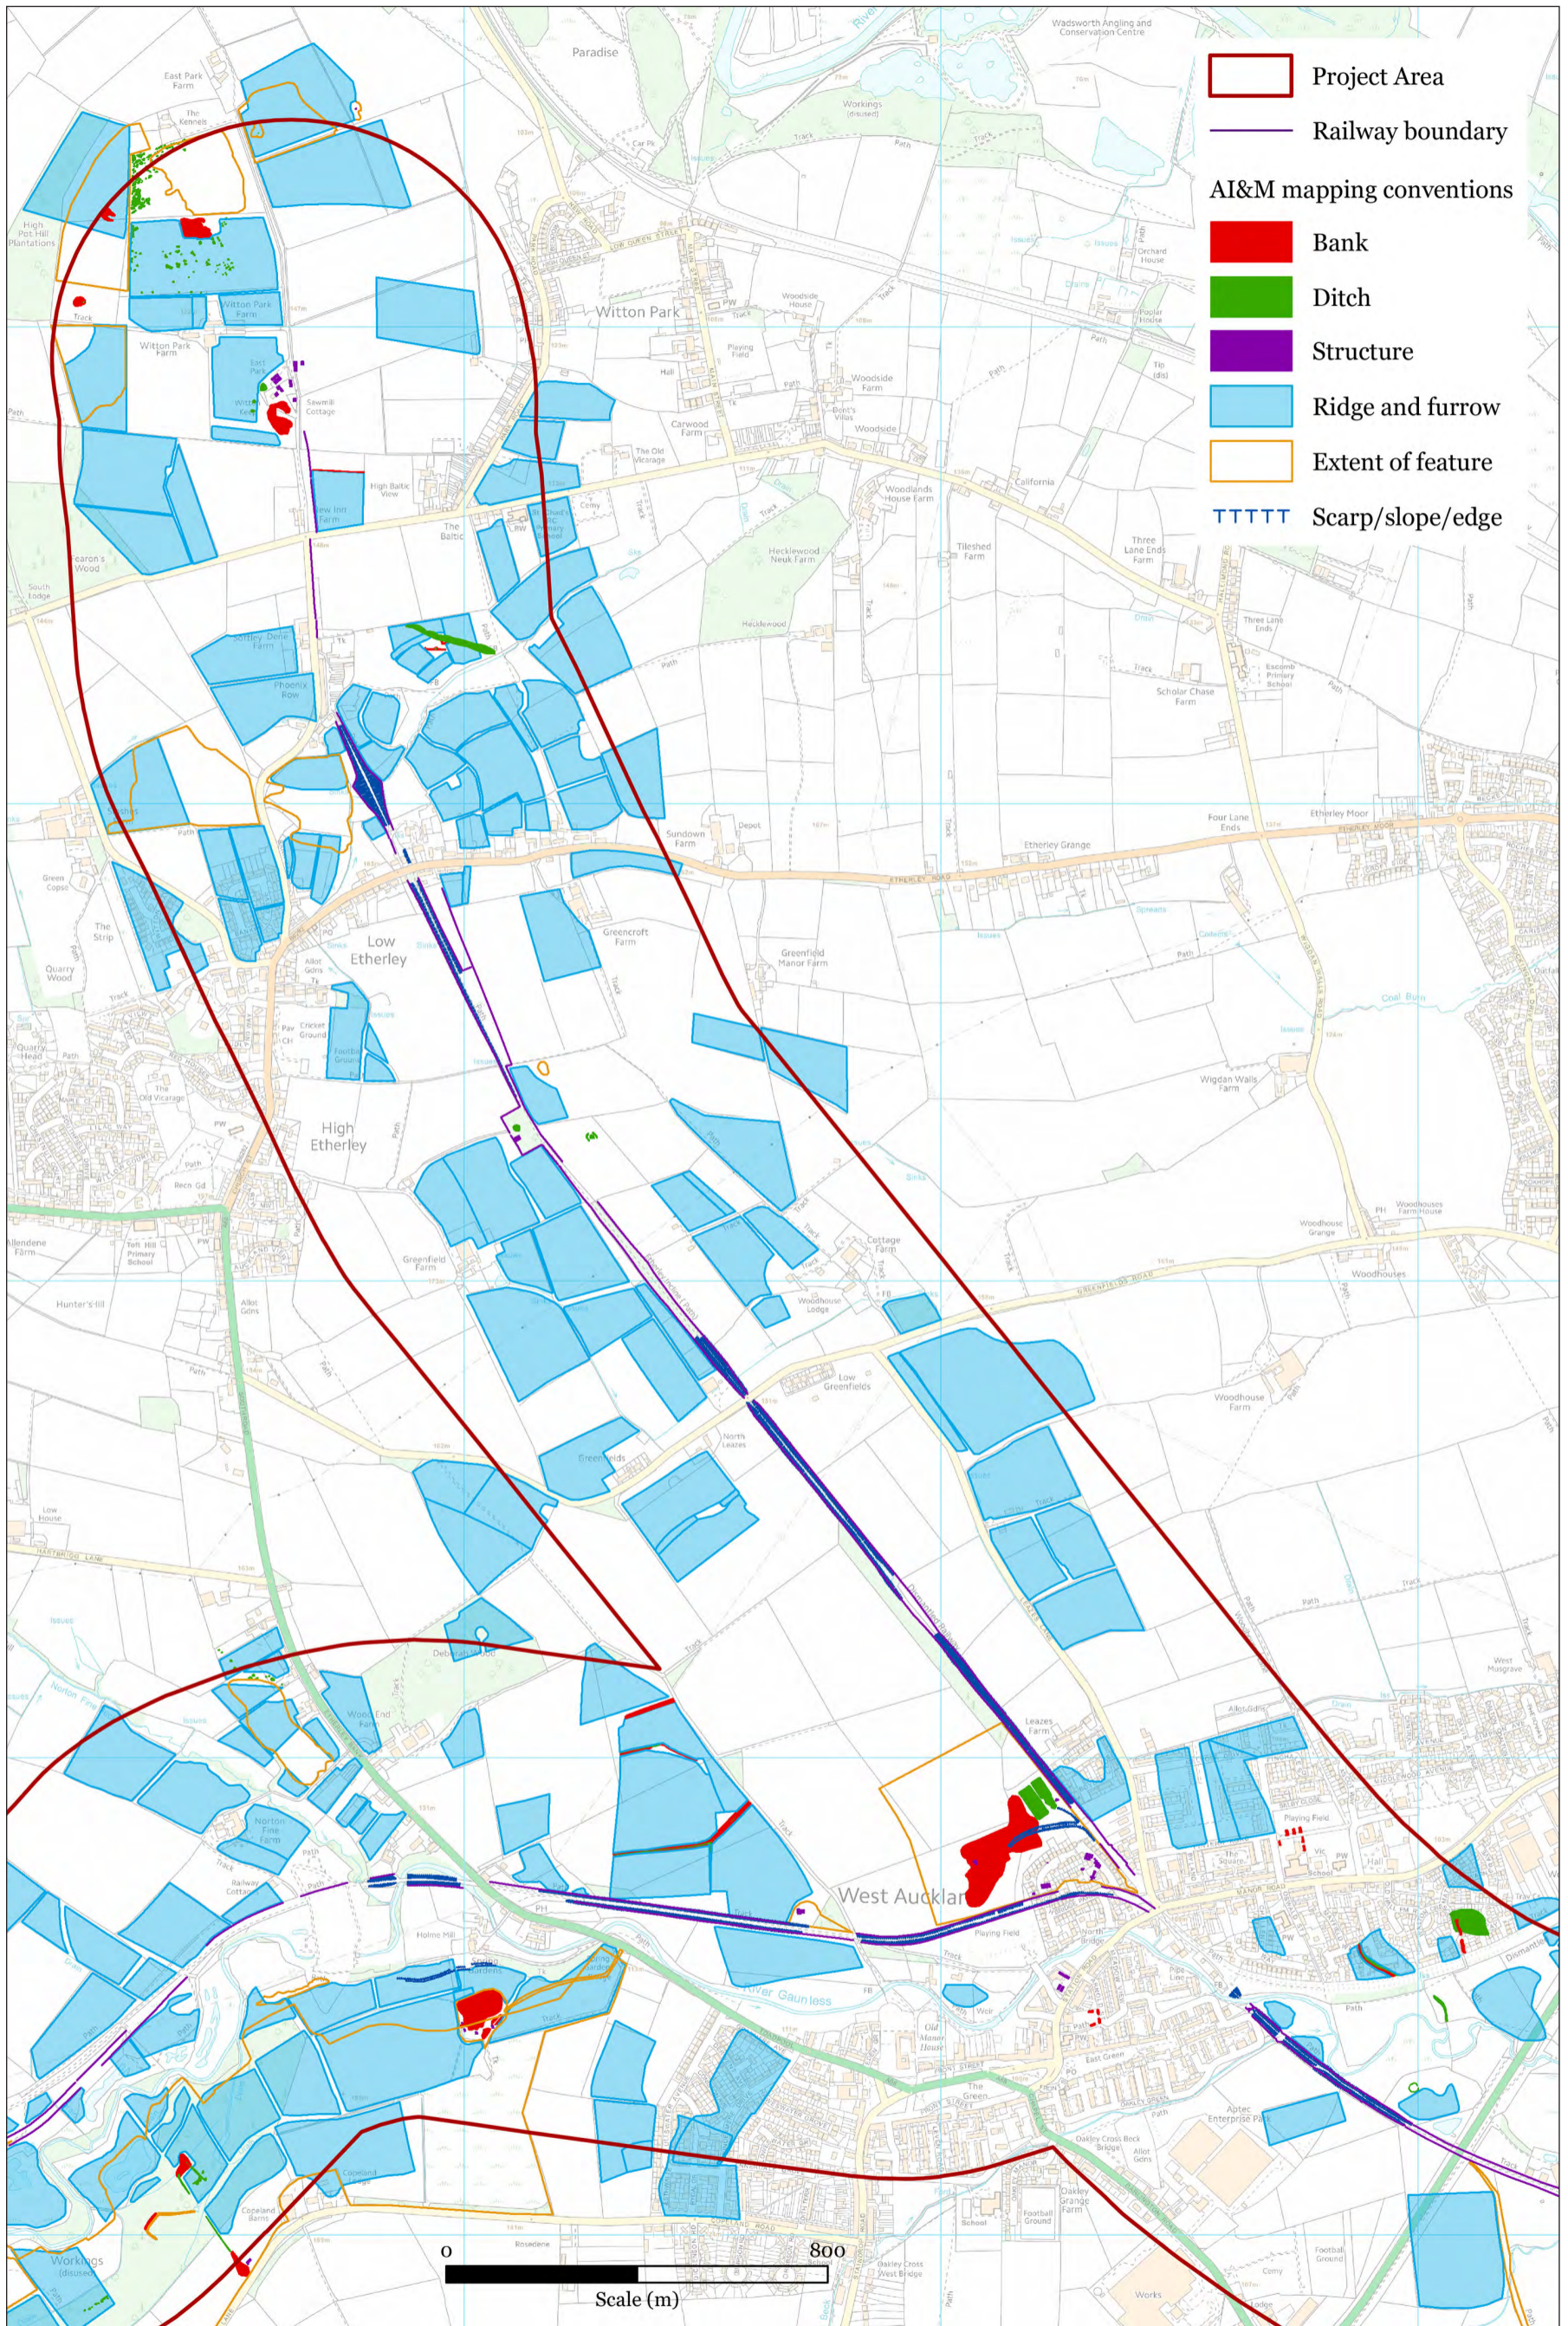
Fig 84: Archaeological and railway features visible on historic aerial photographs between Witton Park and the Gaunless Bridge. Archaeological mapping © Historic England; Base map © Crown Copyright and database right 2019.

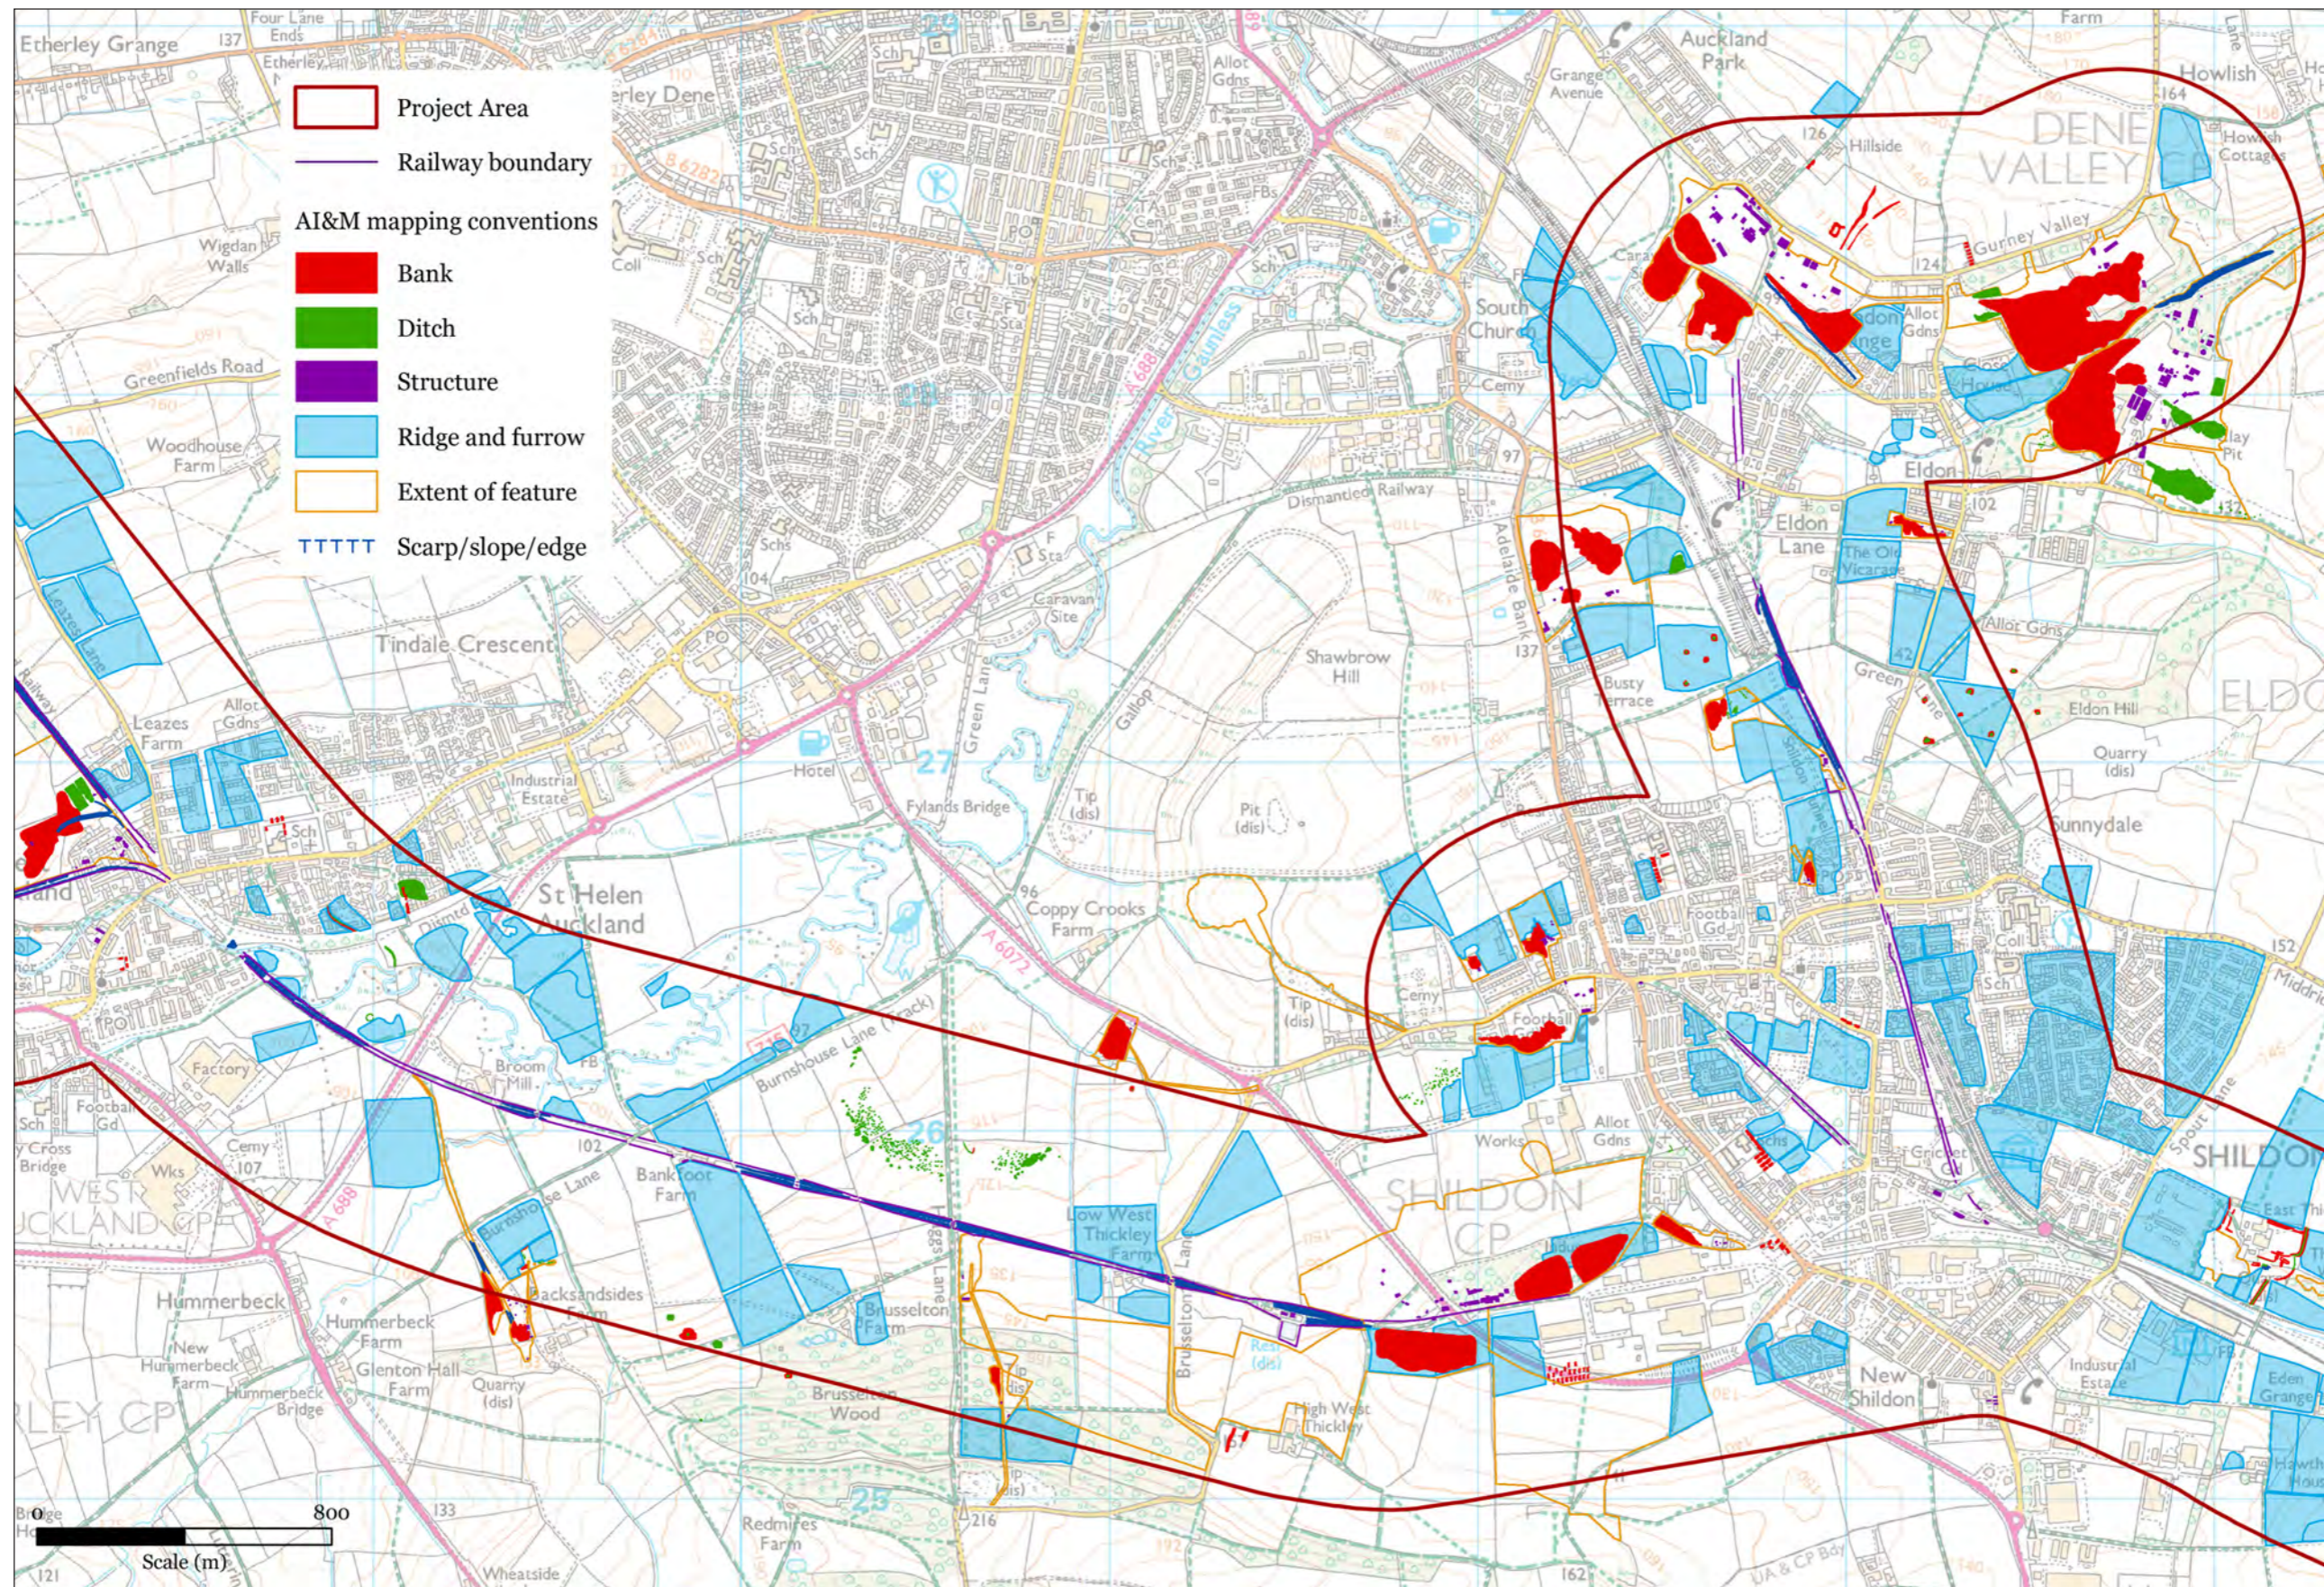
Fig 85: Archaeological and railway features visible on historic aerial photographs between Gaunless Bridge and Shildon, including the Black Boy Branch Line and Surtees Railway. Archaeological mapping © Historic England; Base map © Crown Copyright and database right 2019.
