# Stockton and Darlington Railway Heritage Action Zone Aerial Investigation & Mapping Report

**STOCKTON AND DARLINGTON RAILWAY  
HERITAGE ACTION ZONE**

**Aerial Investigation & Mapping Report**

NGR: NZ 290 156

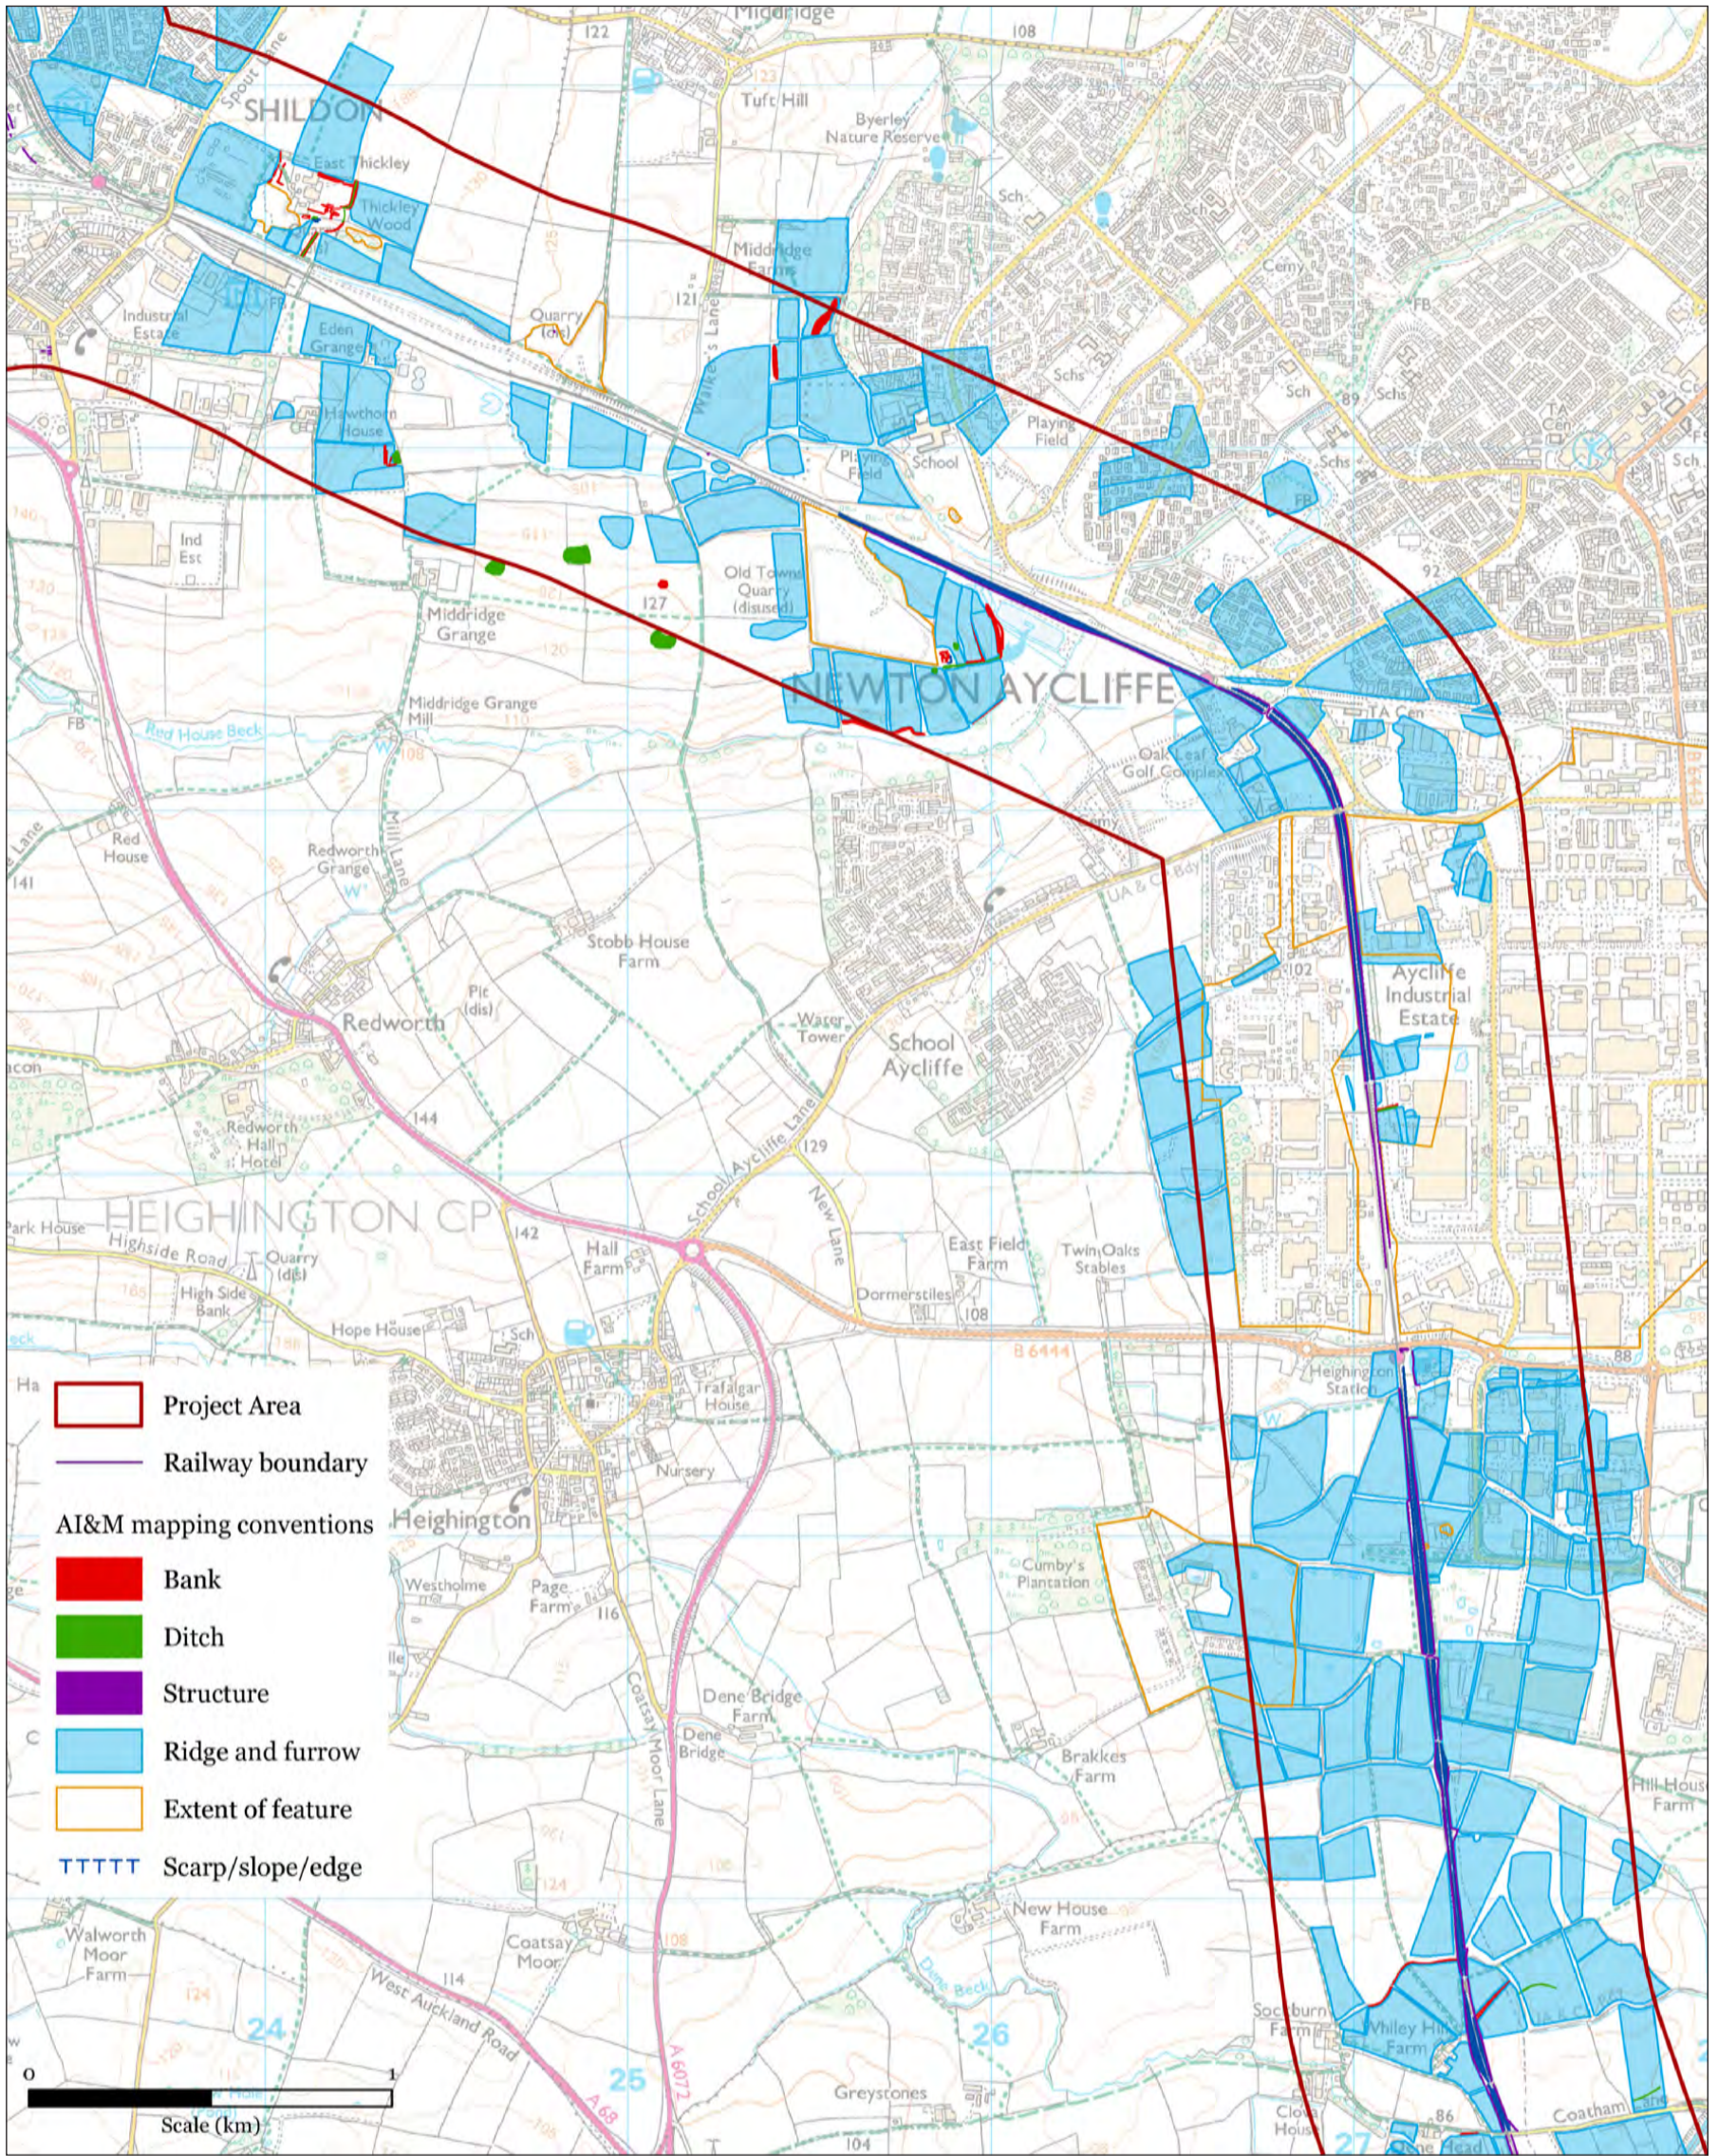
Fig 86: Archaeological and railway features visible on historic aerial photographs between Shildon and Coatham Lane. Archaeological mapping © Historic England; Base map © Crown Copyright and database right 2019.

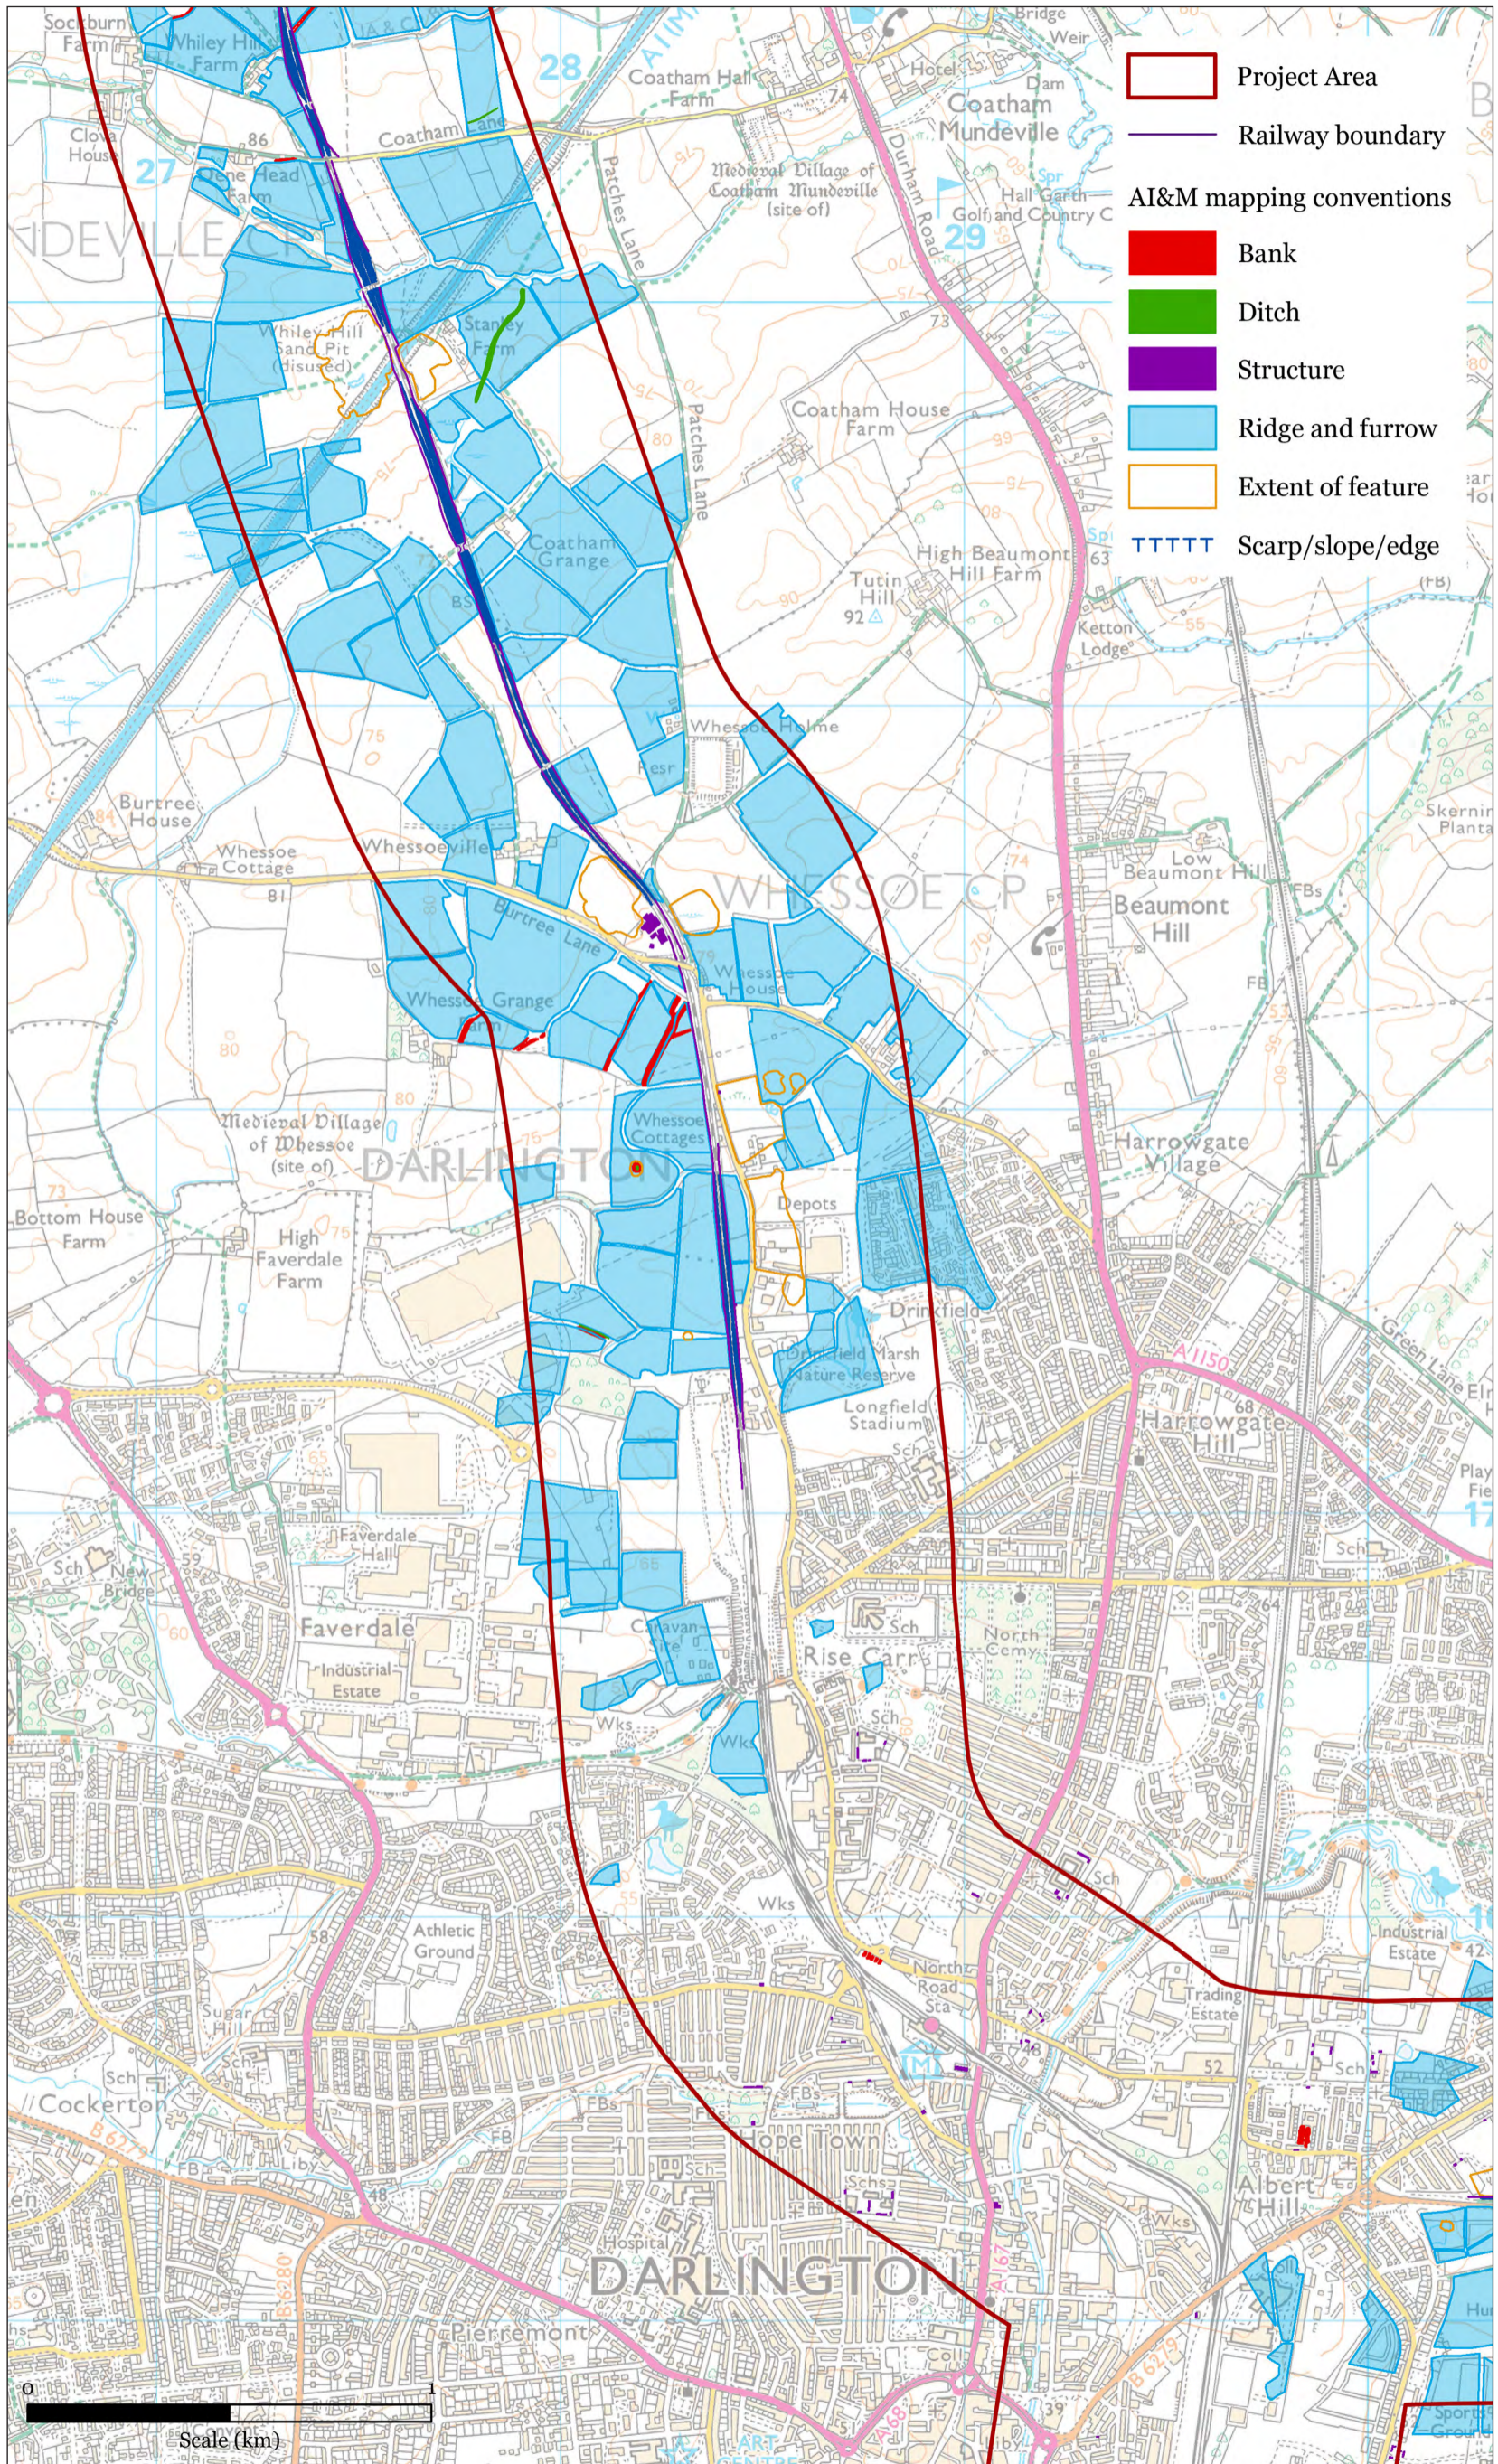
Fig 87: Archaeological and railway features visible on historic aerial photographs between Coatham Lane and Darlington. Archaeological mapping © Historic England; Base map © Crown Copyright and database right 2019.

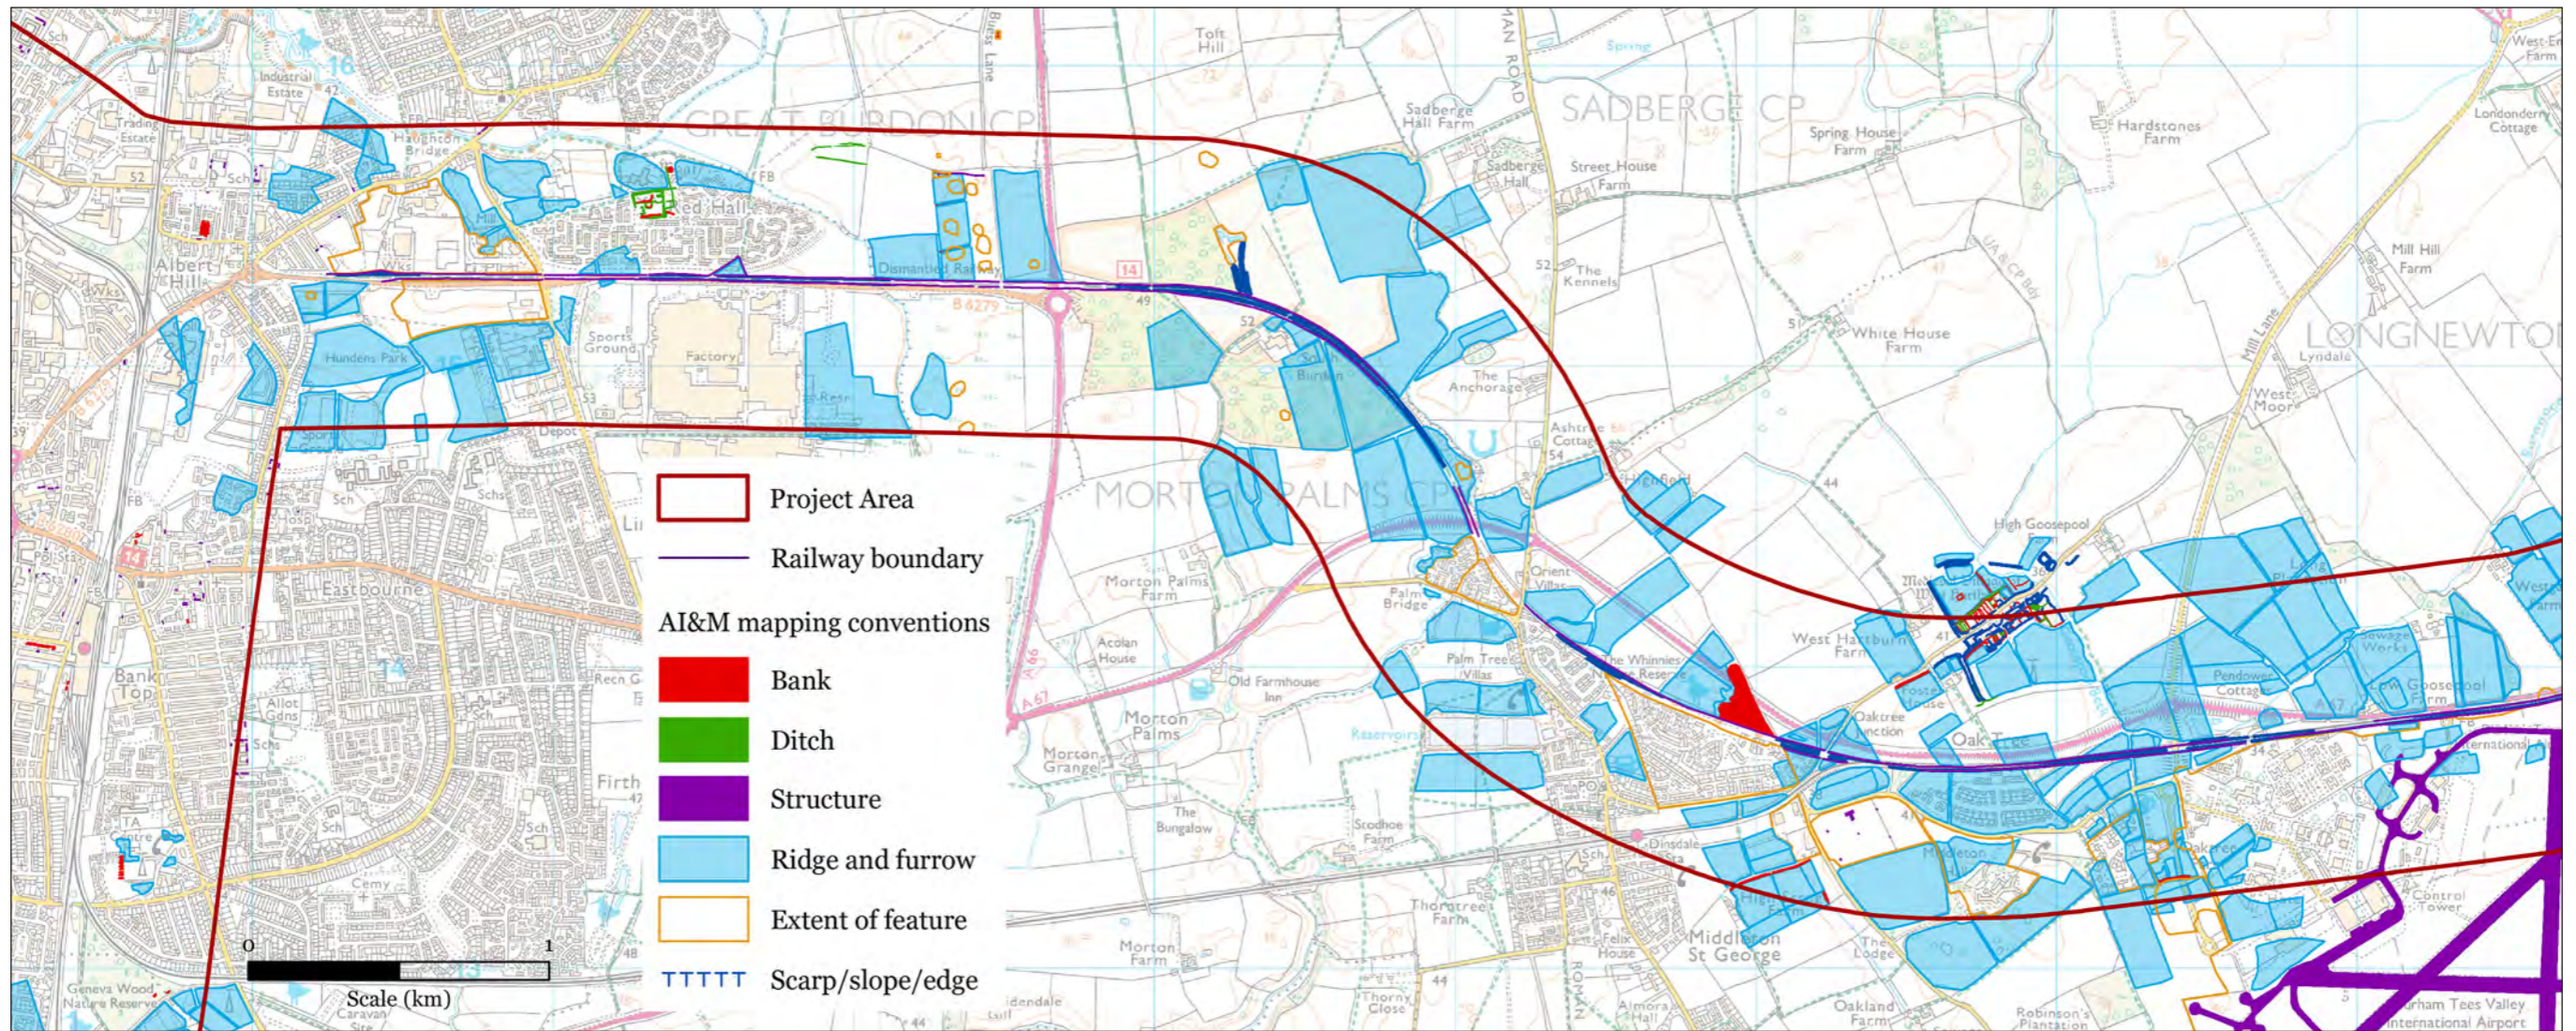
Fig 88: Archaeological and railway features visible on historic aerial photographs between Darlington and Low Goosepool Farm. Archaeological mapping © Historic England; Base map © Crown Copyright and database right 2019.

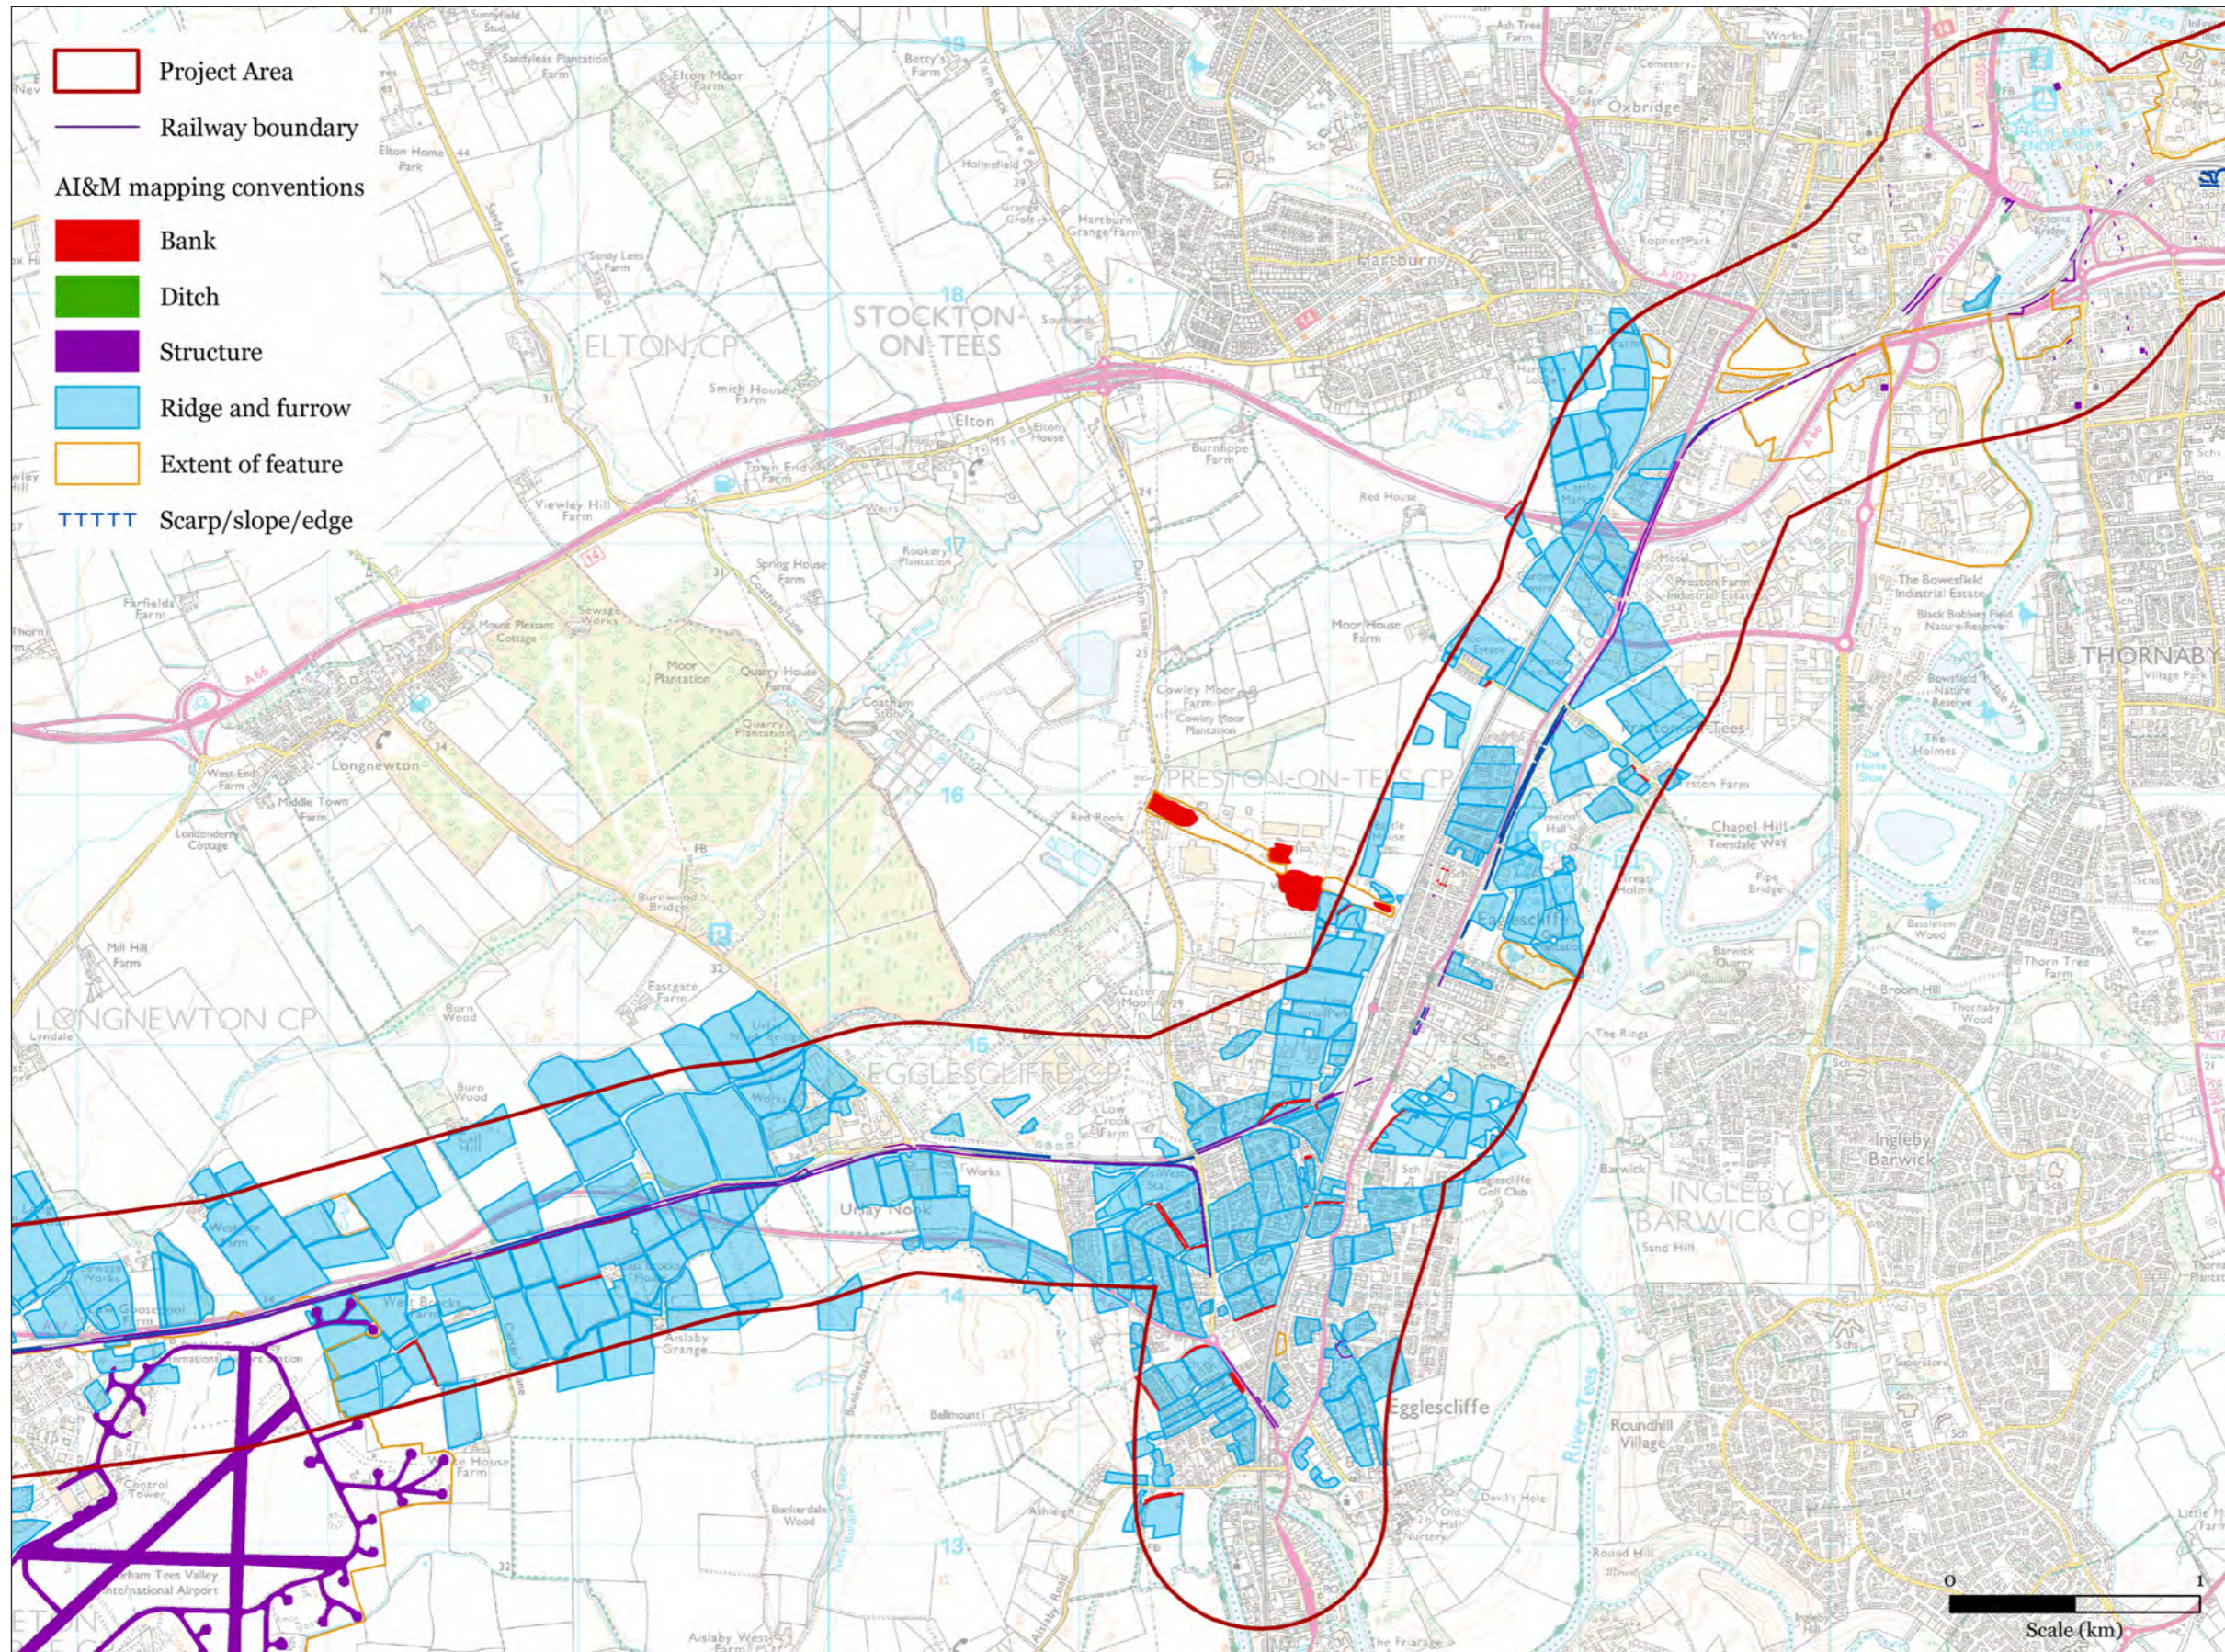
Fig 89: Archaeological and railway features visible on historic aerial photographs between Low Goosepool Farm and Stockton-on-Tees, including the Yarm Branch Line. Archaeological mapping © Historic England; Base map © Crown Copyright and database right 2019.

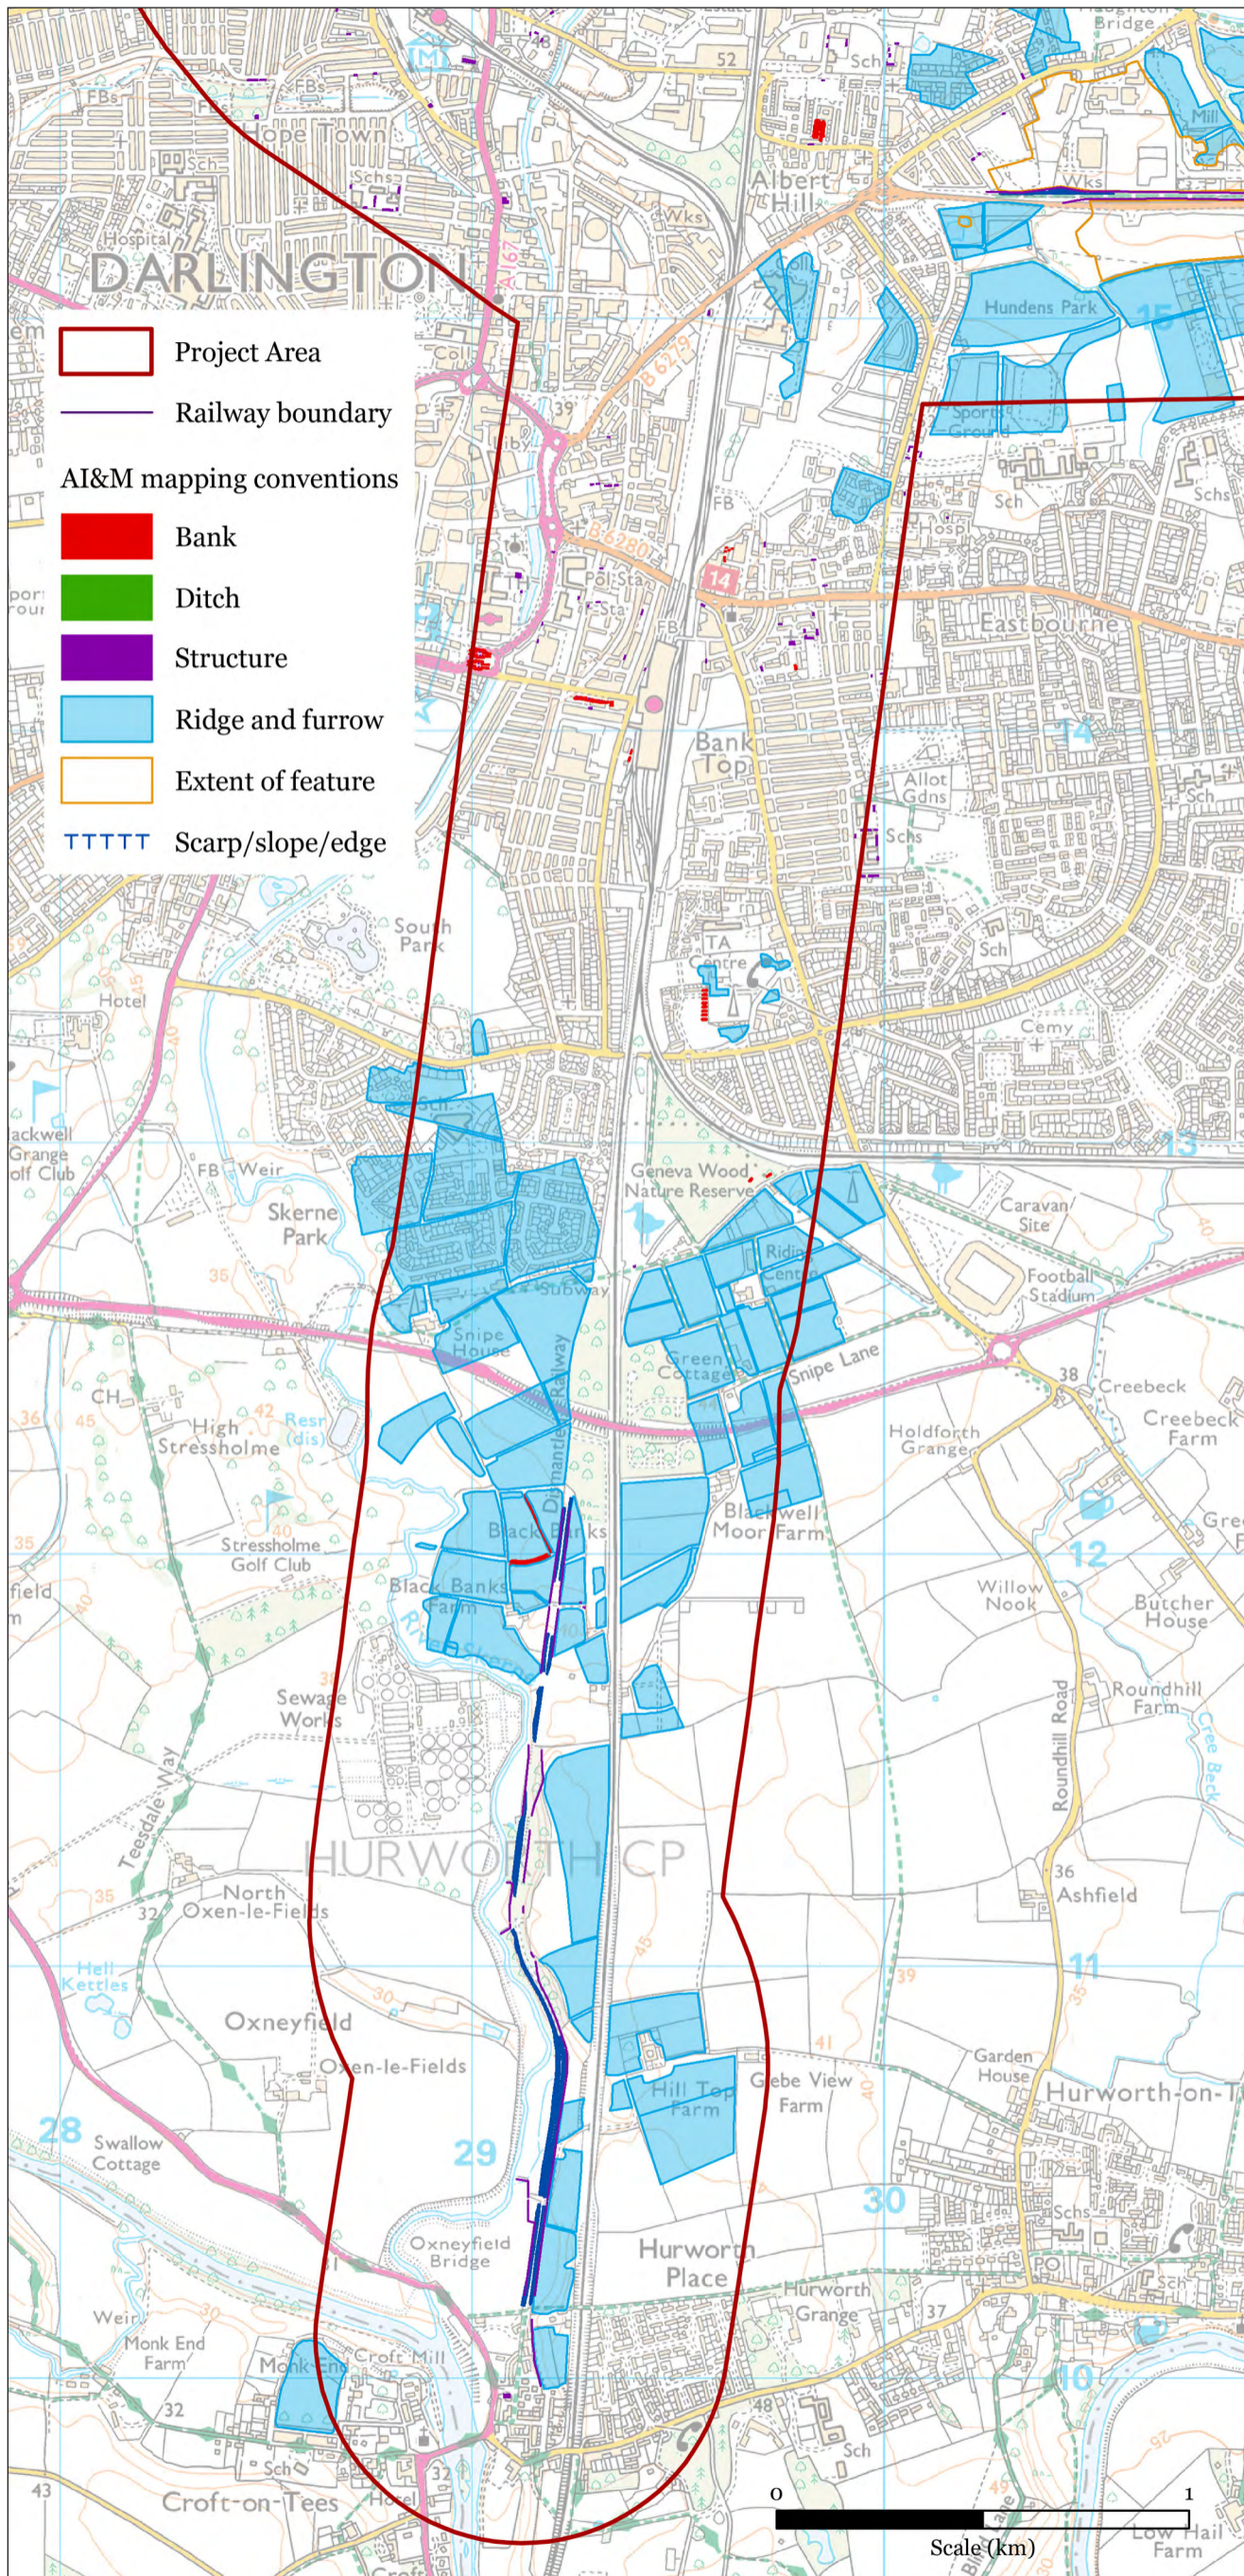
Fig 90: Archaeological and railway features visible on historic aerial photographs along the Croft Branch Line. Archaeological mapping © Historic England; Base map © Crown Copyright and database right 2019.

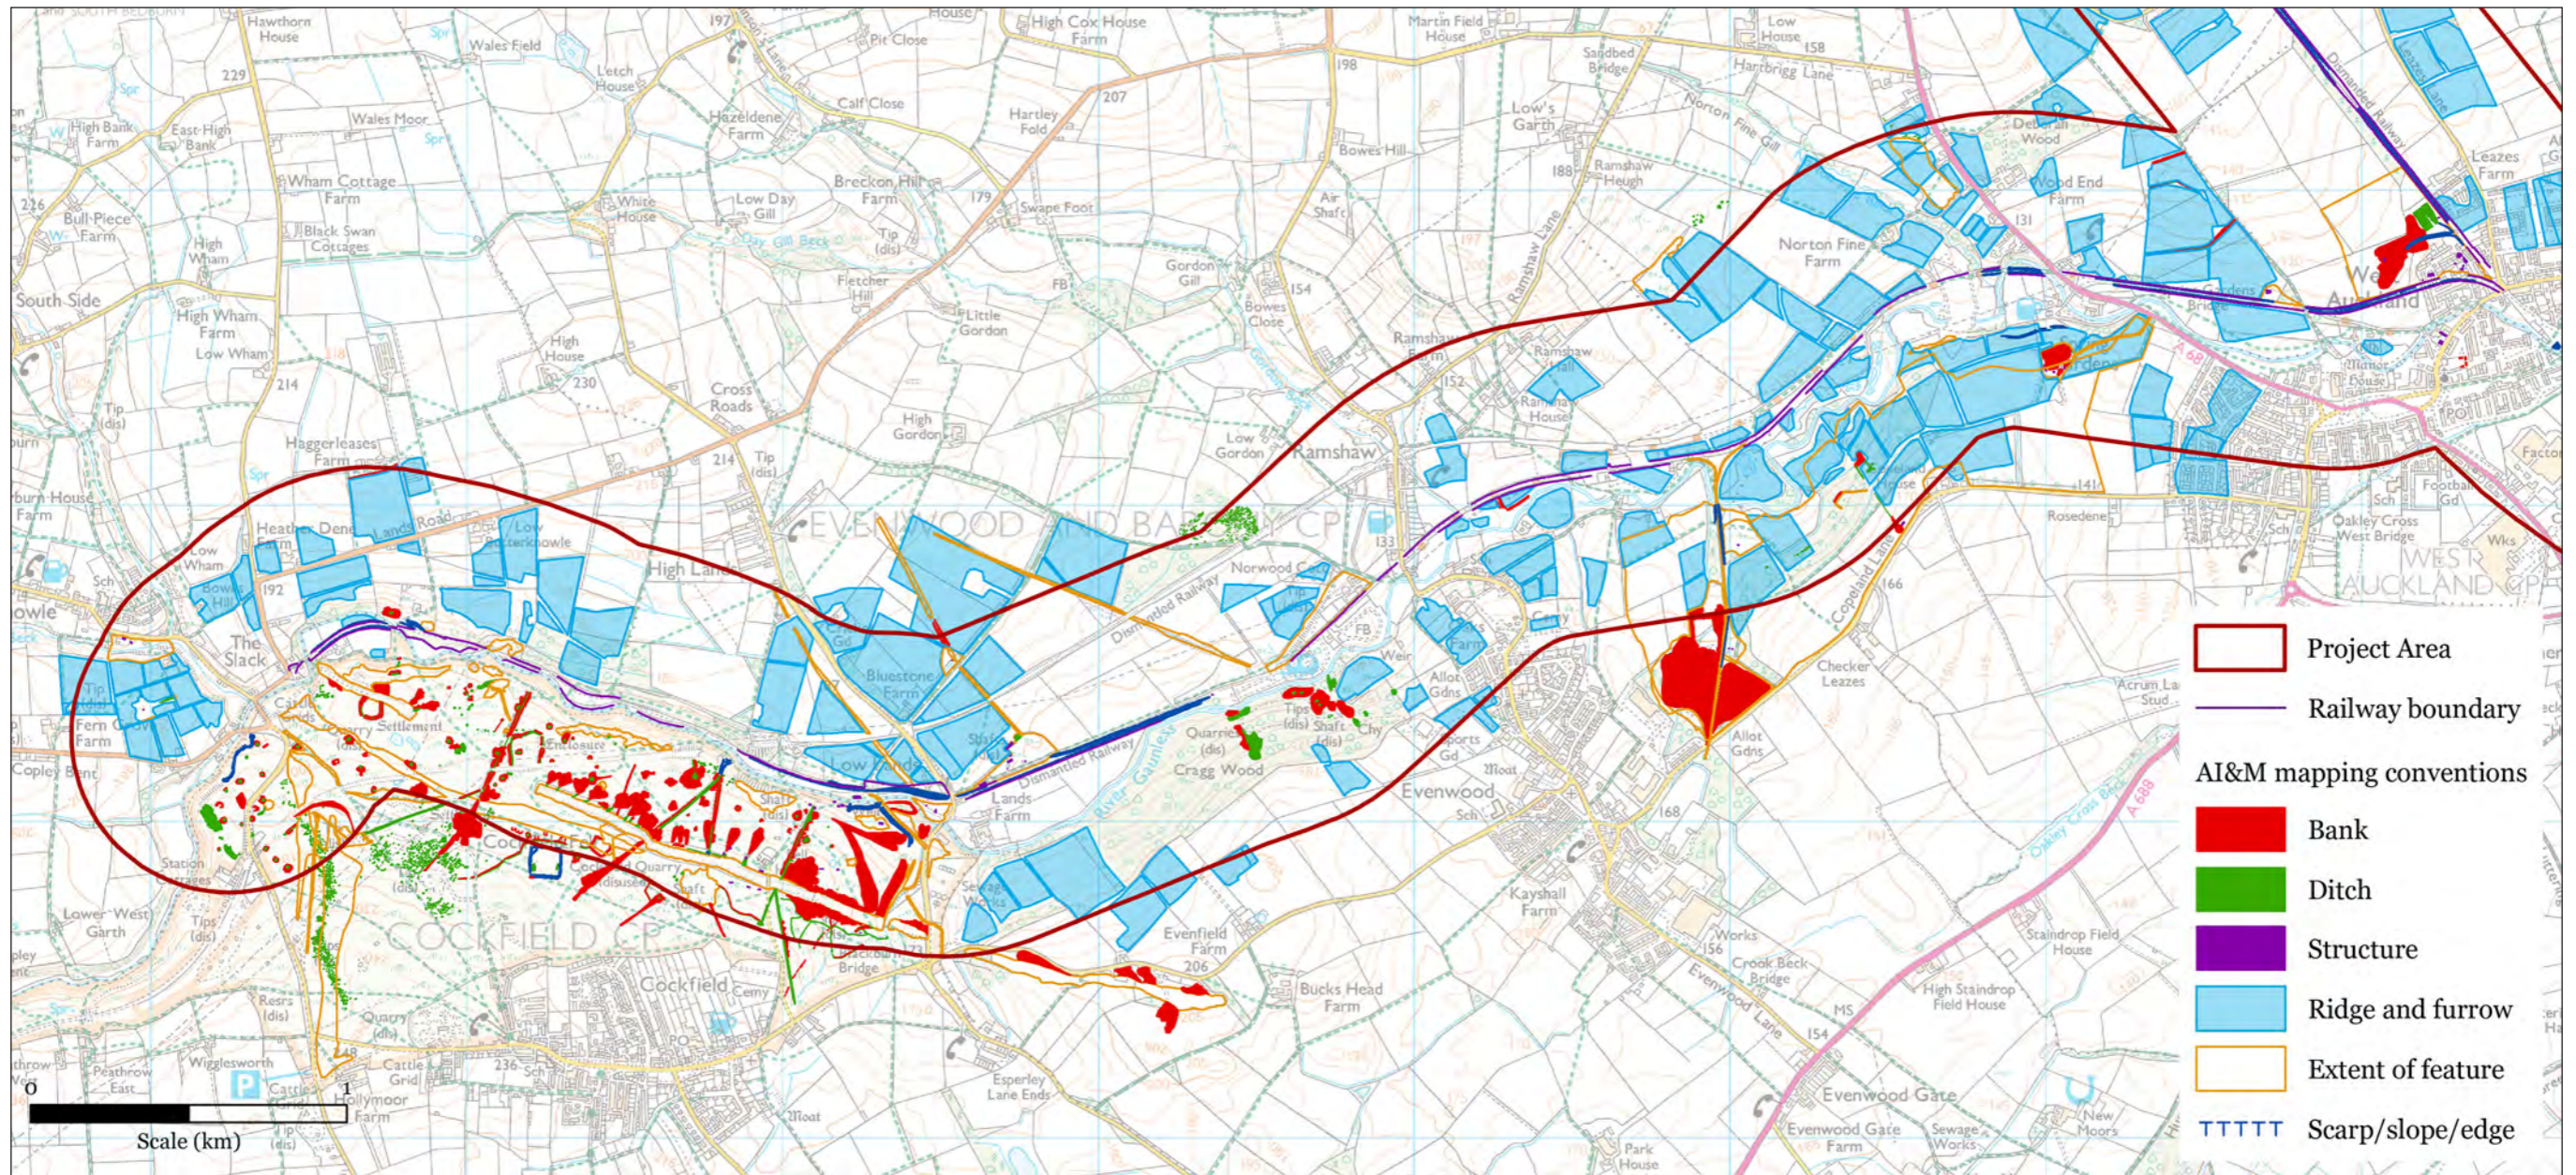
Fig 91: Archaeological and railway features visible on historic aerial photographs along the Haggerleases Branch Line and Surtees Railway. Archaeological mapping © Historic England; Base map © Crown Copyright and database right 2019.
