# Stockton and Darlington Railway Heritage Action Zone Aerial Investigation & Mapping Report

**STOCKTON AND DARLINGTON RAILWAY  
HERITAGE ACTION ZONE**

**Aerial Investigation & Mapping Report**

NGR: NZ 290 156

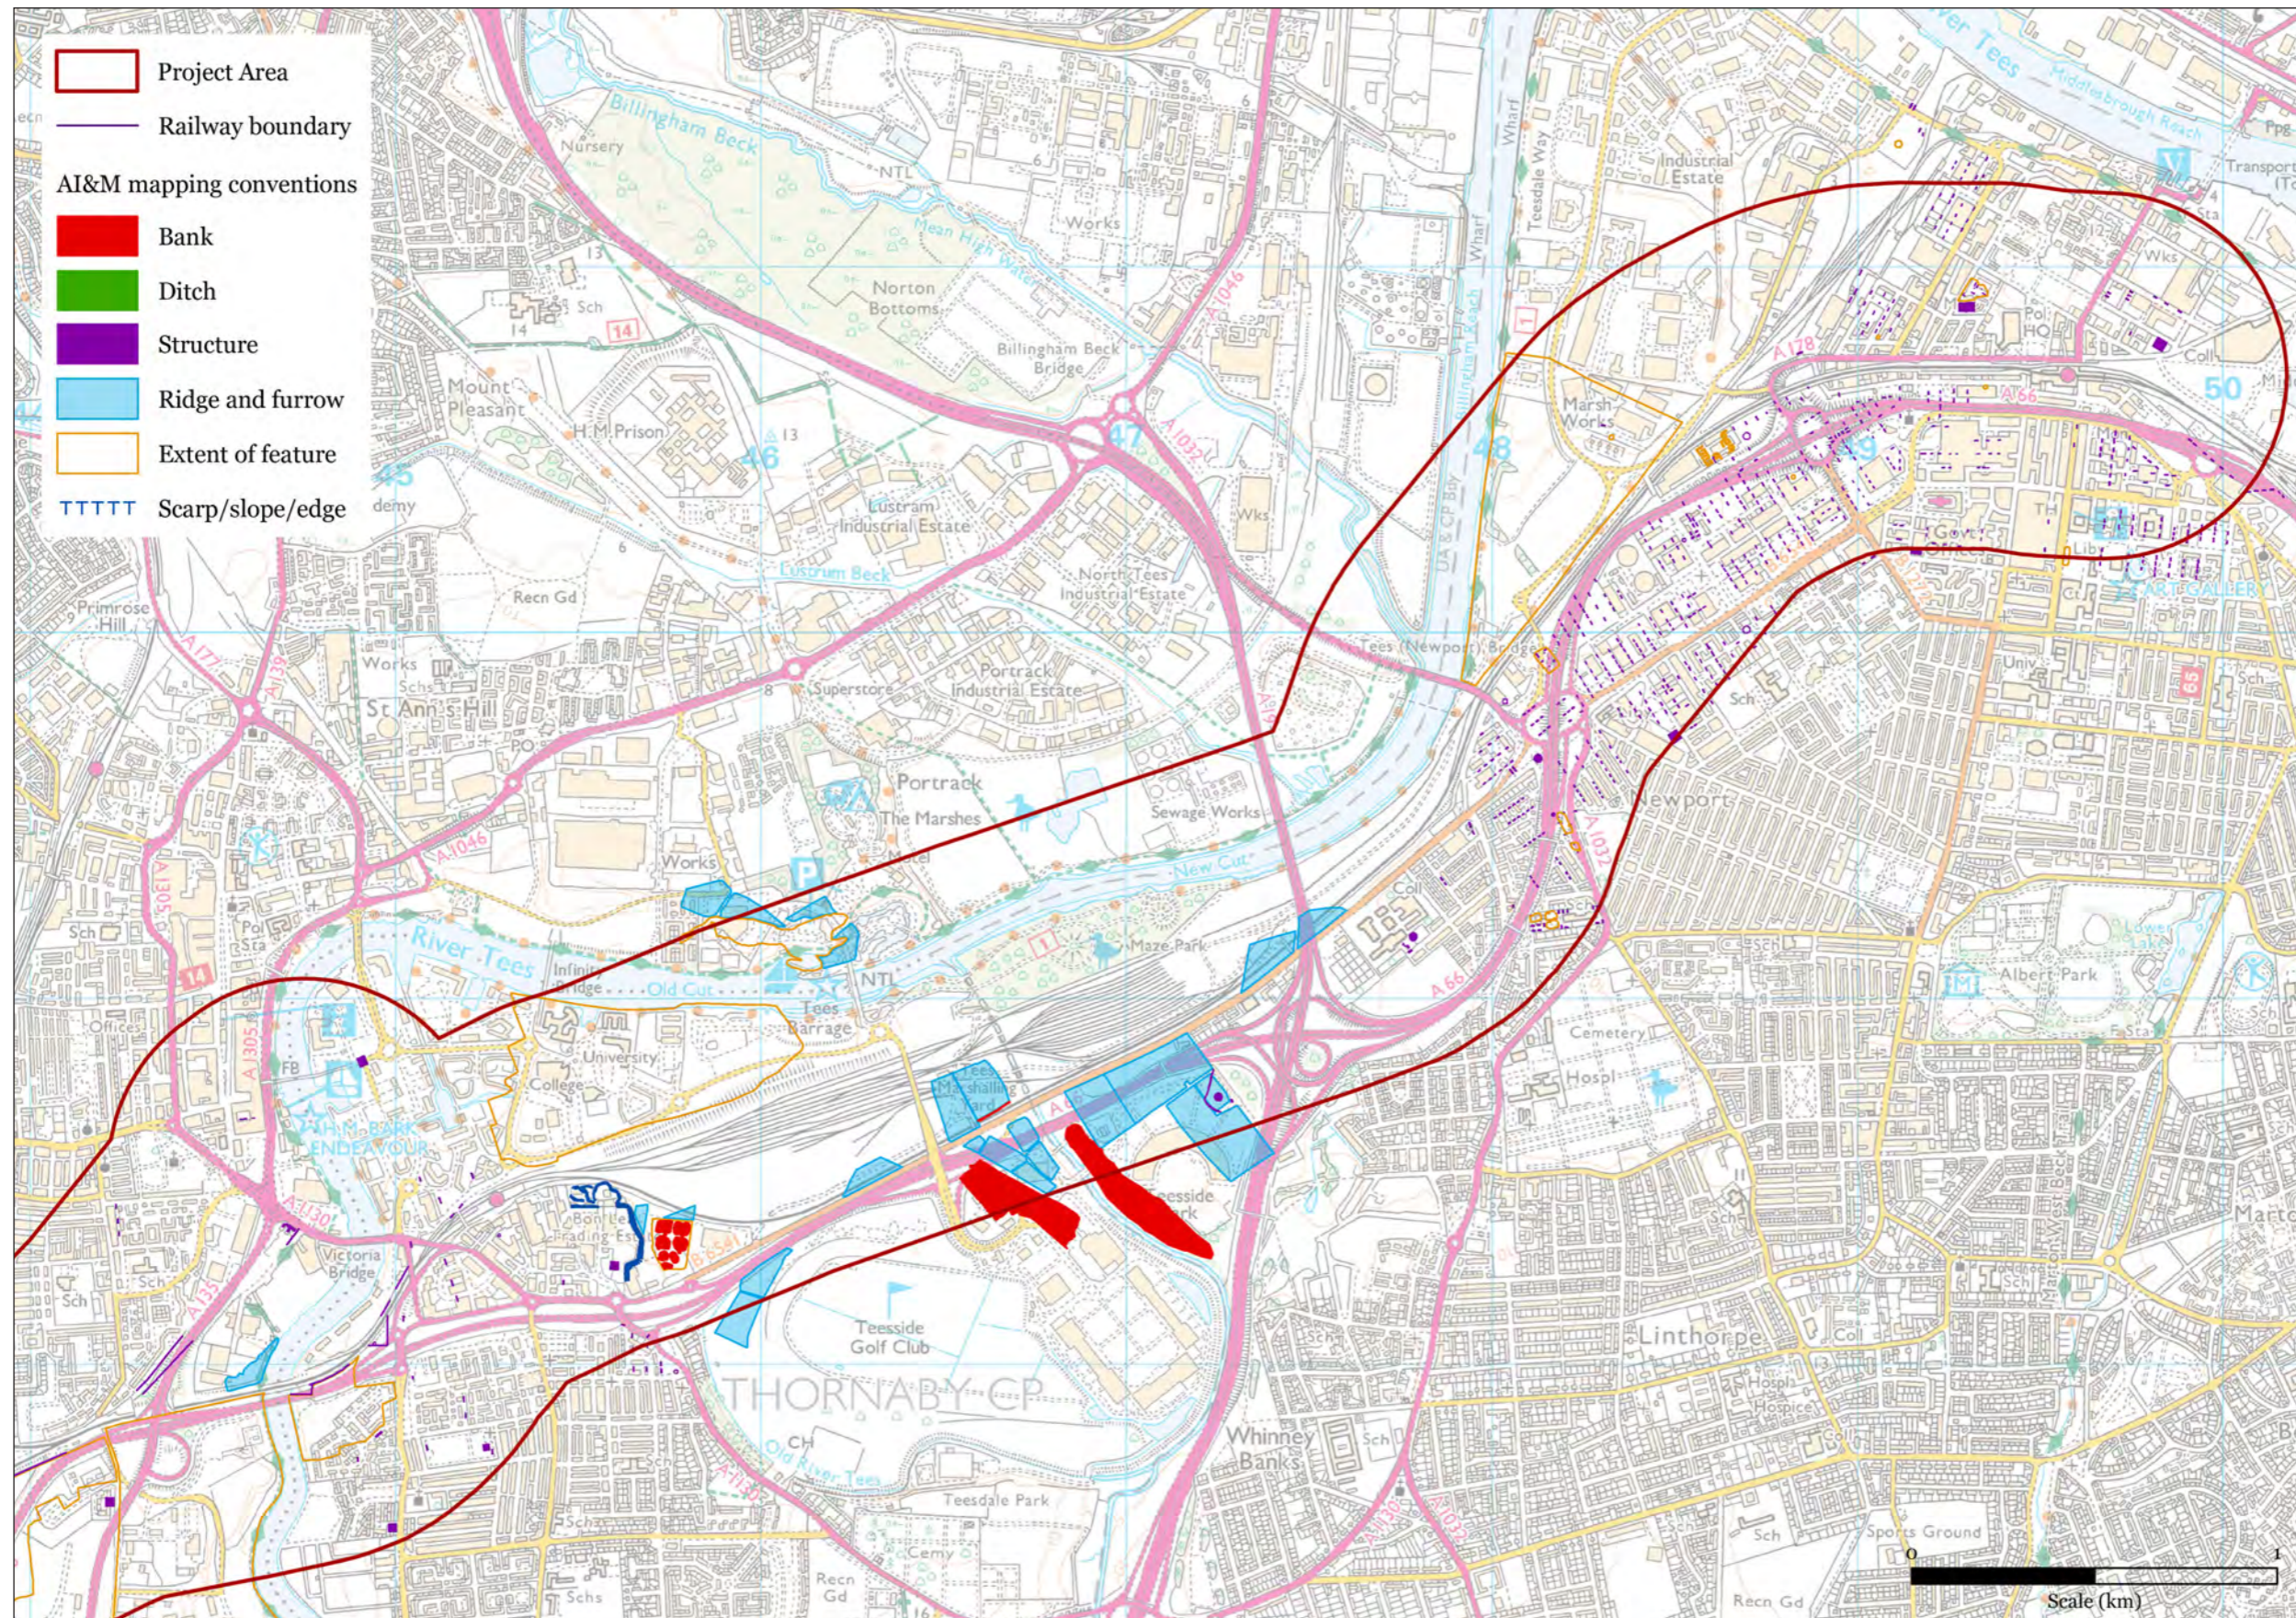
Fig 92: Archaeological and railway features visible on historic aerial photographs along the Middlesbrough Extension. Archaeological mapping © Historic England; Base map © Crown Copyright and database right 2019.
